RFP #18-02 for College-Wide Roof Repairs

**Damage Report**

DEFECT/DAMAGE LIST HURRICANE IRMA

### ROOF SURVEY DAMAGE REPORT- HURRICANE IRMA

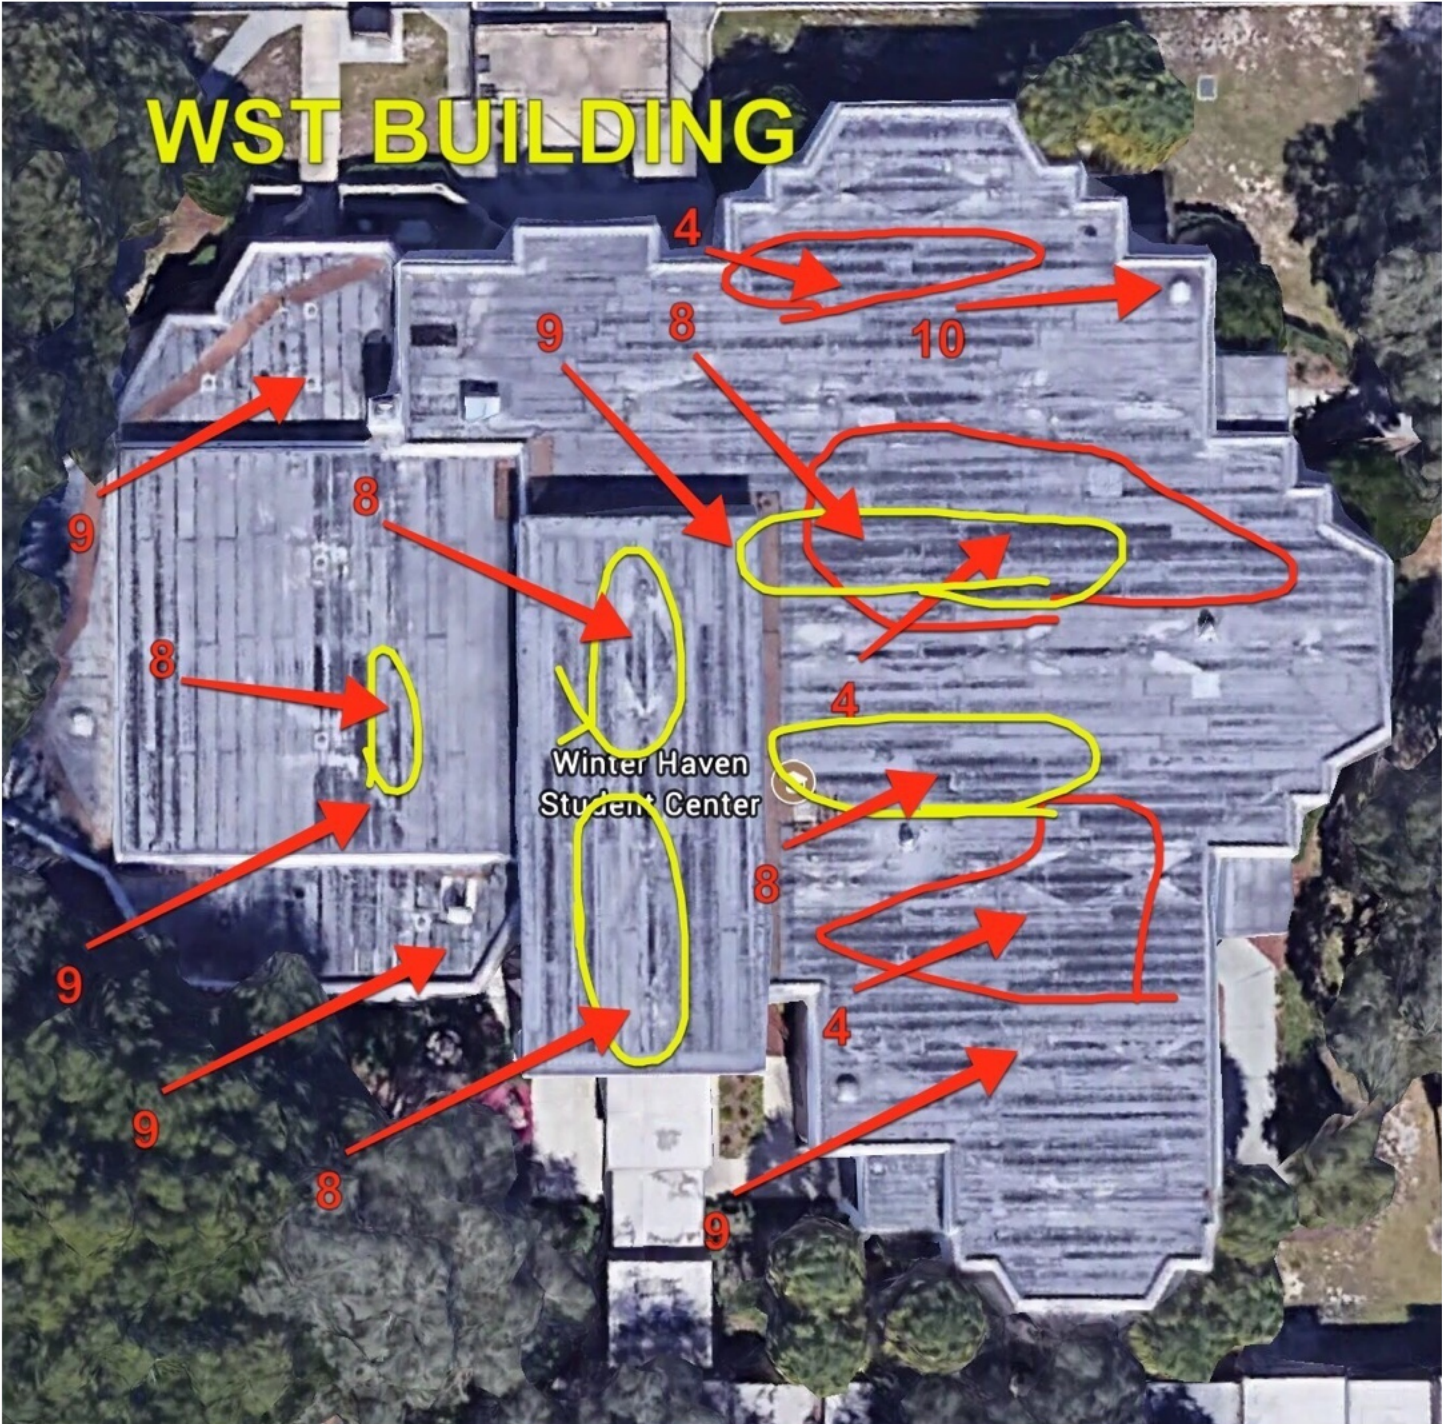
Upper roof area.

Item # 8- Roof membrane possibly uplifted from winds.

Note: Item # 8 is isolated on lower roofs and extensive on the high roof. Approximately 35% of the high roof appears to have lifted during the storm. Membrane remains sound but has detached from the substrate.
