RFP #18-02 for College-Wide Roof Repairs

**Damage Report**

DEFECT/DAMAGE LIST HURRICANE IRMA

### ROOF SURVEY DAMAGE REPORT- HURRICANE IRMA

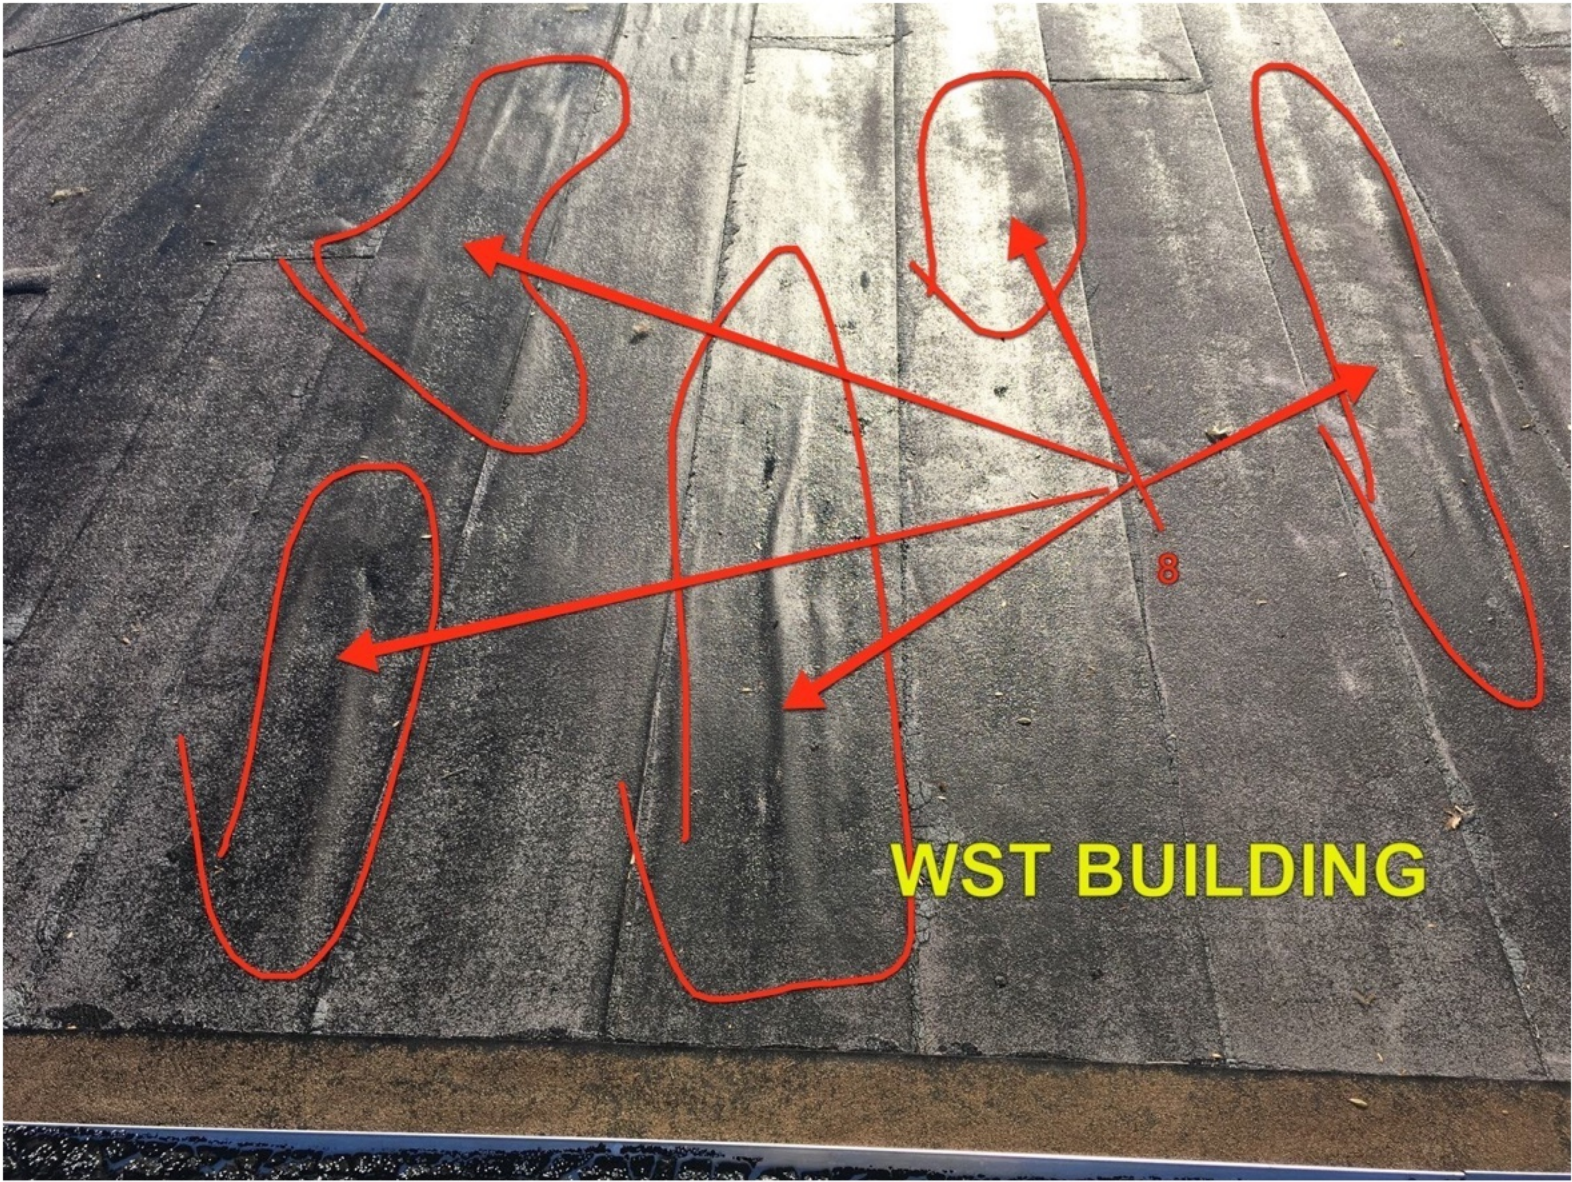
Upper roof area.

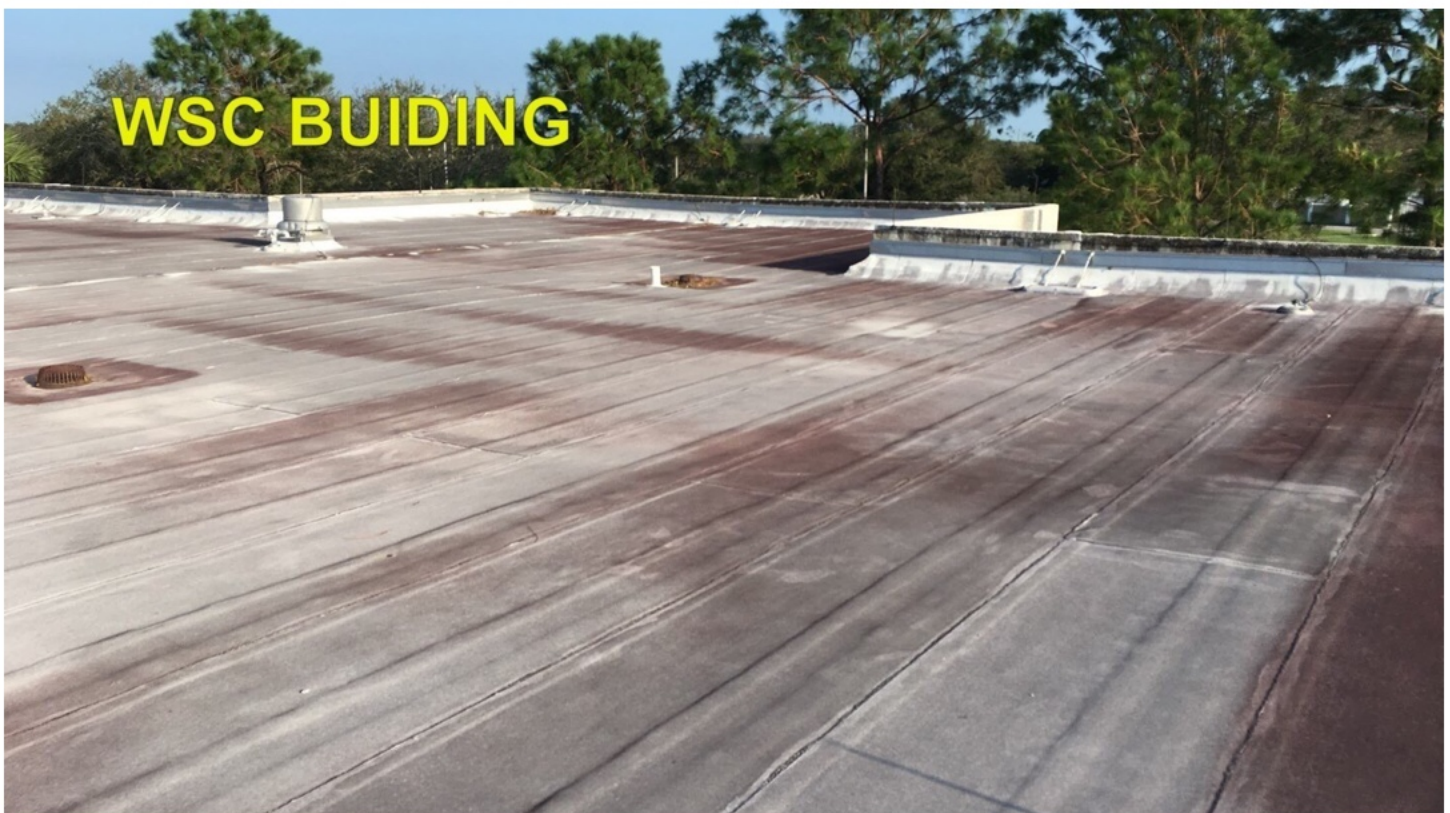
Item # 10- Damage to equipment- vents, power ventilators, hoods. The cap to a stainless steel vent stack was missing from its attachment anchor.

Note: No damage was noted to membrane from wind borne debris. Mineral surfacing appears in place with no major issues. Roof system appeared from walking observation to be well bonded to the substrate.

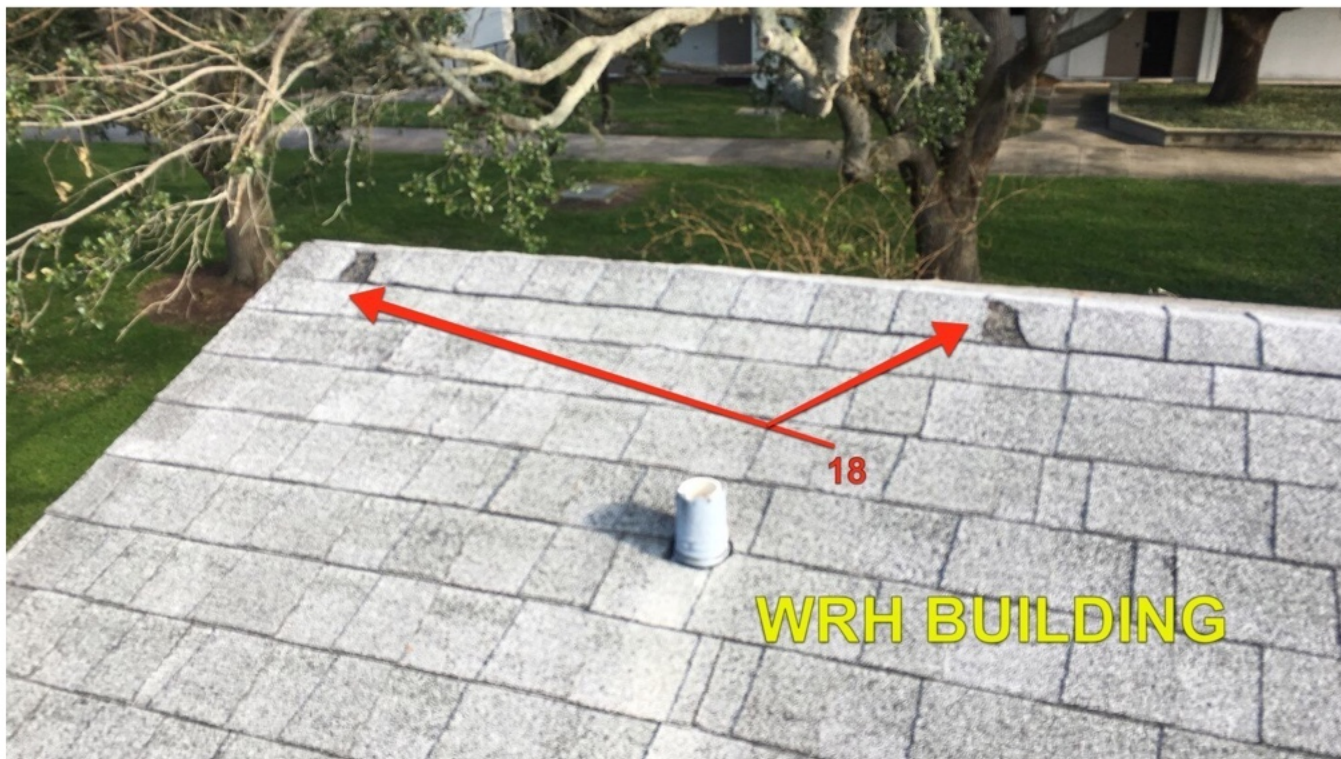
Item #18- damage to shingle roof system, broken shingles, missing shingles or flashings.

Note: Damage to shingles was limited to several locations with minor area damage.

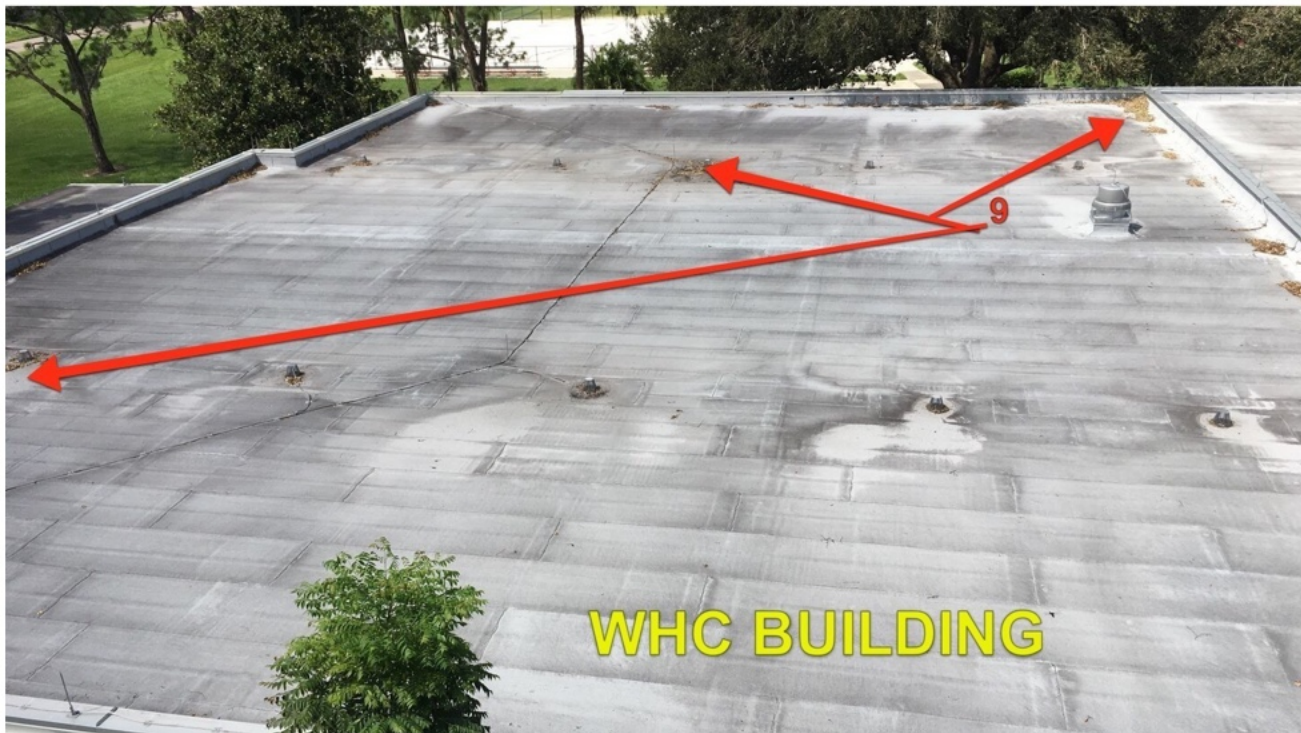
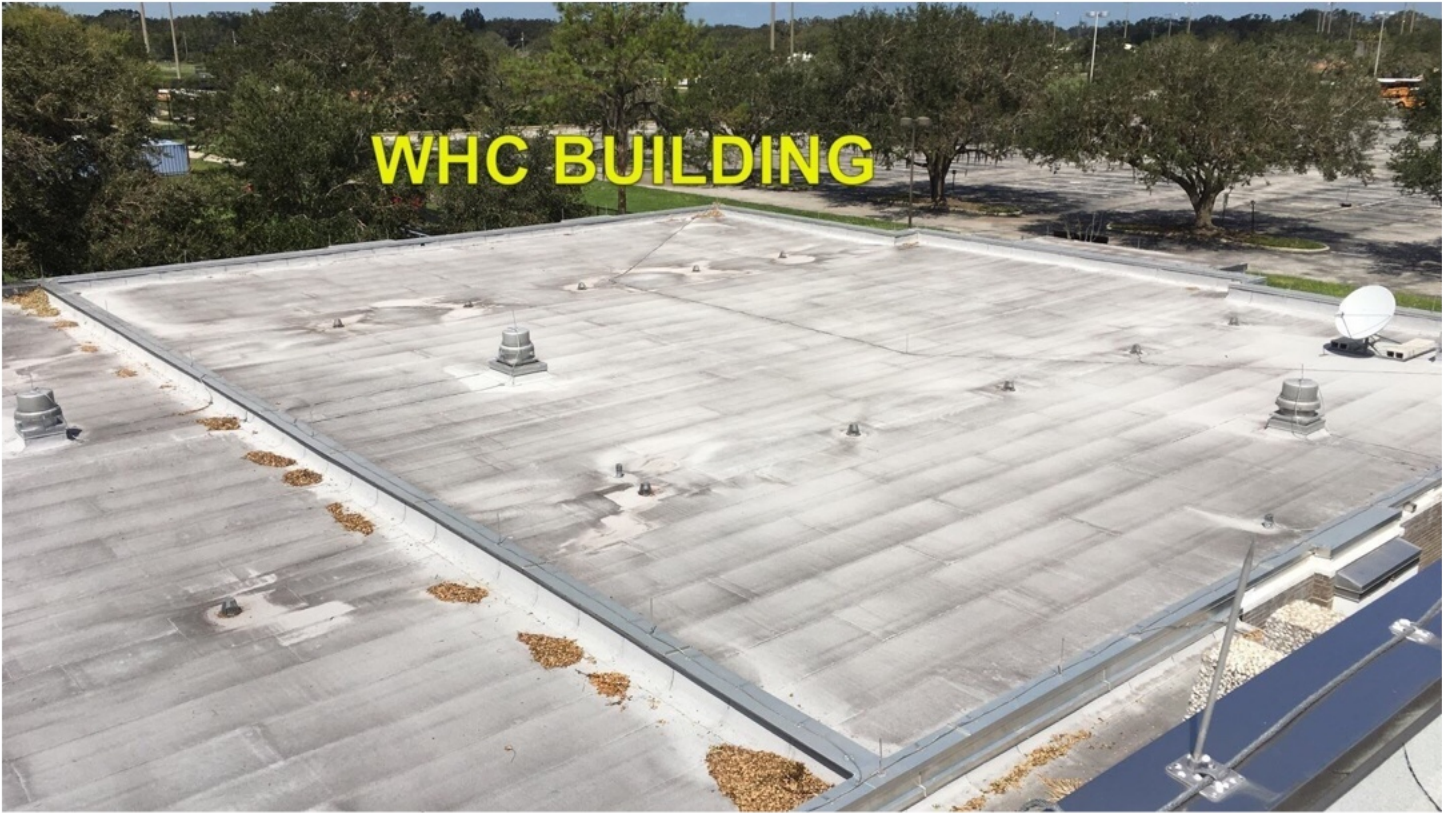
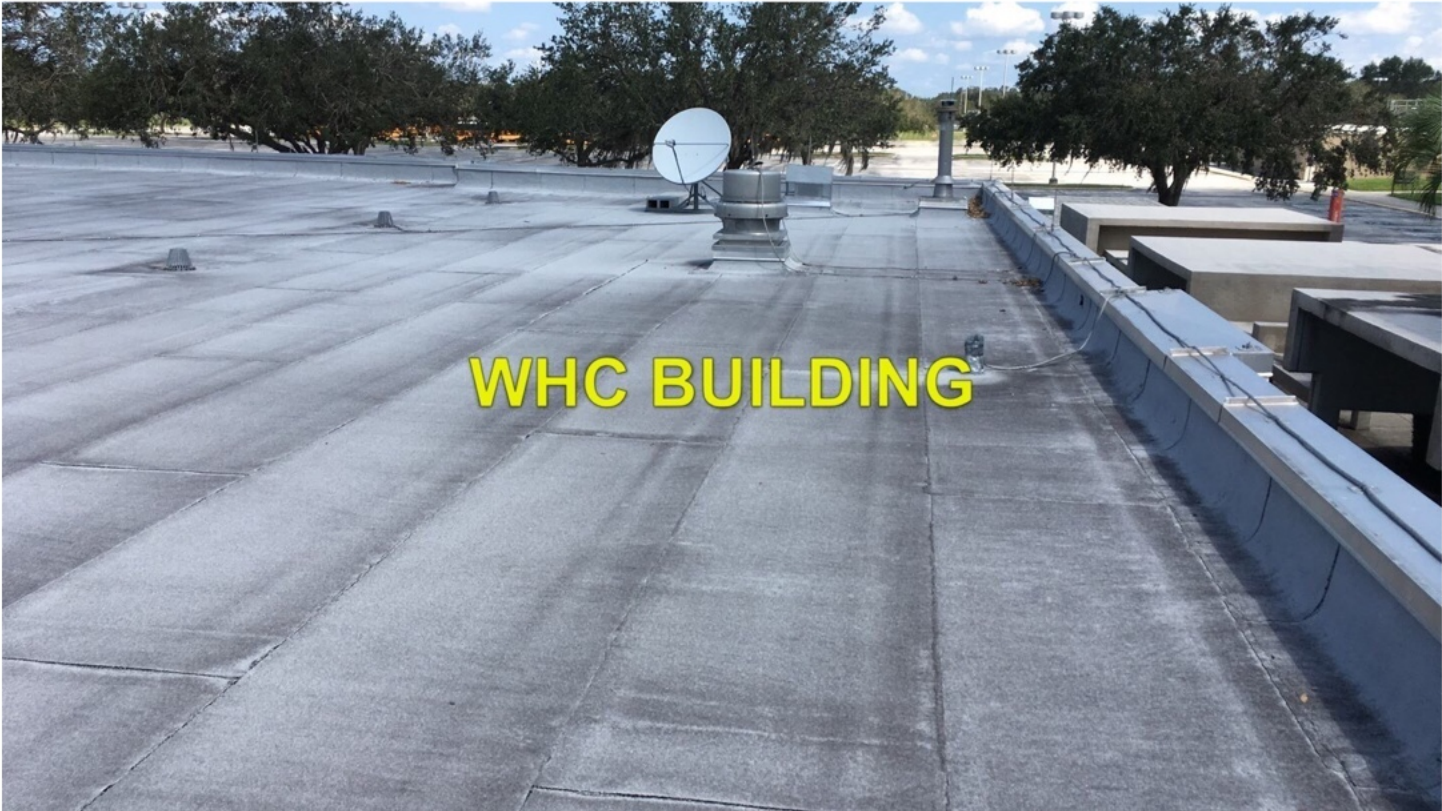
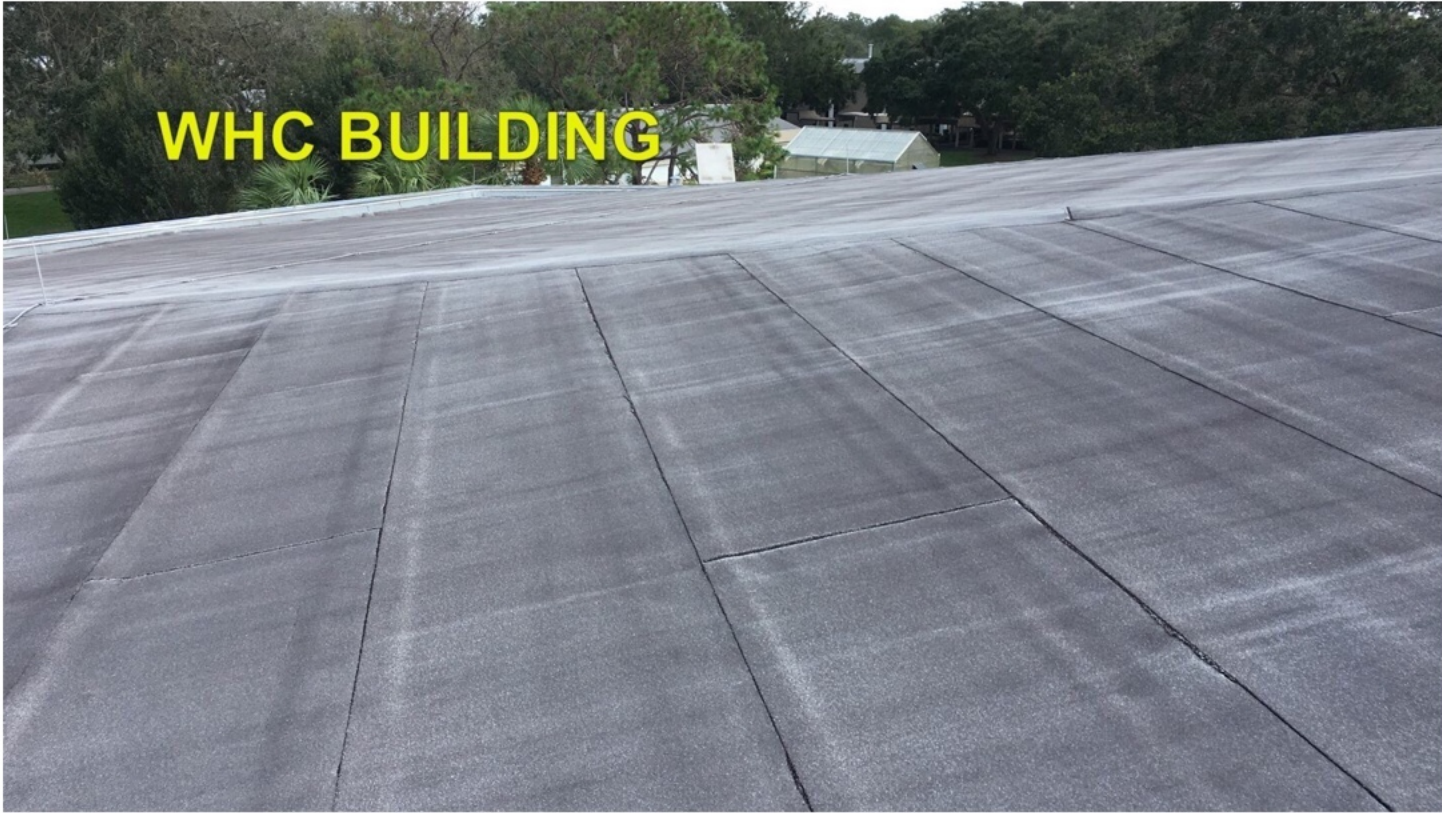
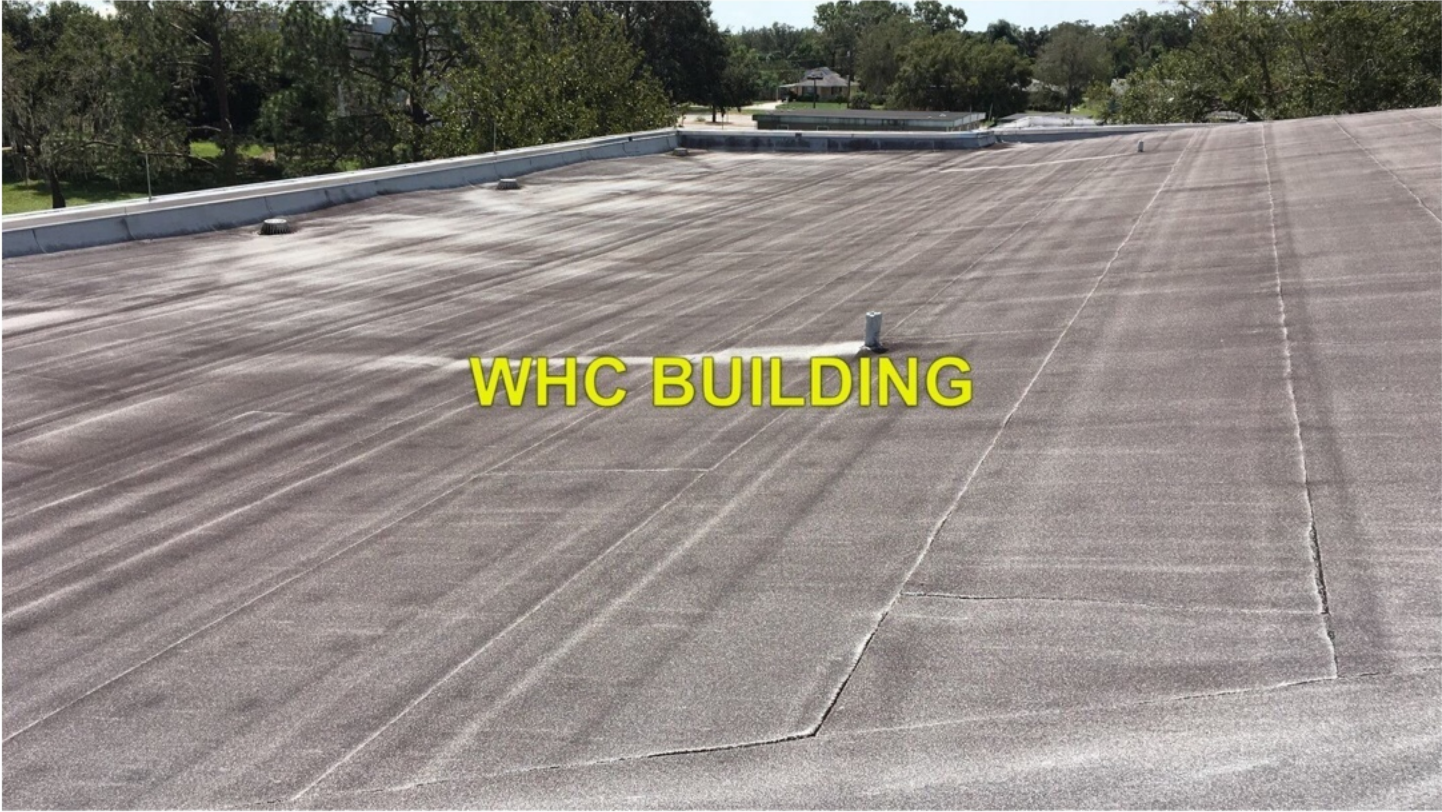
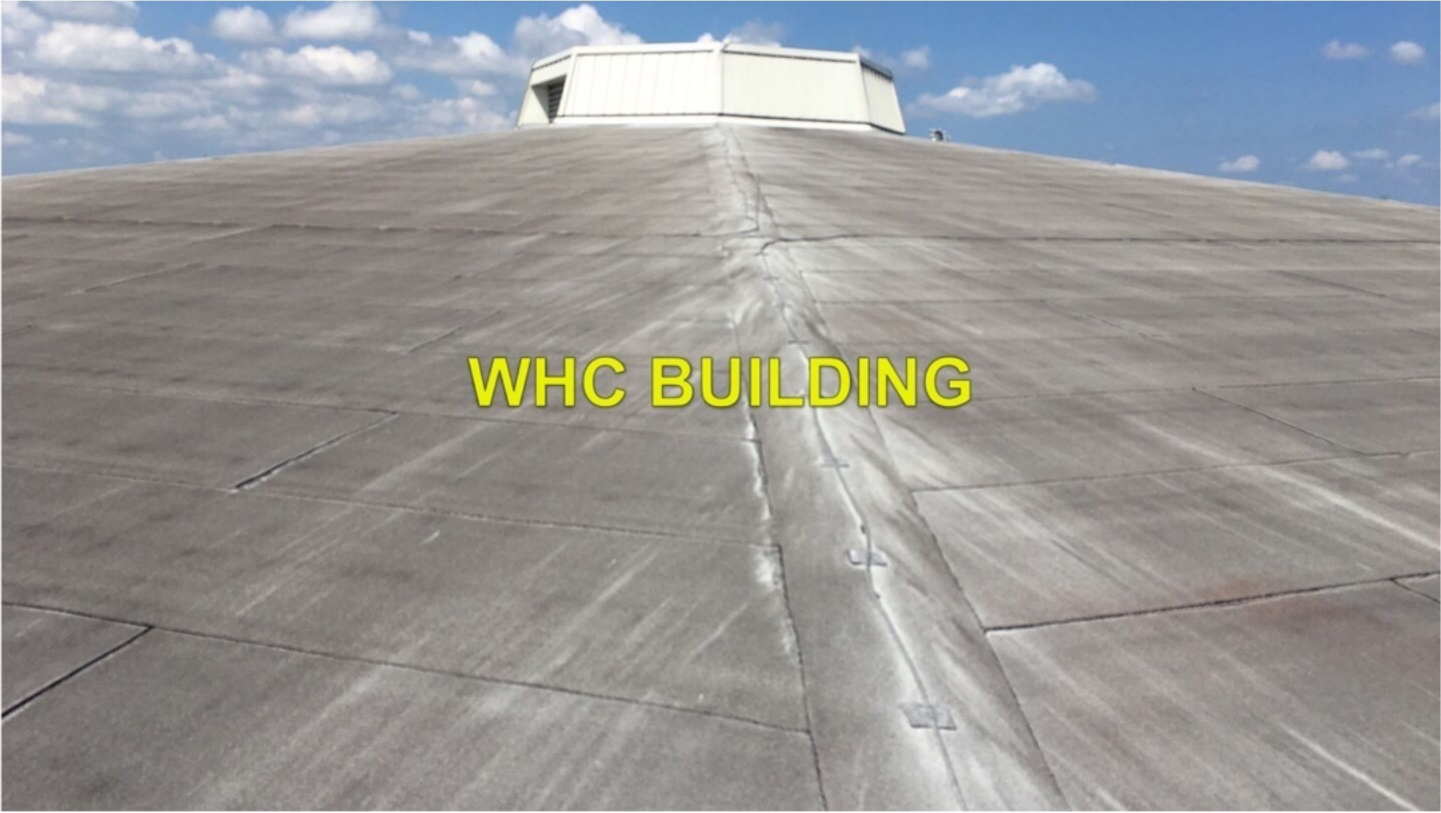
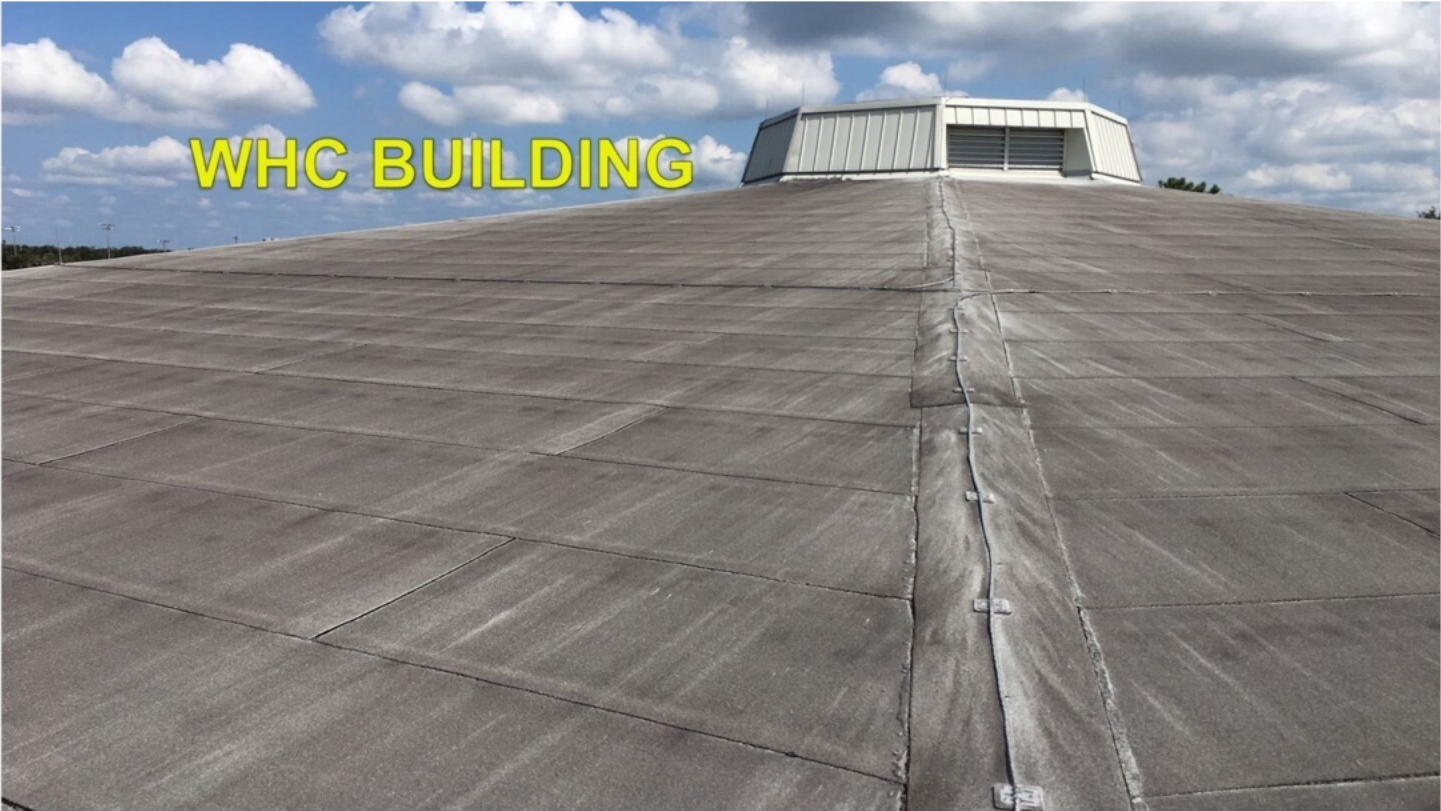
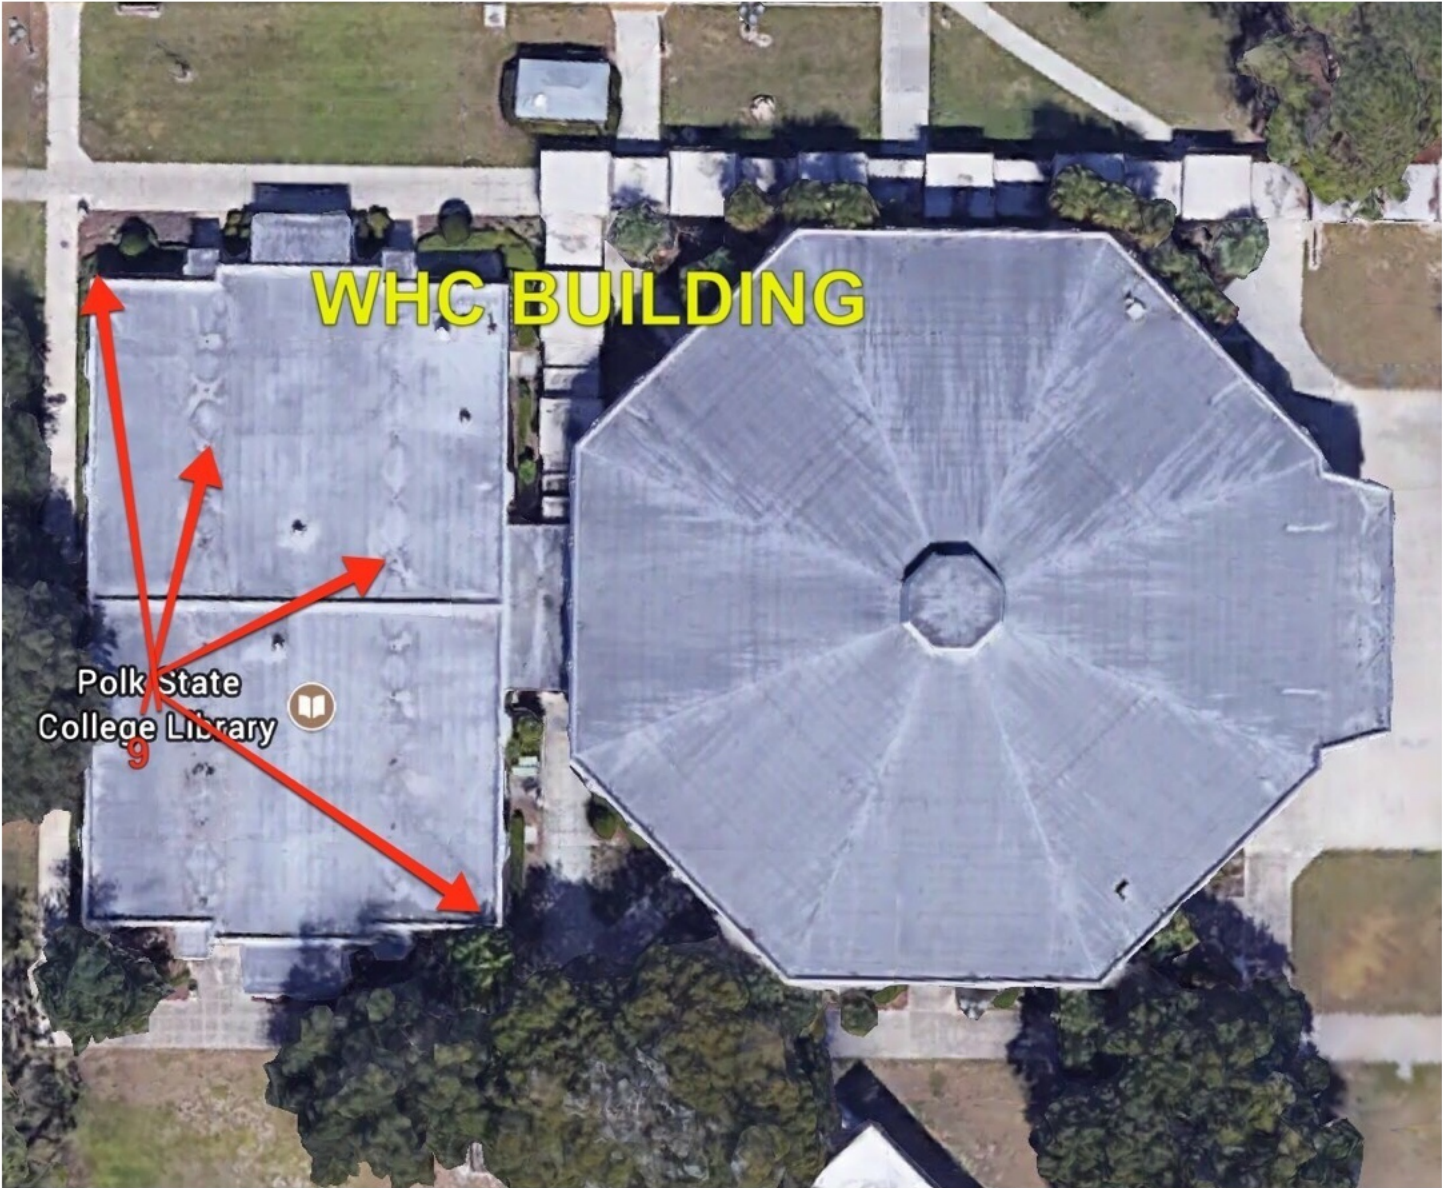
Item # 9- Debris on the roof. Debris was noted on the lower roof only.

Note: No damage to roof membrane or mineral surfacing was noted during the inspection. Lower roof area had the majority of the debris. No indication of damage to membrane from wind borne debris was noted.
