RFP #18-02 for College-Wide Roof Repairs

**Damage Report**

DEFECT/DAMAGE LIST HURRICANE IRMA

### ROOF SURVEY DAMAGE REPORT- HURRICANE IRMA

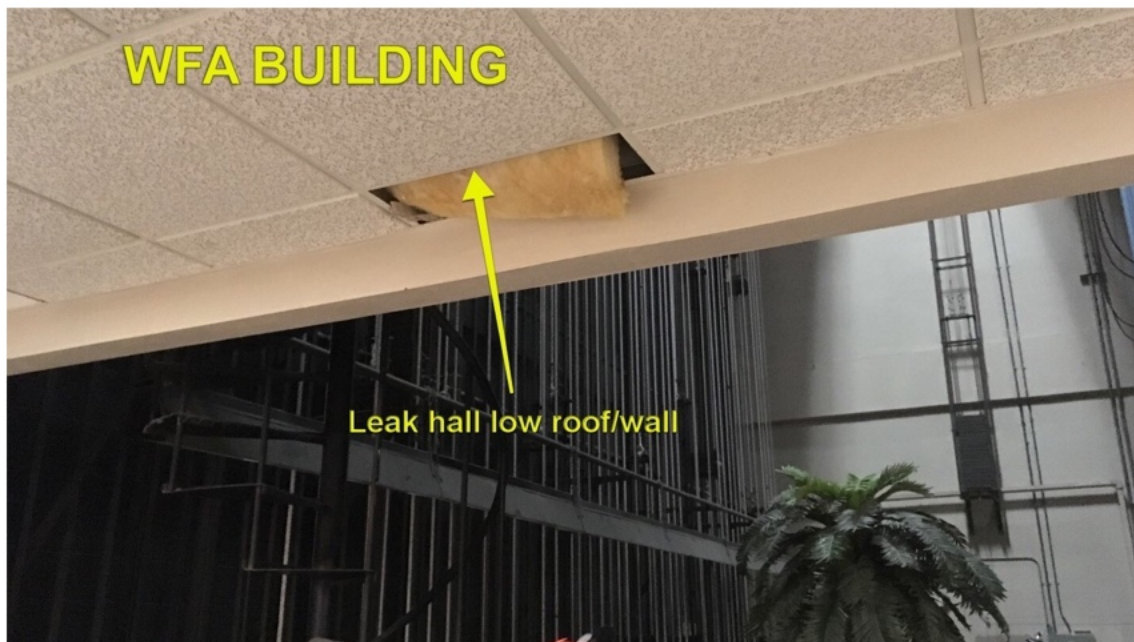
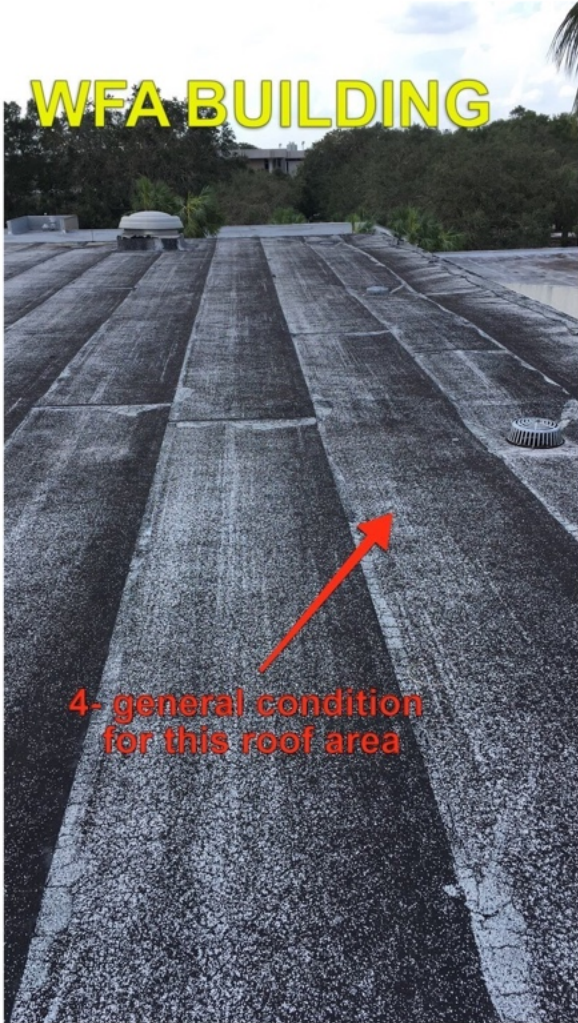
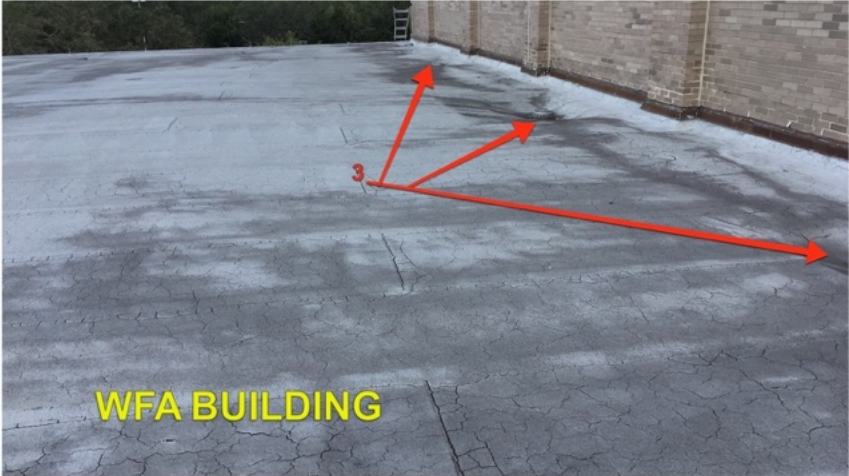
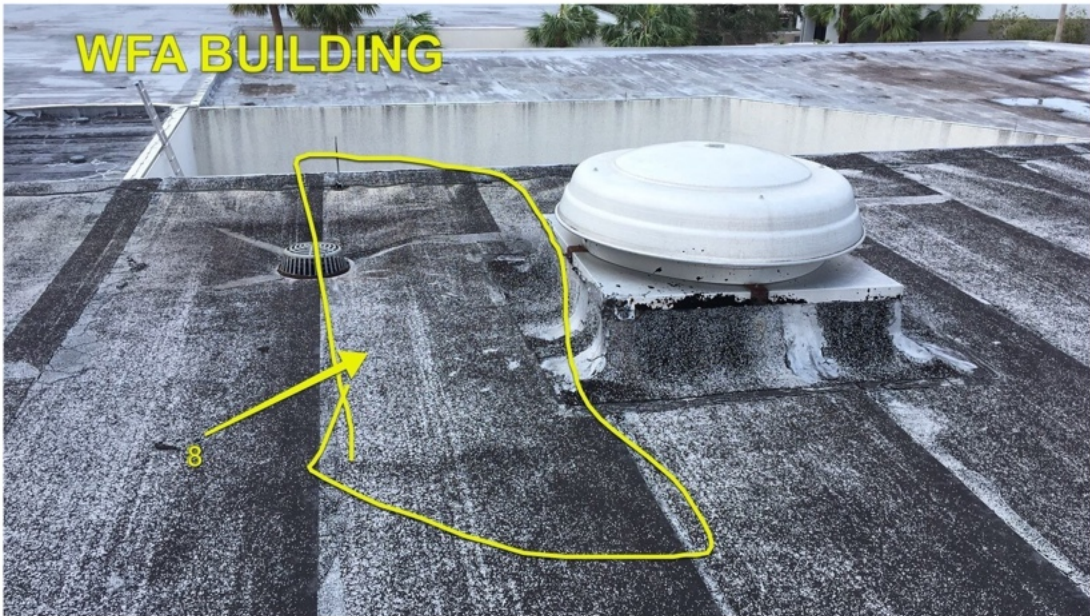
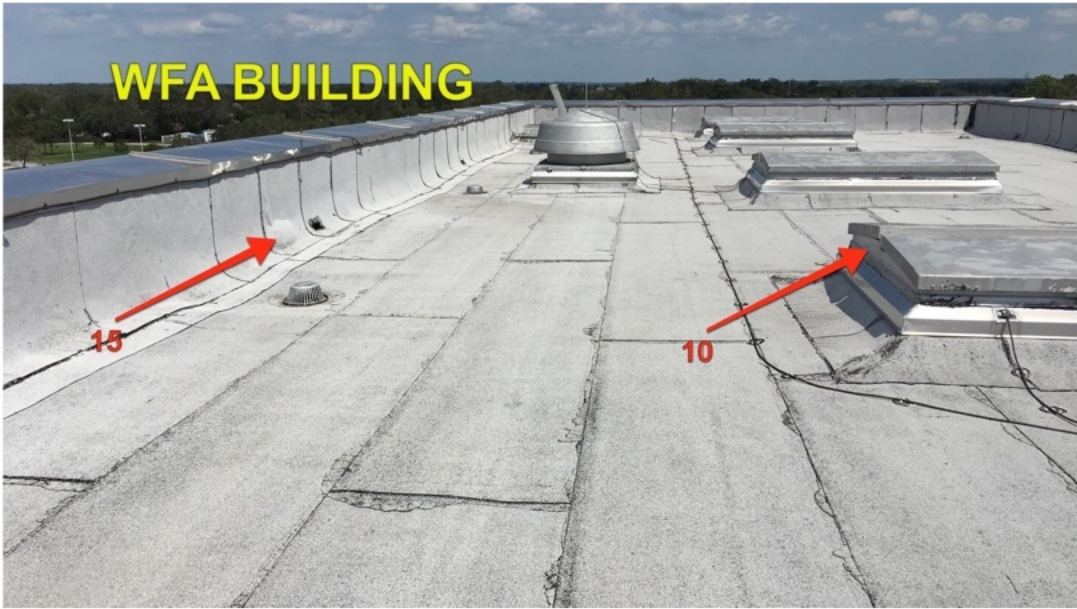
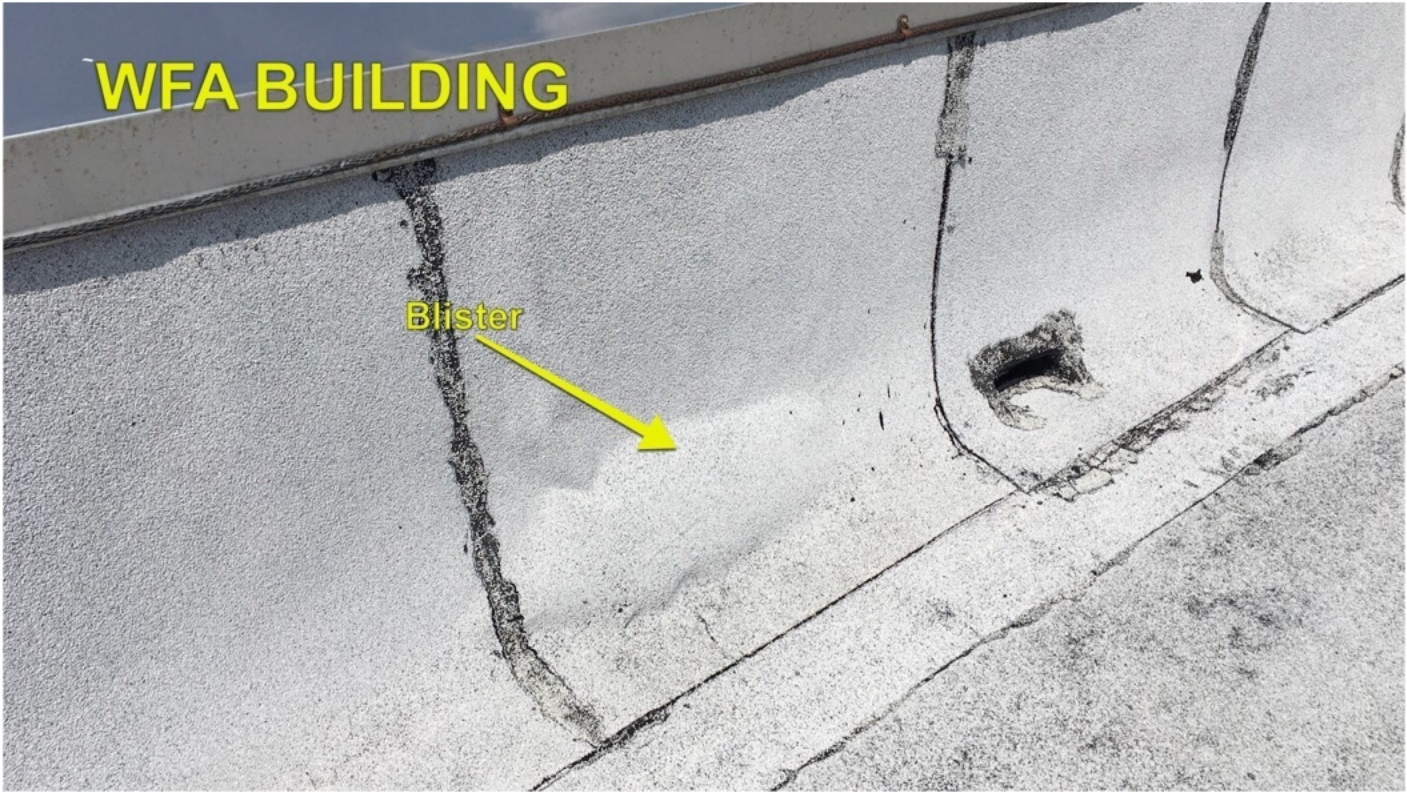
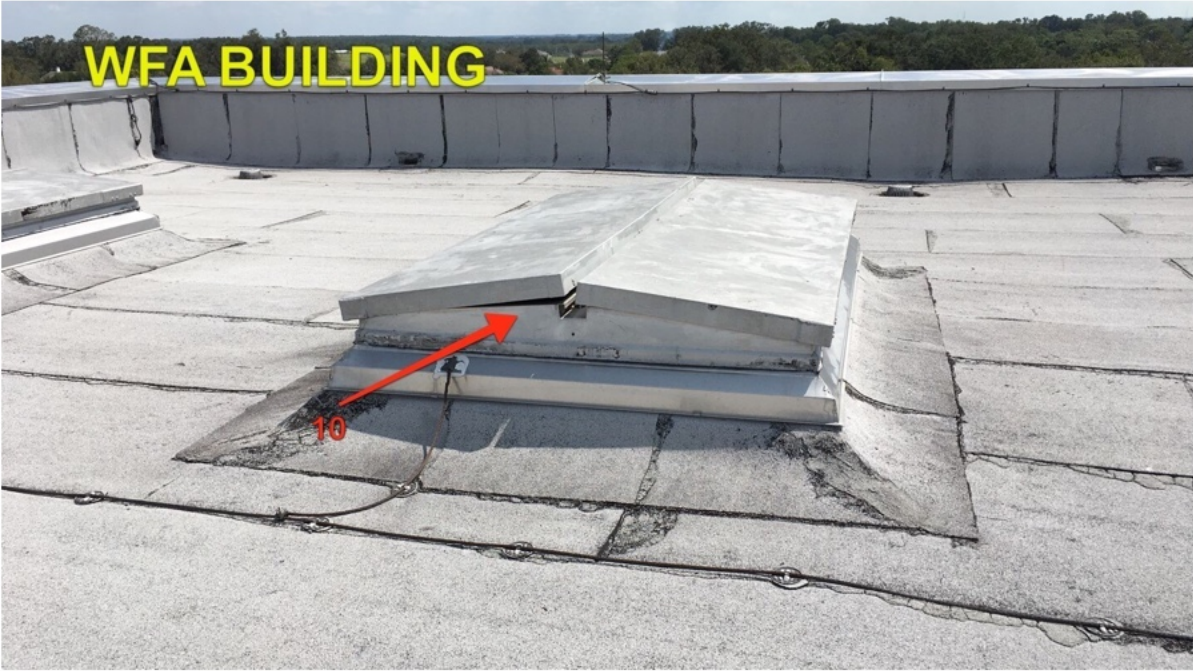
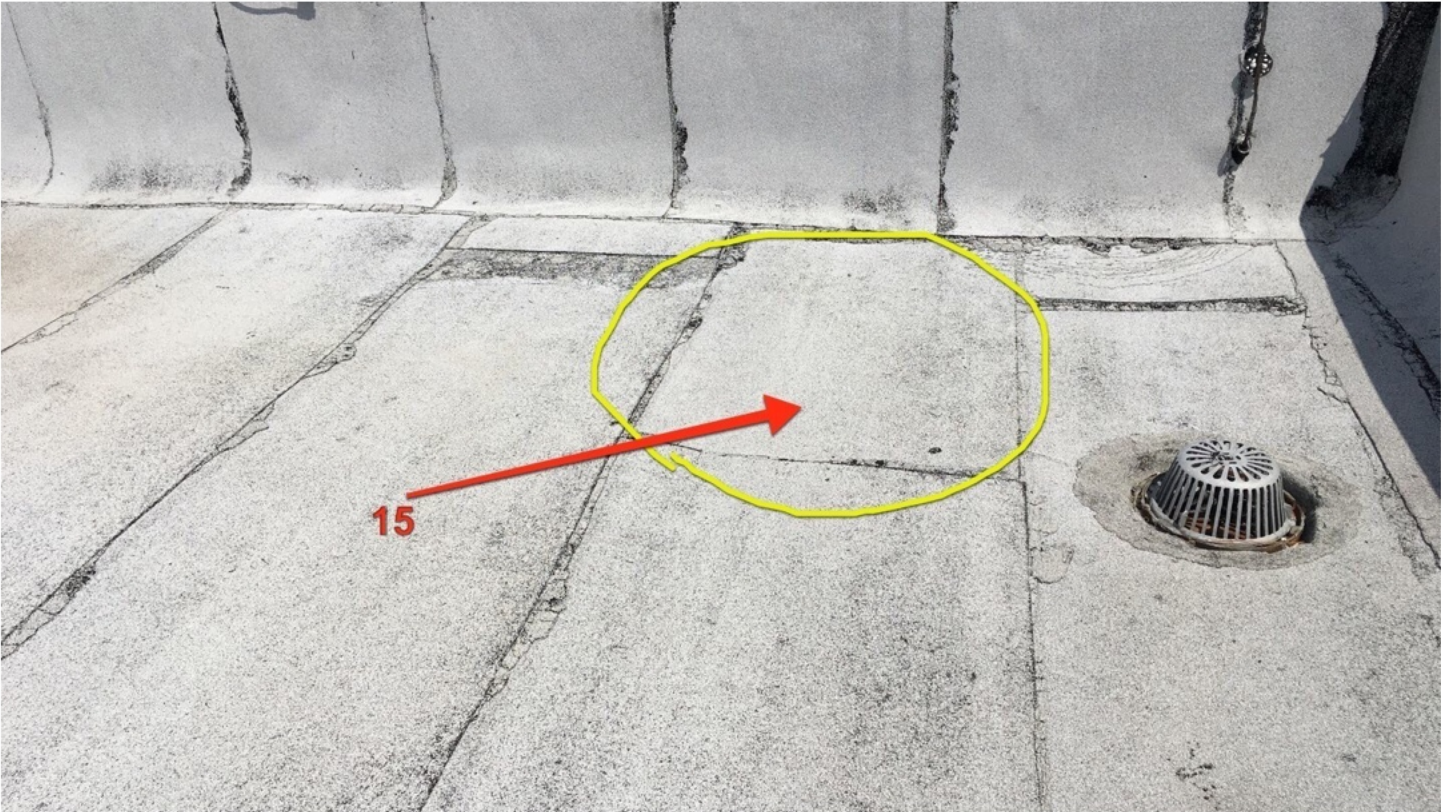
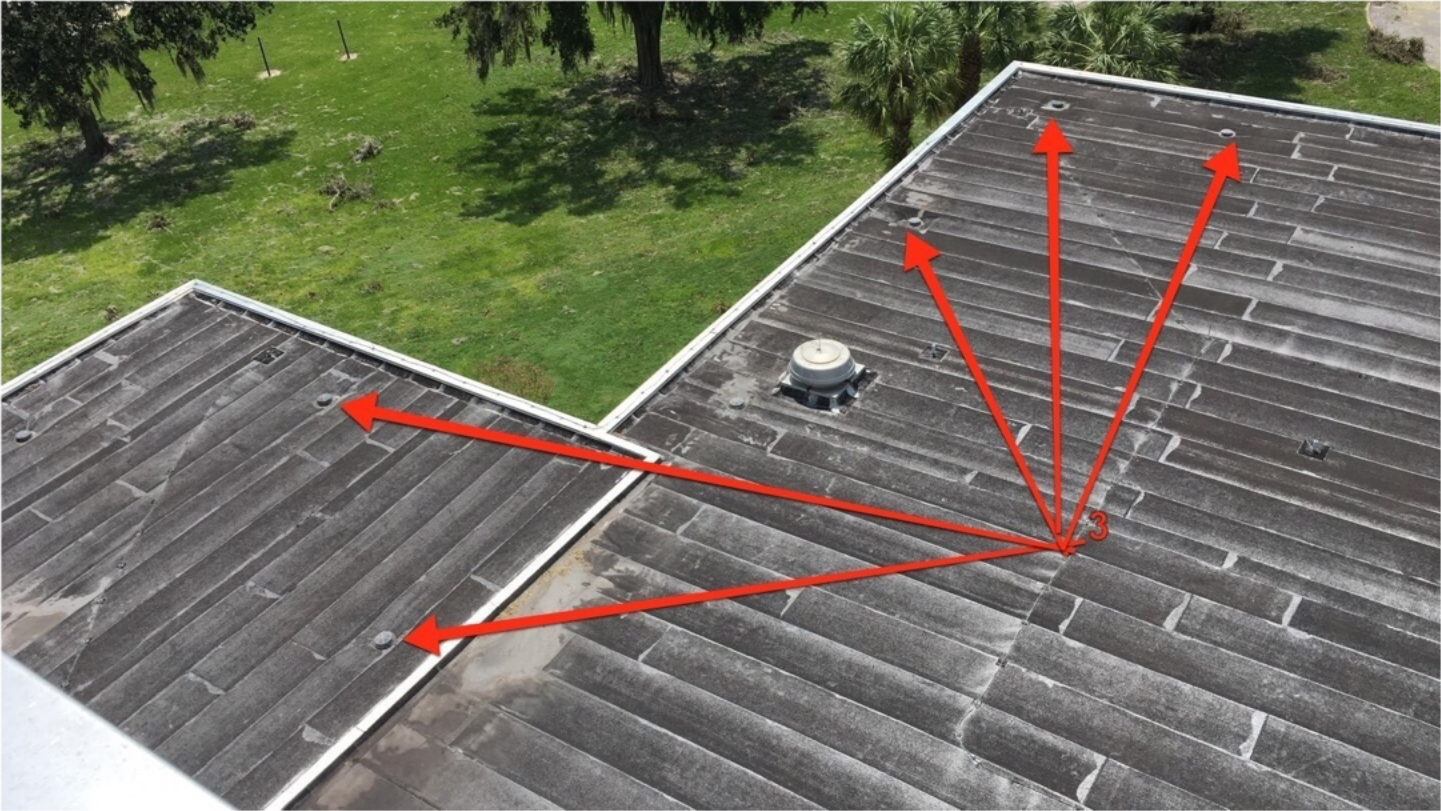
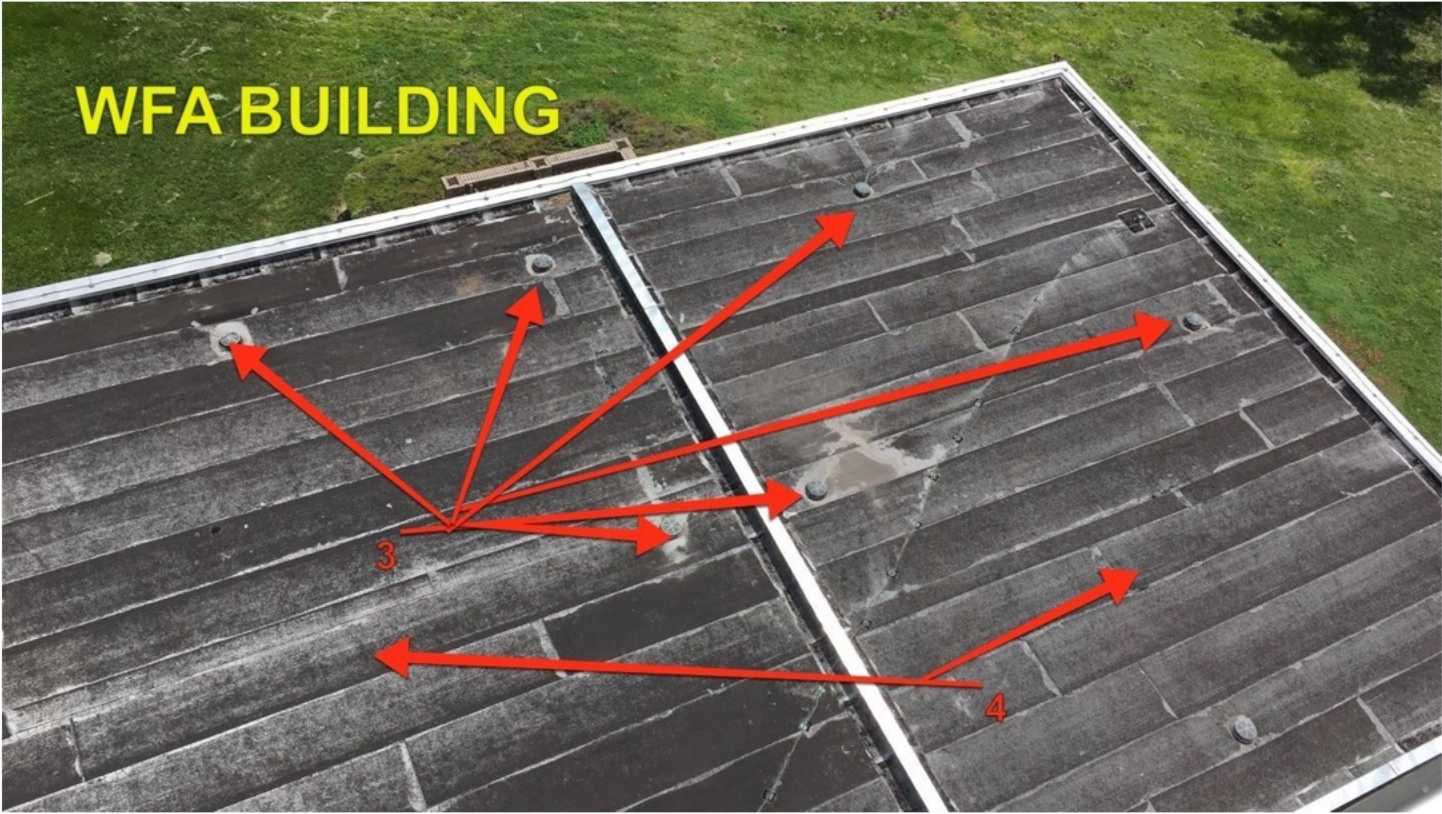
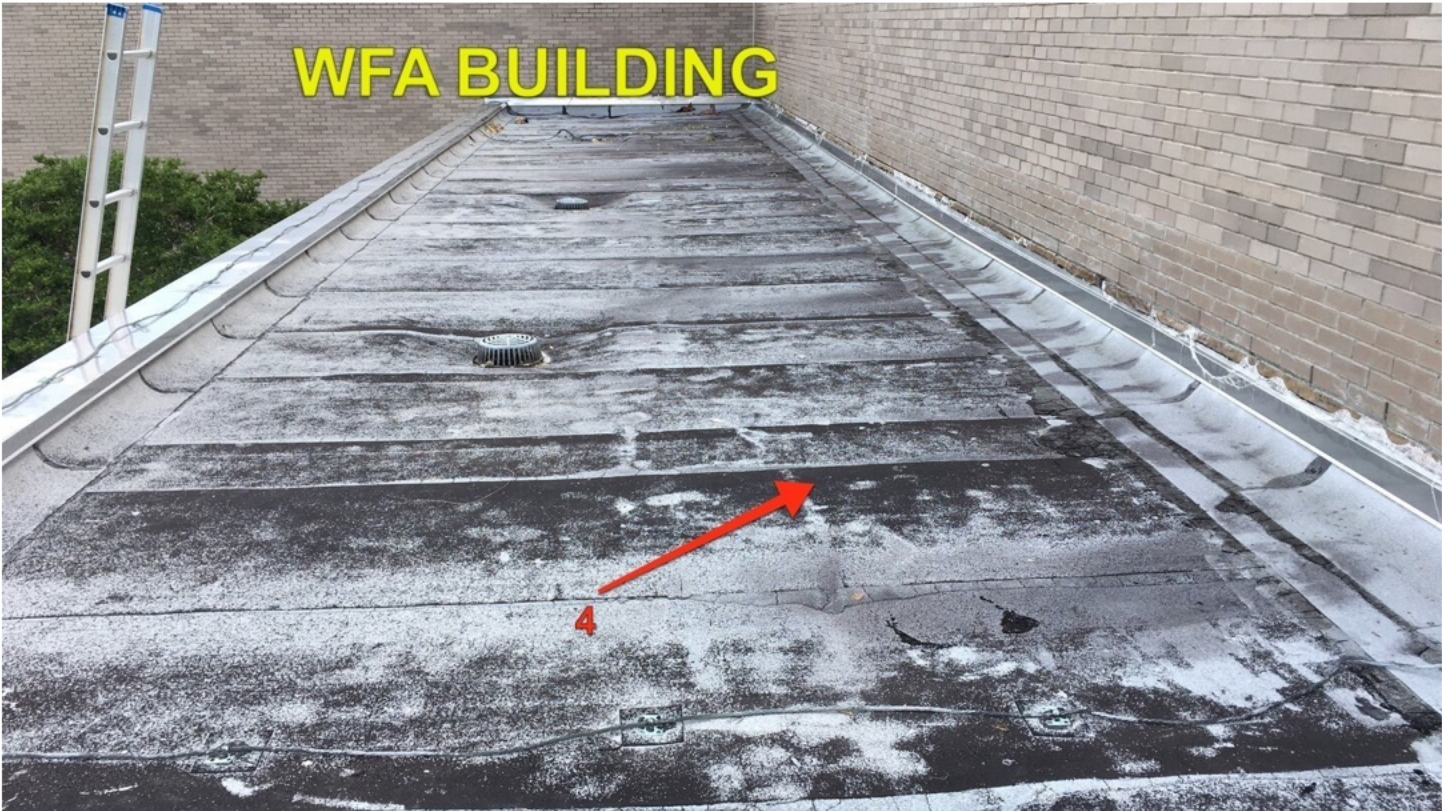
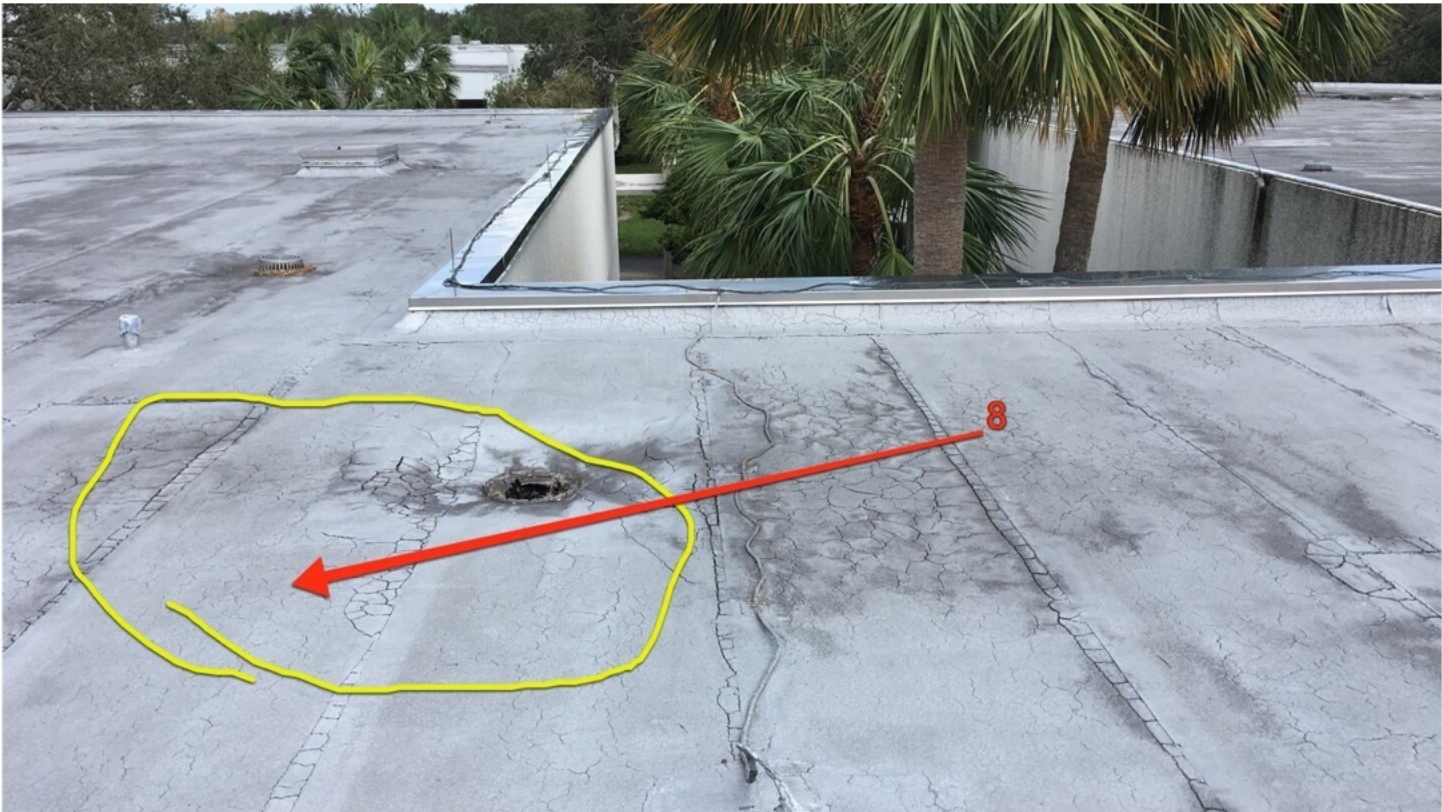
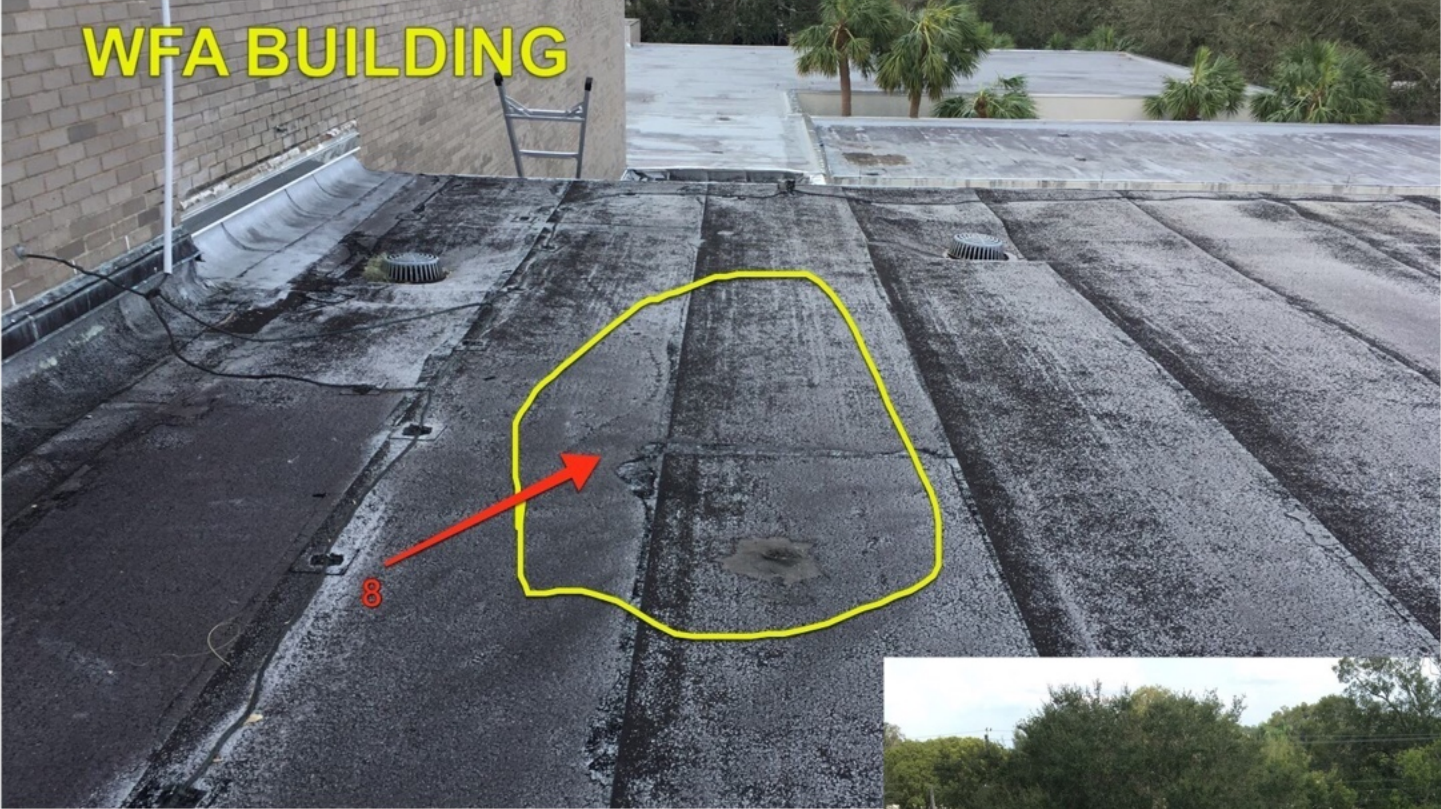
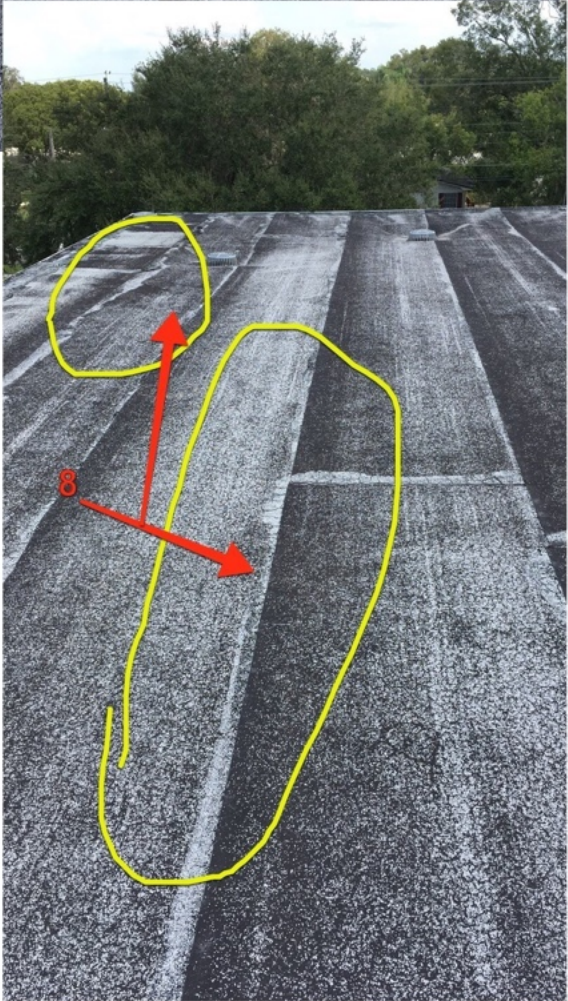
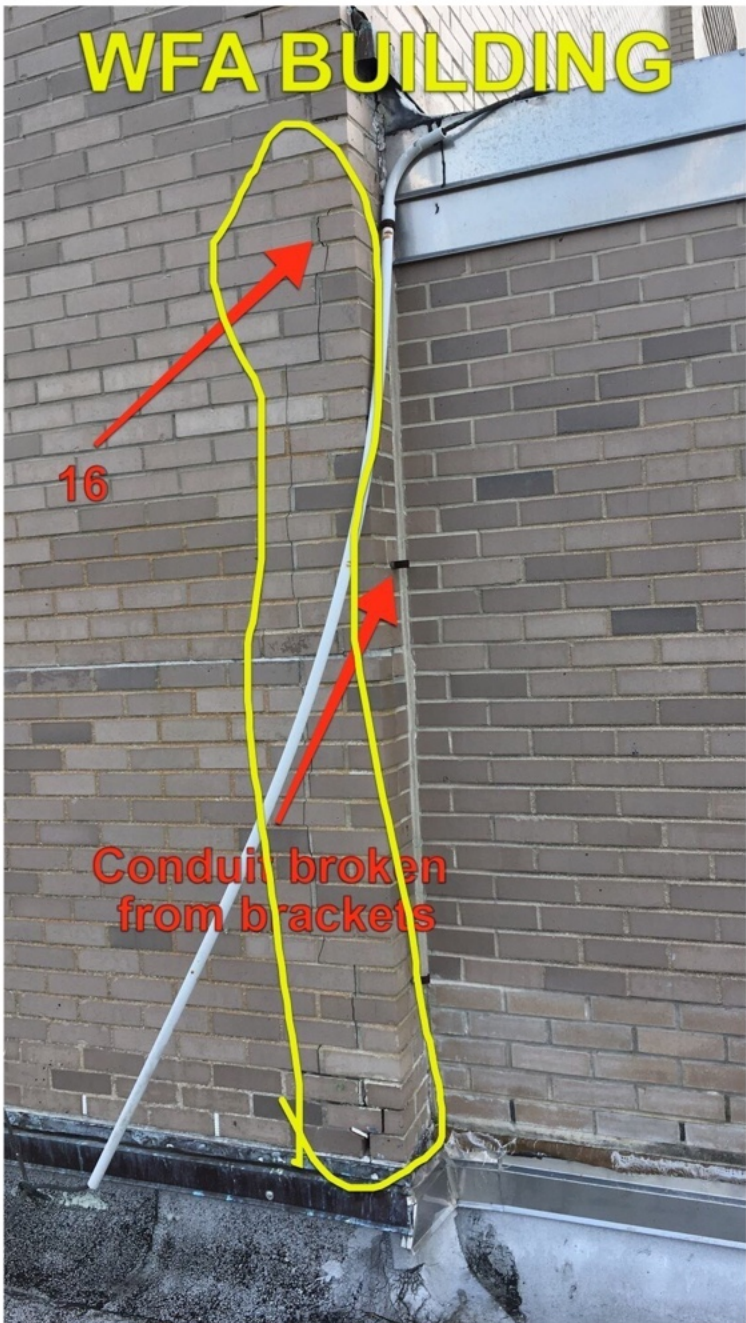
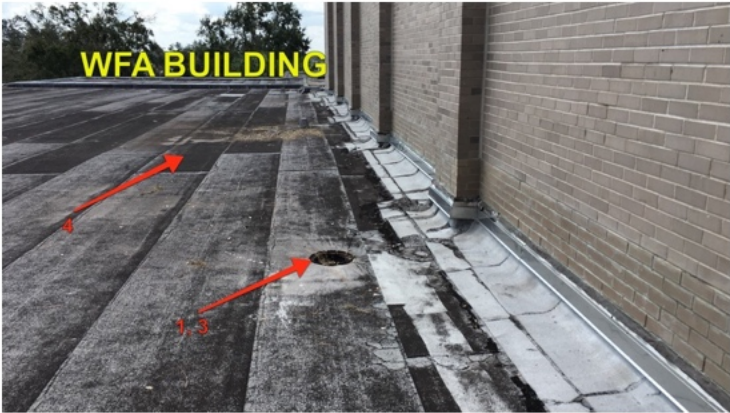
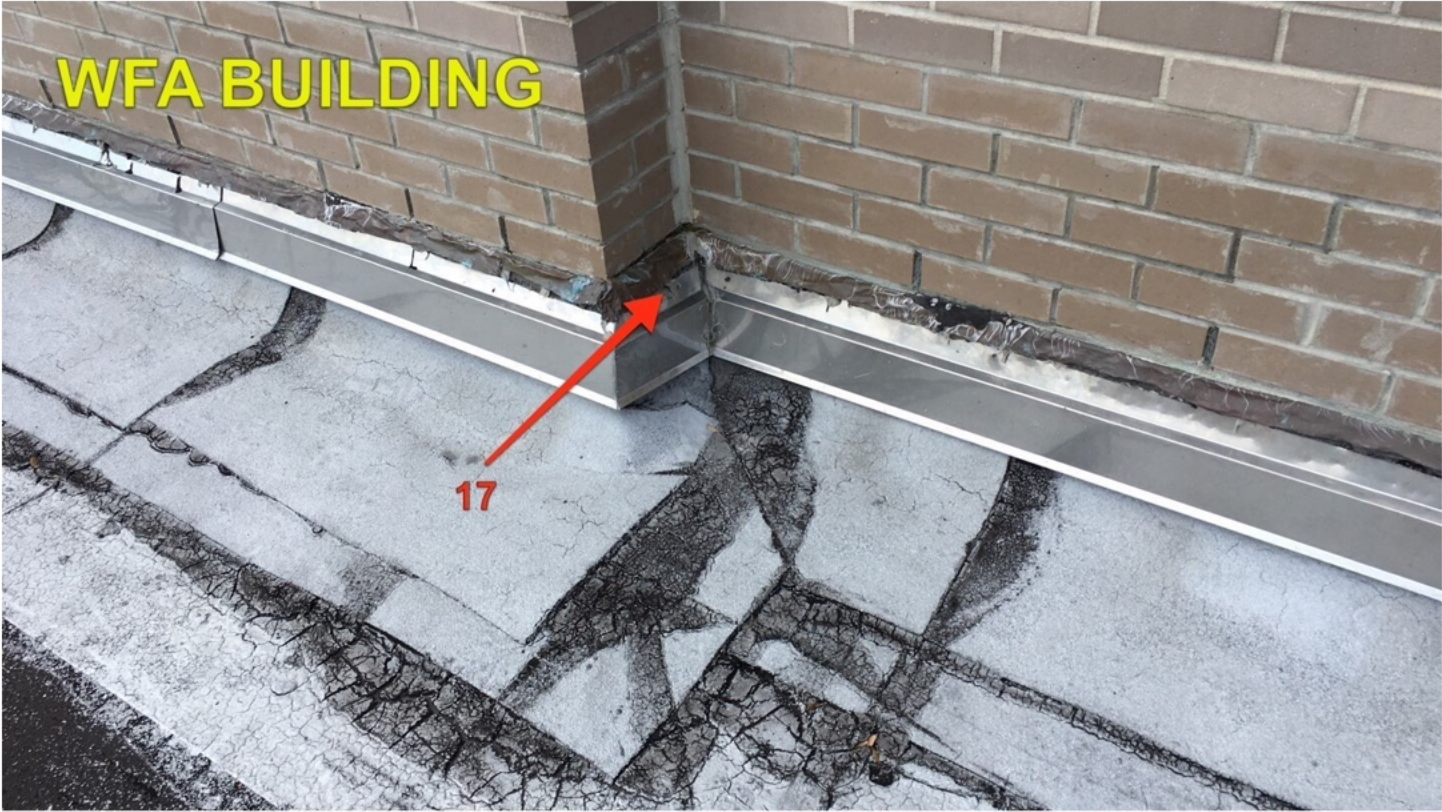
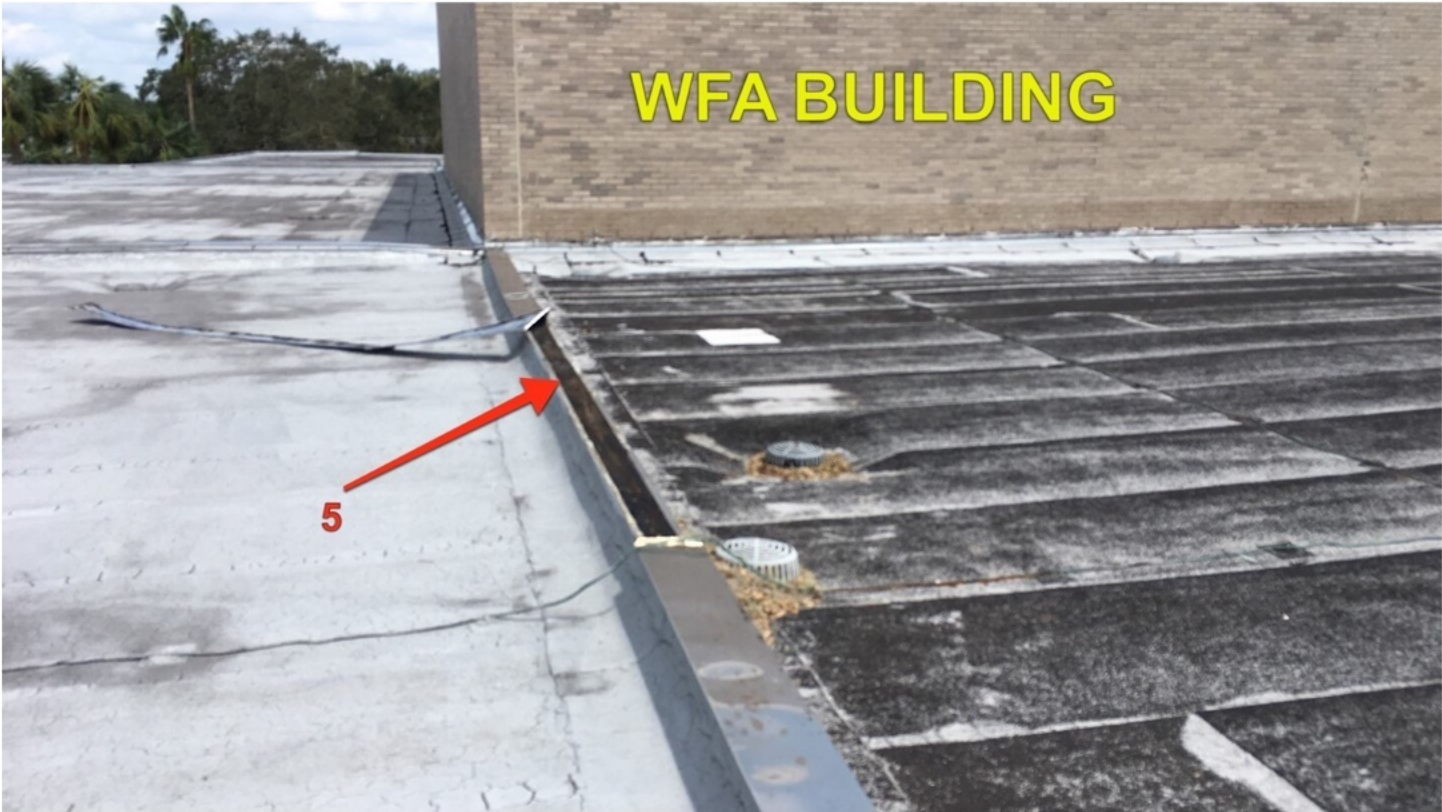
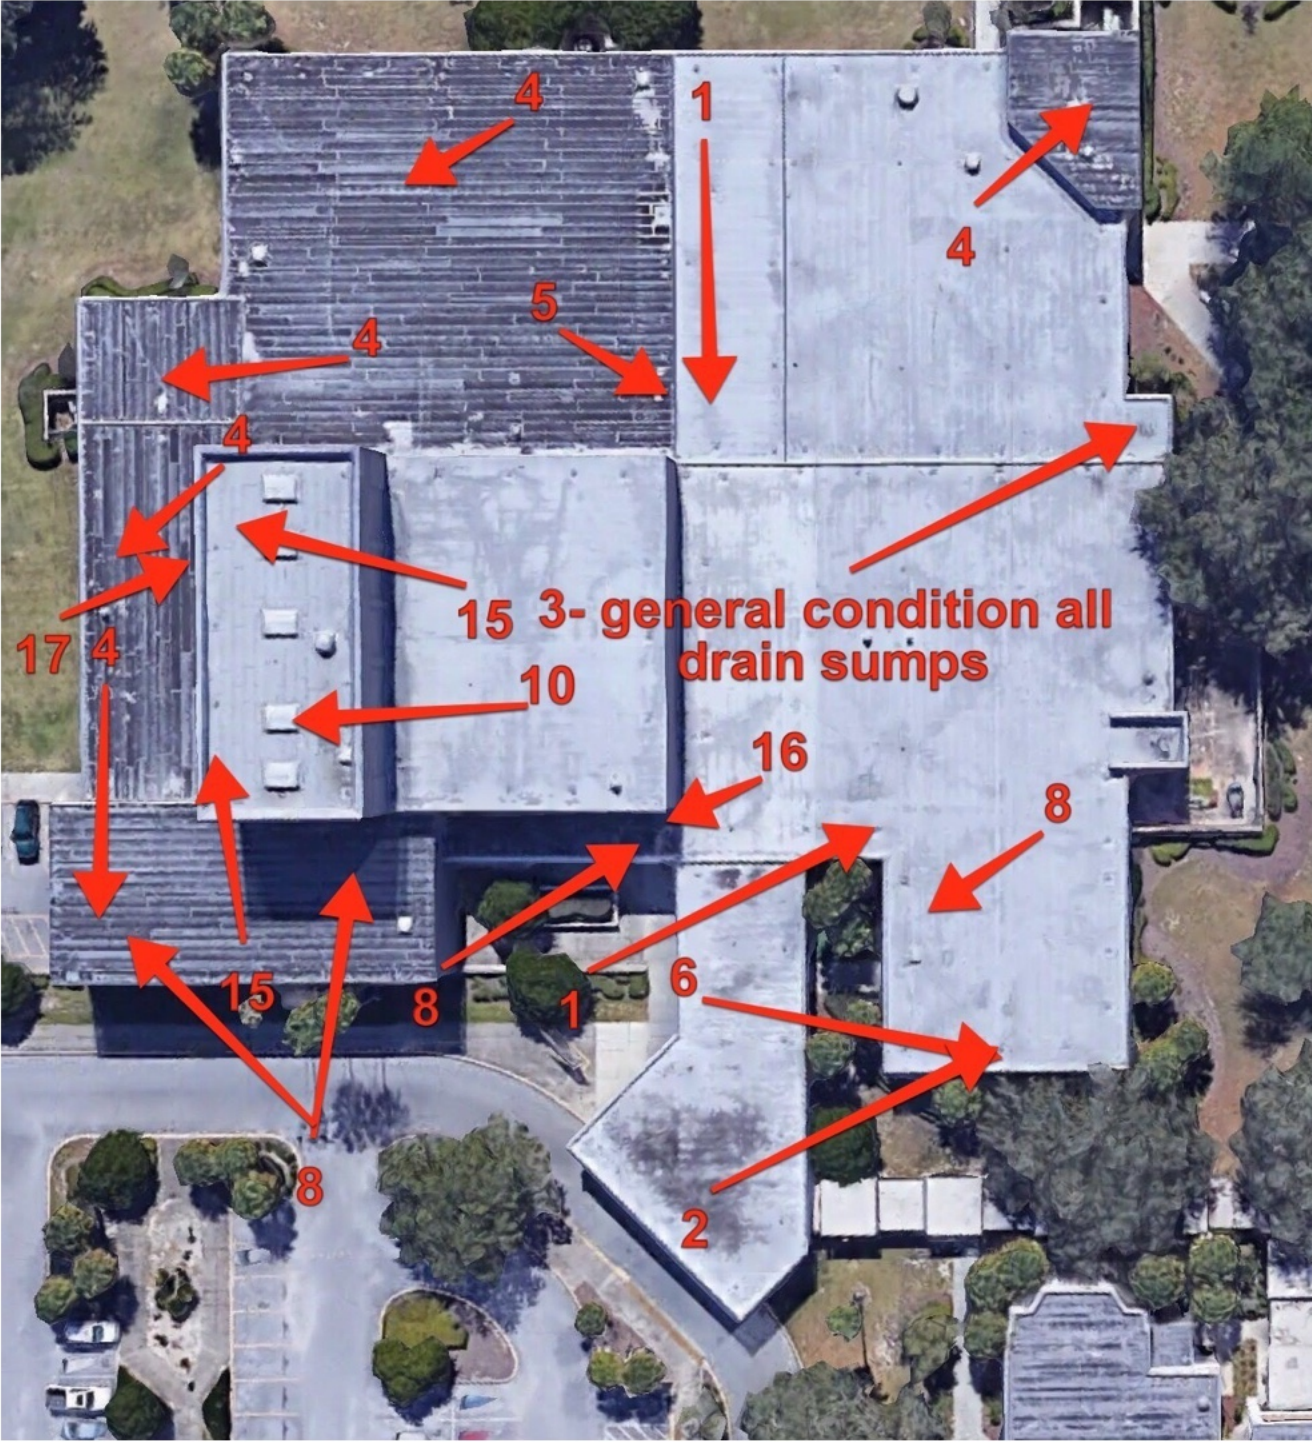
Active Leaks: One active leak was noted in the hall area adjacent to the back of the stage. Ceiling tile was on floor at this location. Area is connection between low roof and high wall.

Item # 1- a number of drain baskets have been displaced or are missing.

Item # 2- one drain basket appears to have suffered impact from debris and is damaged.

Item # 3- loose membrane at drain sump area. This condition is present at numerous locations. It appears it is possible that water pressure from water that overpowered the drains penetrated drain bowl flashing and caused the flashing membrane at the drain to be compromised. Membrane is loose at area that surrounds the drain bowl and sump.

Item # 4- mineral surfacing eroded by wind driven rain. It appears that extensive areas of mineral surfacing on modified bitumen cap sheet has eroded. Cap sheet has extensive areas with the black bitumen exposed, mineral surfacing damage has left the cap sheet smooth and exposed to UV damage. This is limited to areas where aluminum coating was not applied to mineral surfaced cap sheet.

Item # 5- damaged expansion joint cover. A section of the metal expansion joint cap on the low roof area has been displaced. This section of metal cap is approximately 20 l/f.

Item # 6- punctured roof membrane. Impact damage was noted at one location (area of damaged drain basket). Cap sheet has been damaged due to impact from debris.

Item # 7- clogged drain location. Several drains were clogged with leaves due to missing strainer baskets. These leaves were cleared from the drains during the inspection to allow free drainage.

Item # 8- roof membrane loose from substrate. In several locations the roof membrane is loose from the substrate and can be identified by foot traffic. It is possible that these locations are the result of uplift from storm winds. Additional testing may be required to confirm the extent of uplifted areas.

Item # 10- Damage to equipment, vents, power ventilators, hoods. A smoke hatch on the upper roof appears to be partially “sprung” as it is not properly closed.

Item # 15- blisters present in membrane. Several blisters were noted during the inspection. One at the wall on the high roof and field of cap sheet.

Item # 16- damage to brick wall. A one location the brick wall has a crack that runs vertically from base to top. A lightning protection cable has been displaced at this location. It is not readily apparent if damage was existing or possibly caused by a lightning strike in the locations.

Item # 17- damage to thru-wall flashing. A an isolated location the thru-wall flashing appears to be displaced from possible impact from debris.

Extent of damage to roof appears to be less than 25% of the roof area. Repairs can be accomplished providing additional testing determines membrane uplift conditions limited to areas noted during the inspection.
