RFP #18-02 for College-Wide Roof Repairs

**Damage Report**

DEFECT/DAMAGE LIST HURRICANE IRMA

### ROOF SURVEY DAMAGE REPORT- HURRICANE IRMA

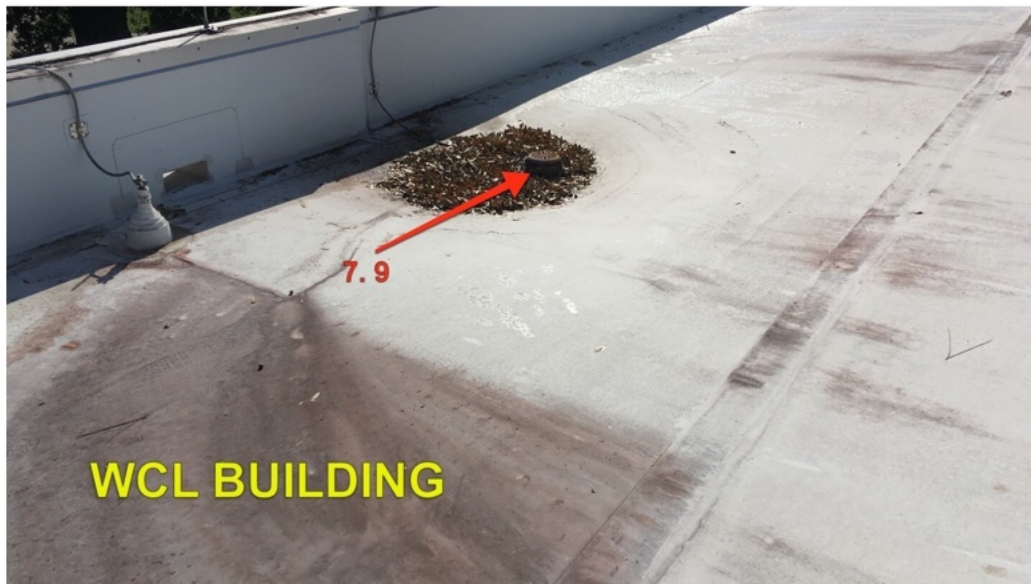
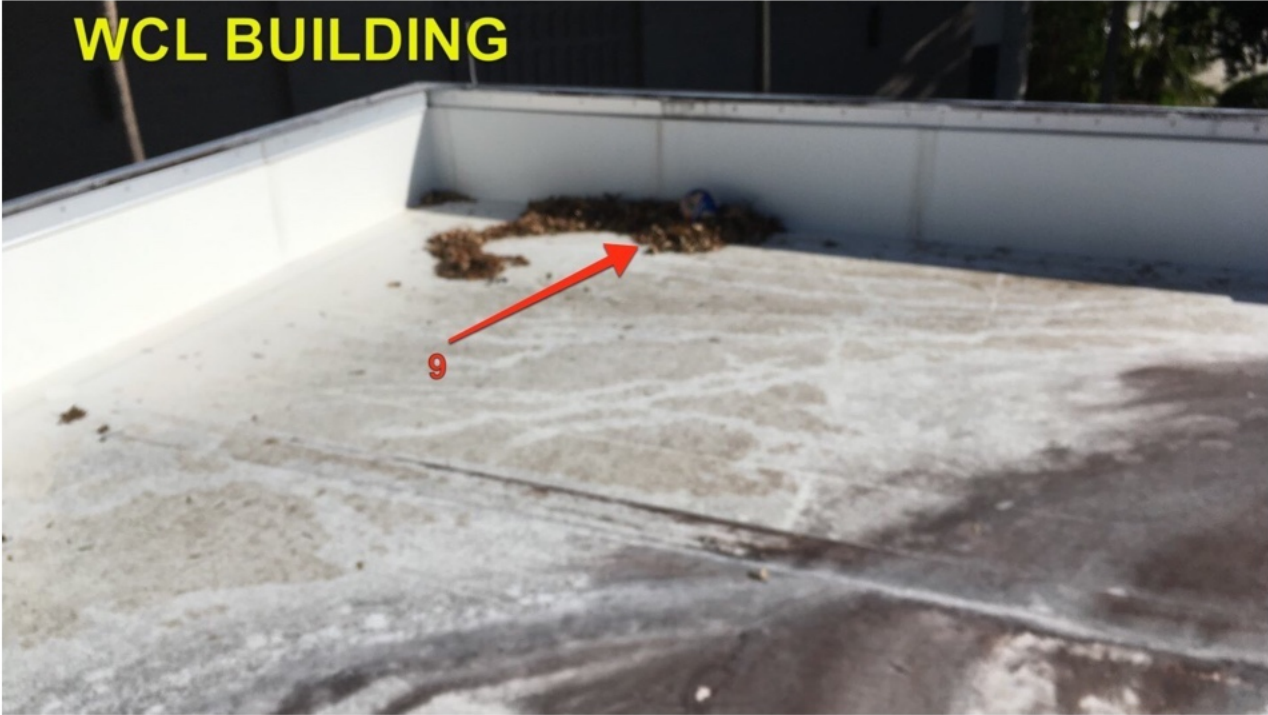
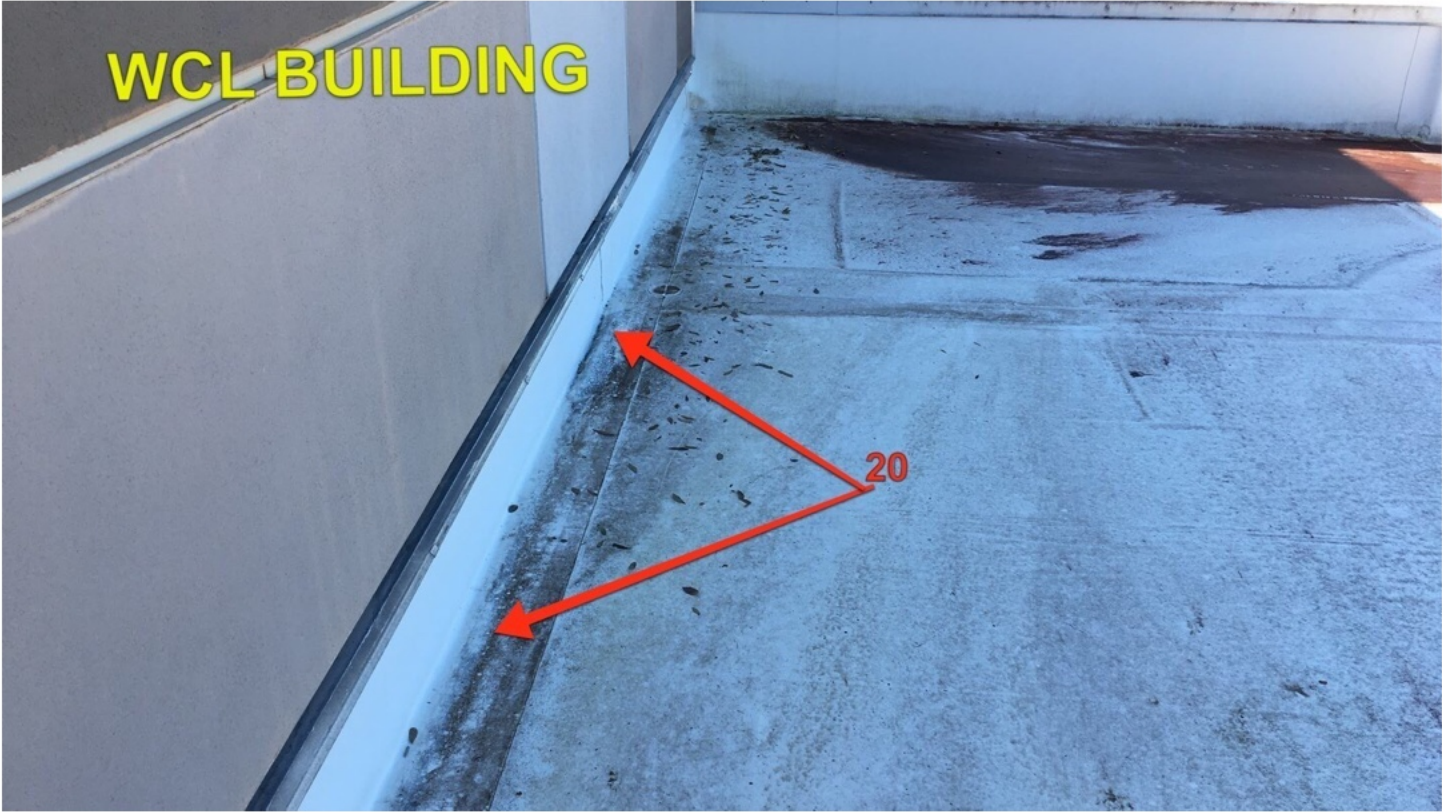
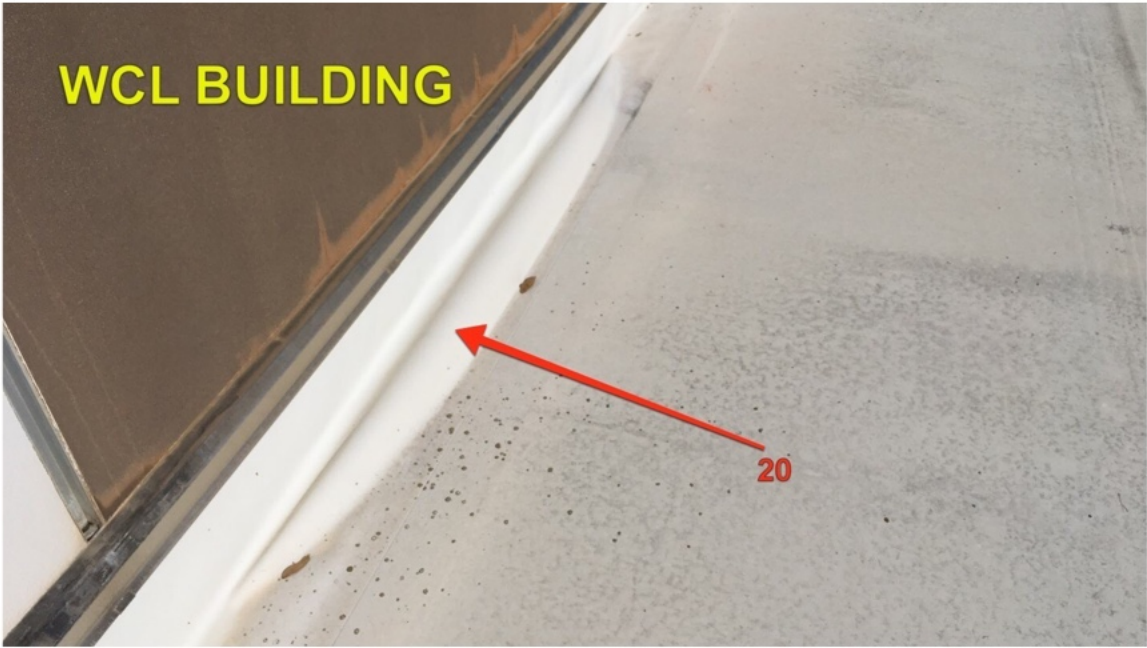
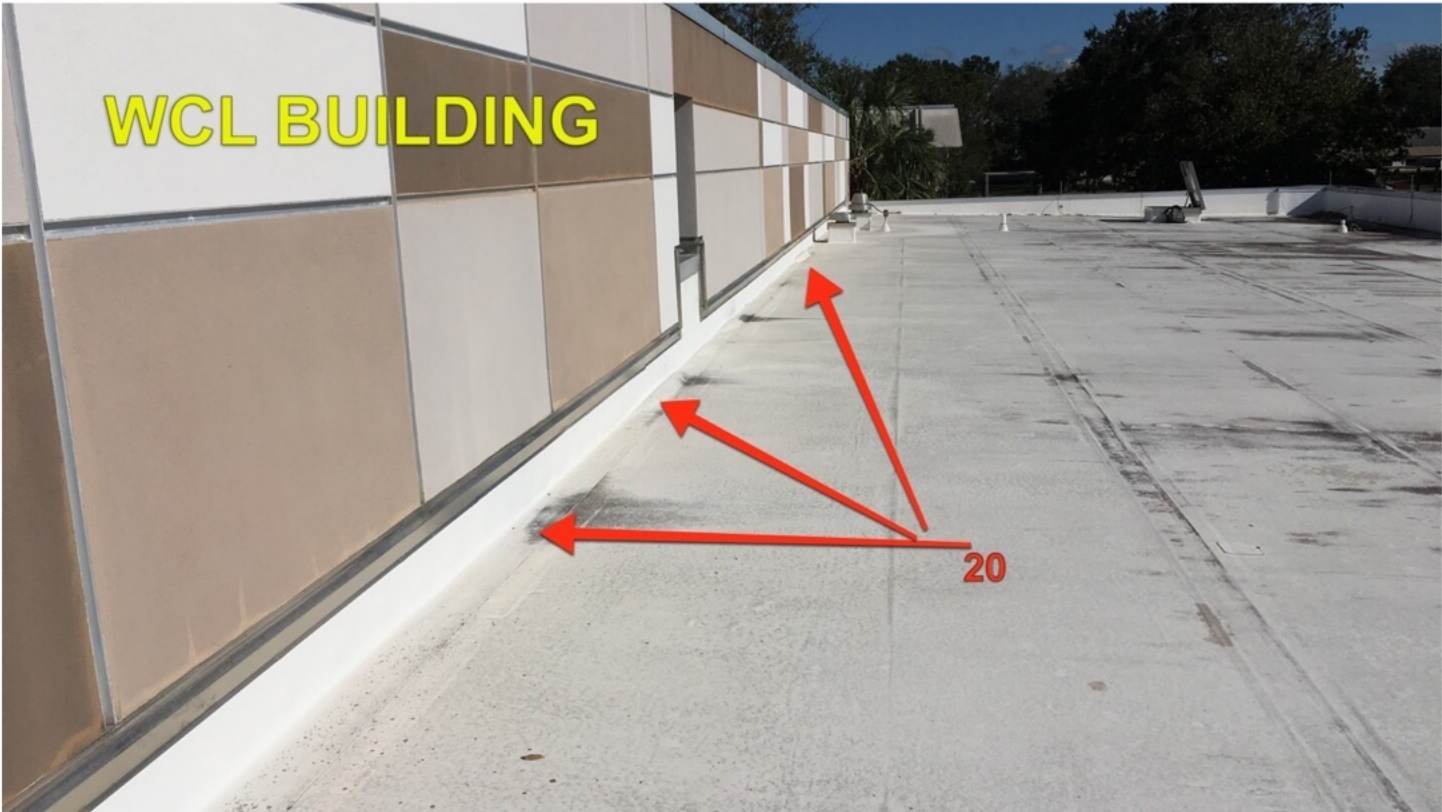
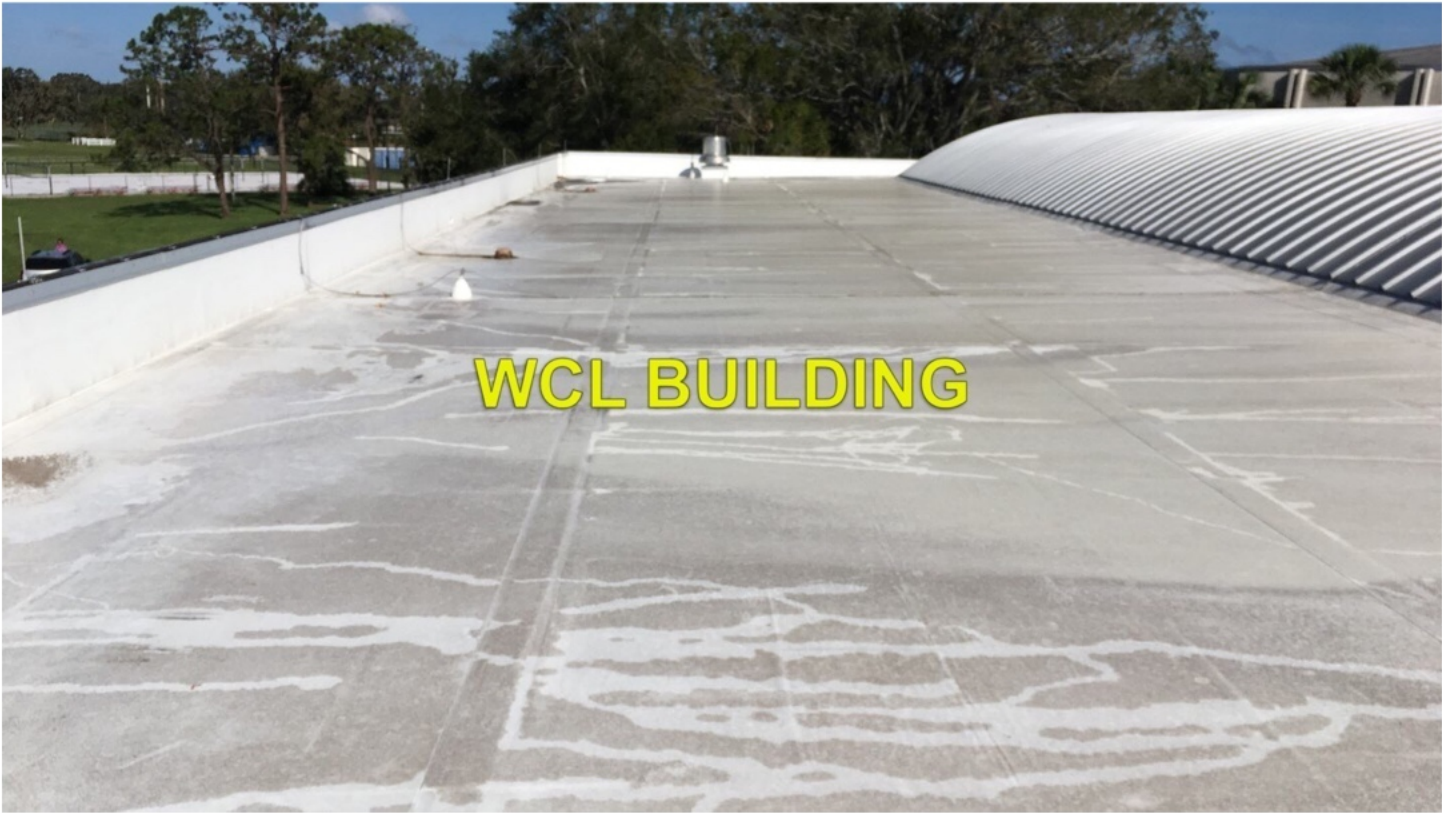
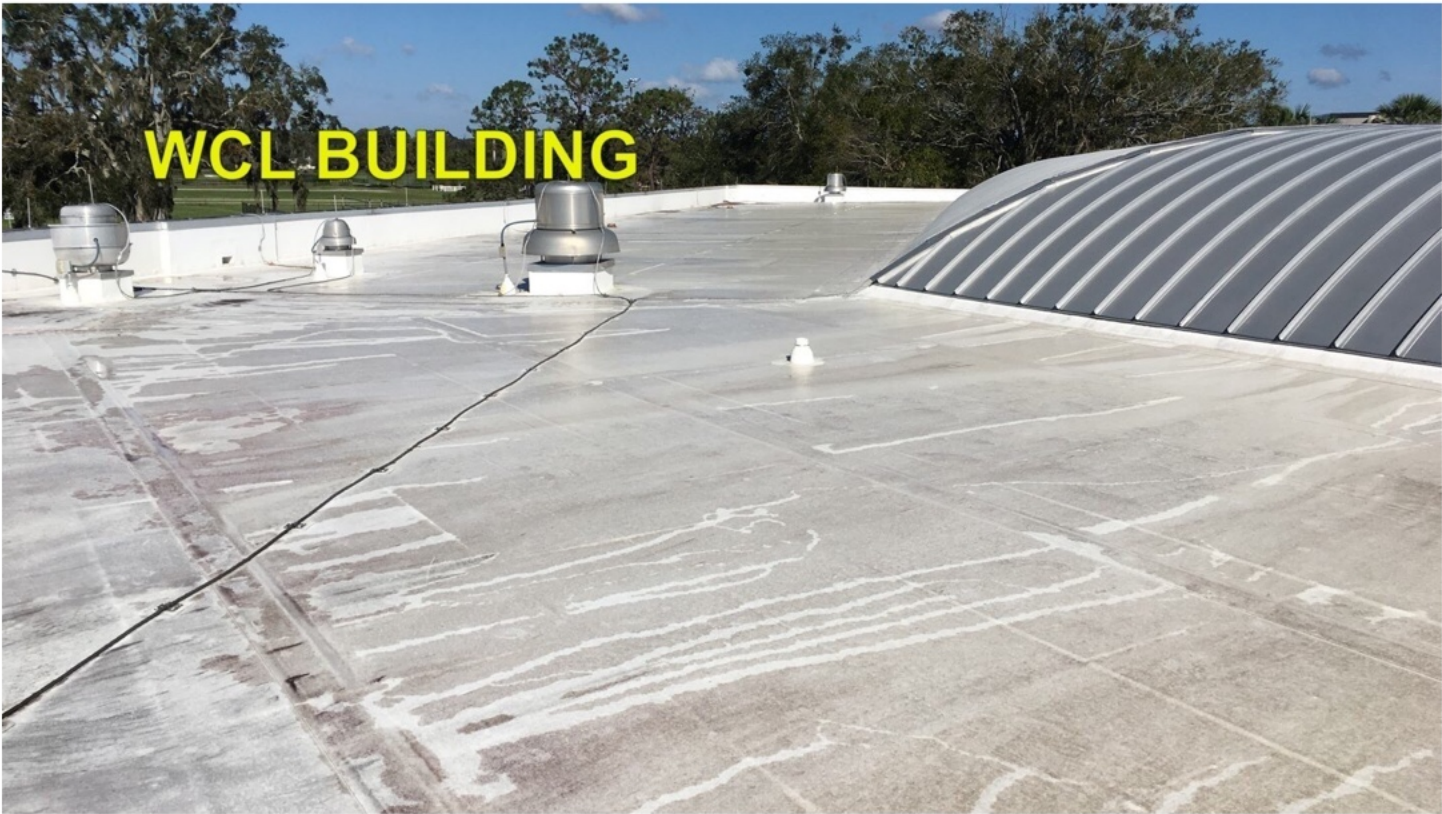
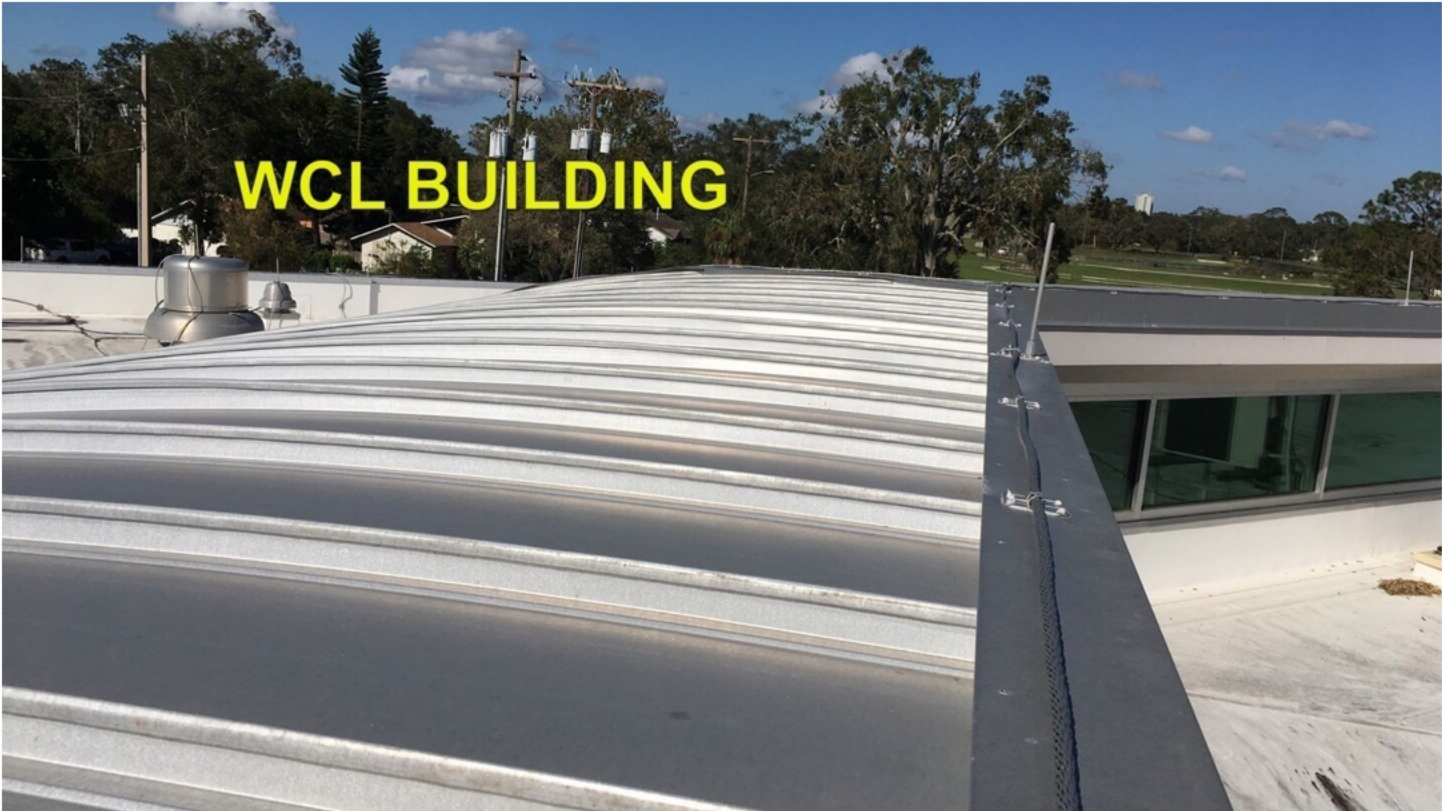
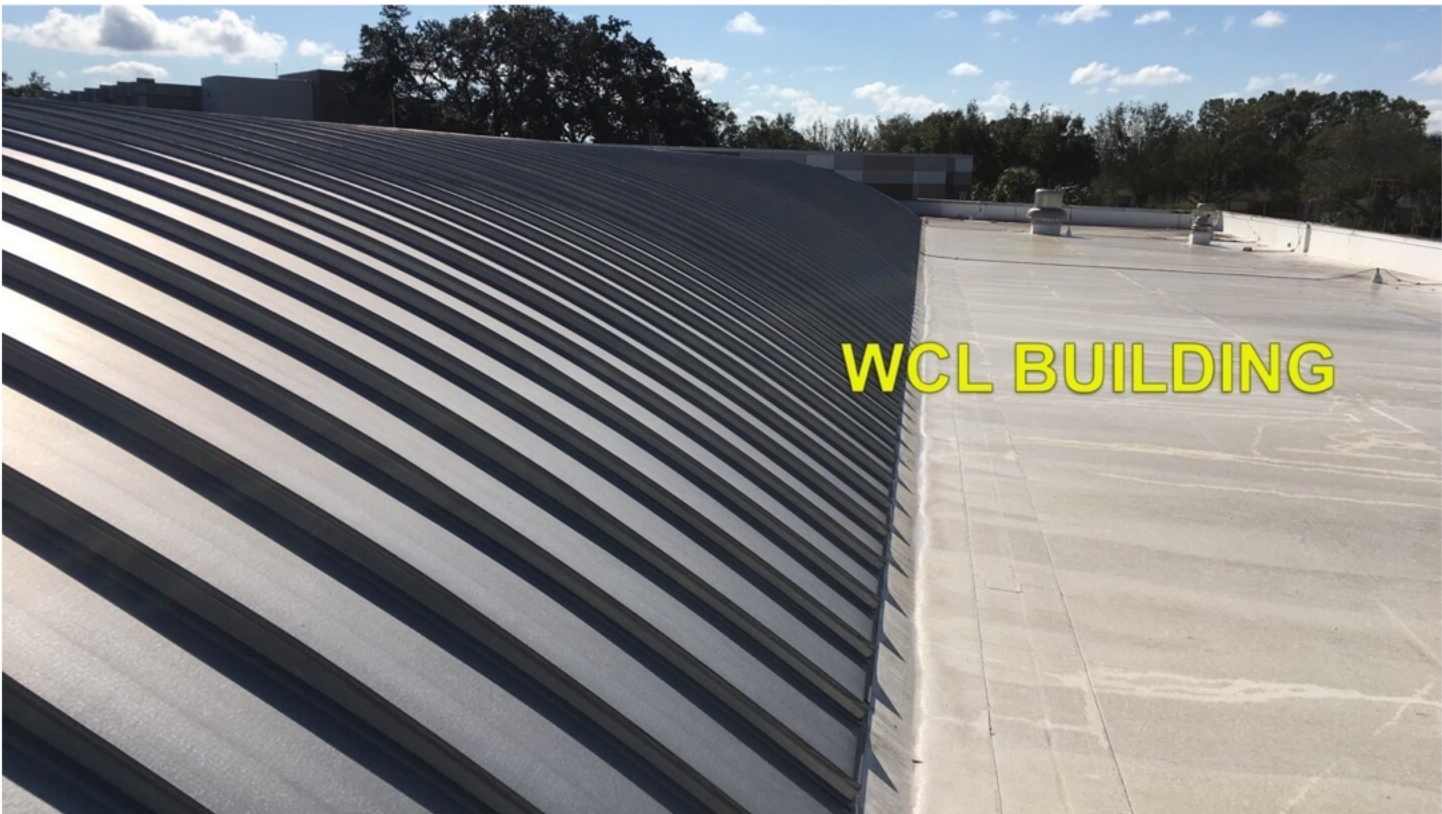
Item # 7- Clogged drain location. An isolated clogged drain was noted on the lower single ply roof.

Note: No punctures or damage was noted on the single ply roof membrane from wind blown debris.

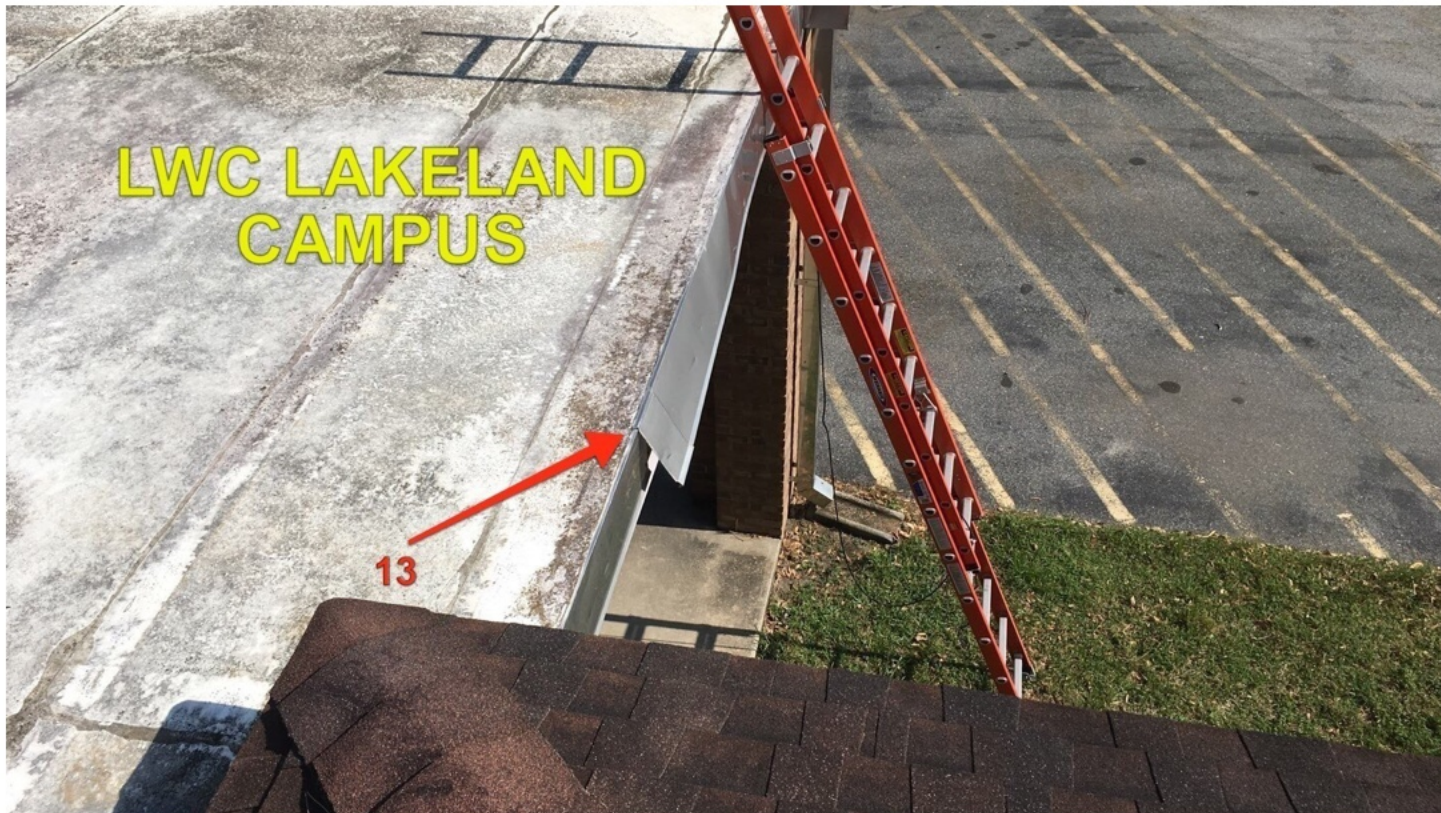
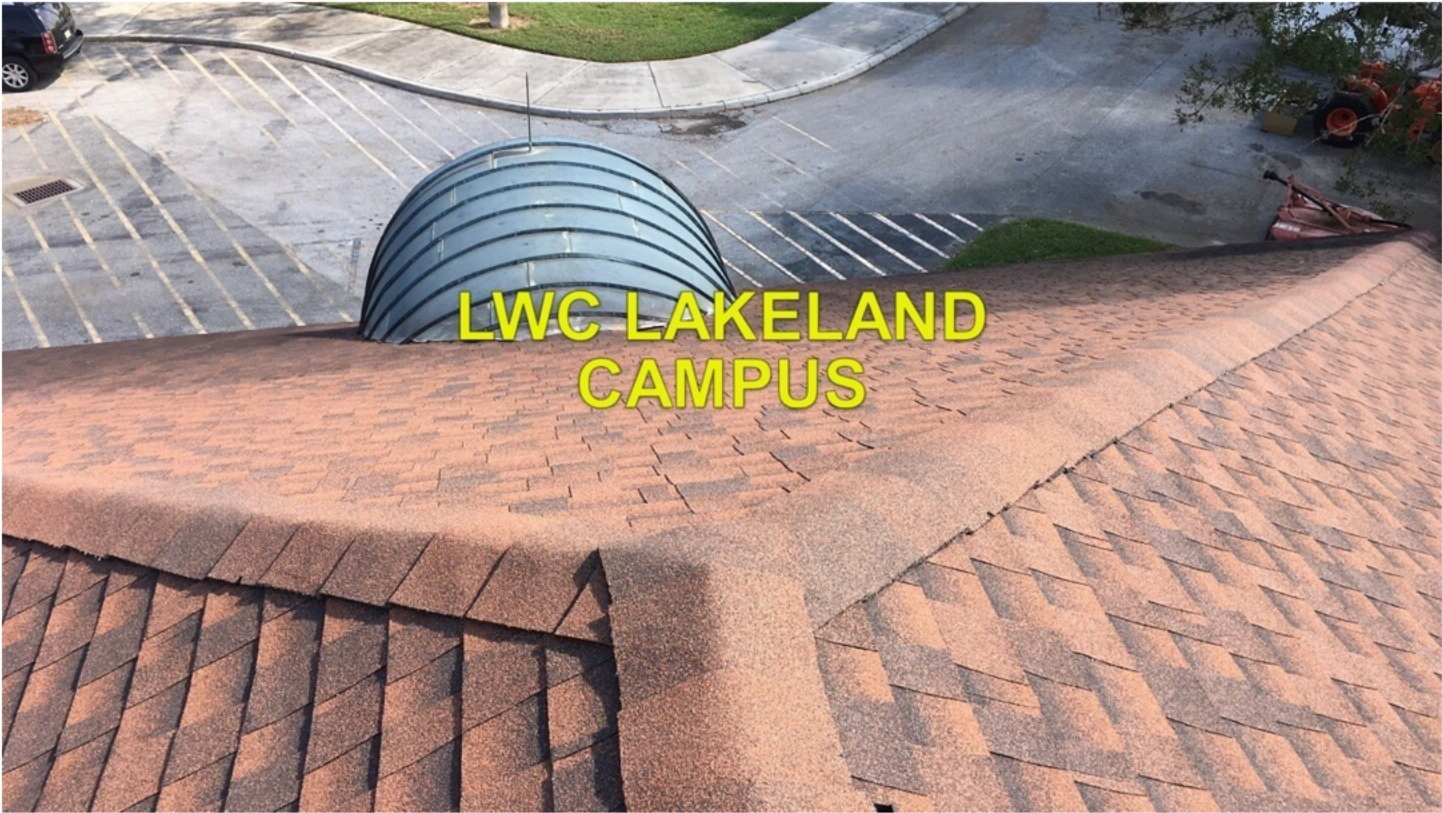
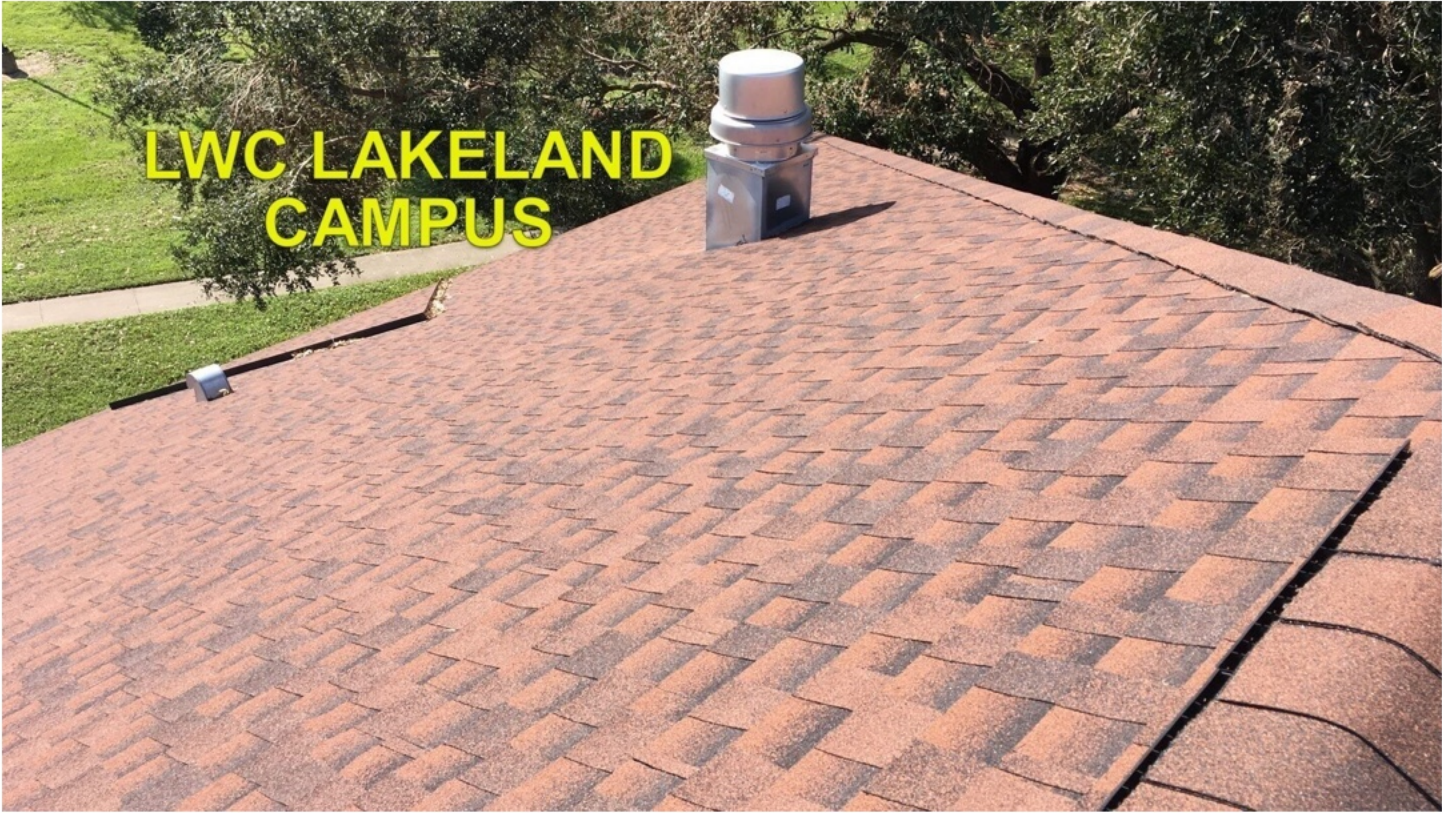
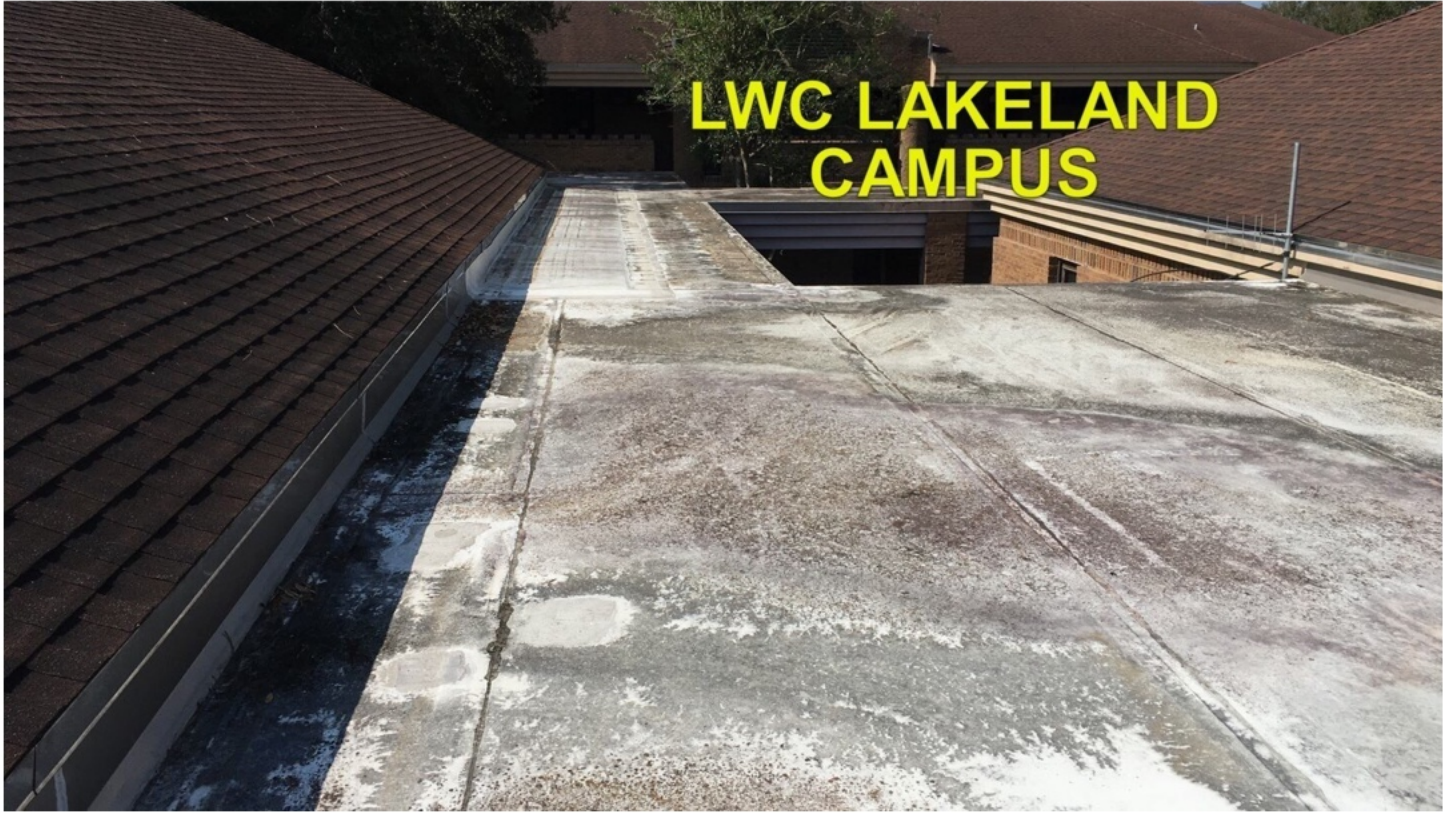
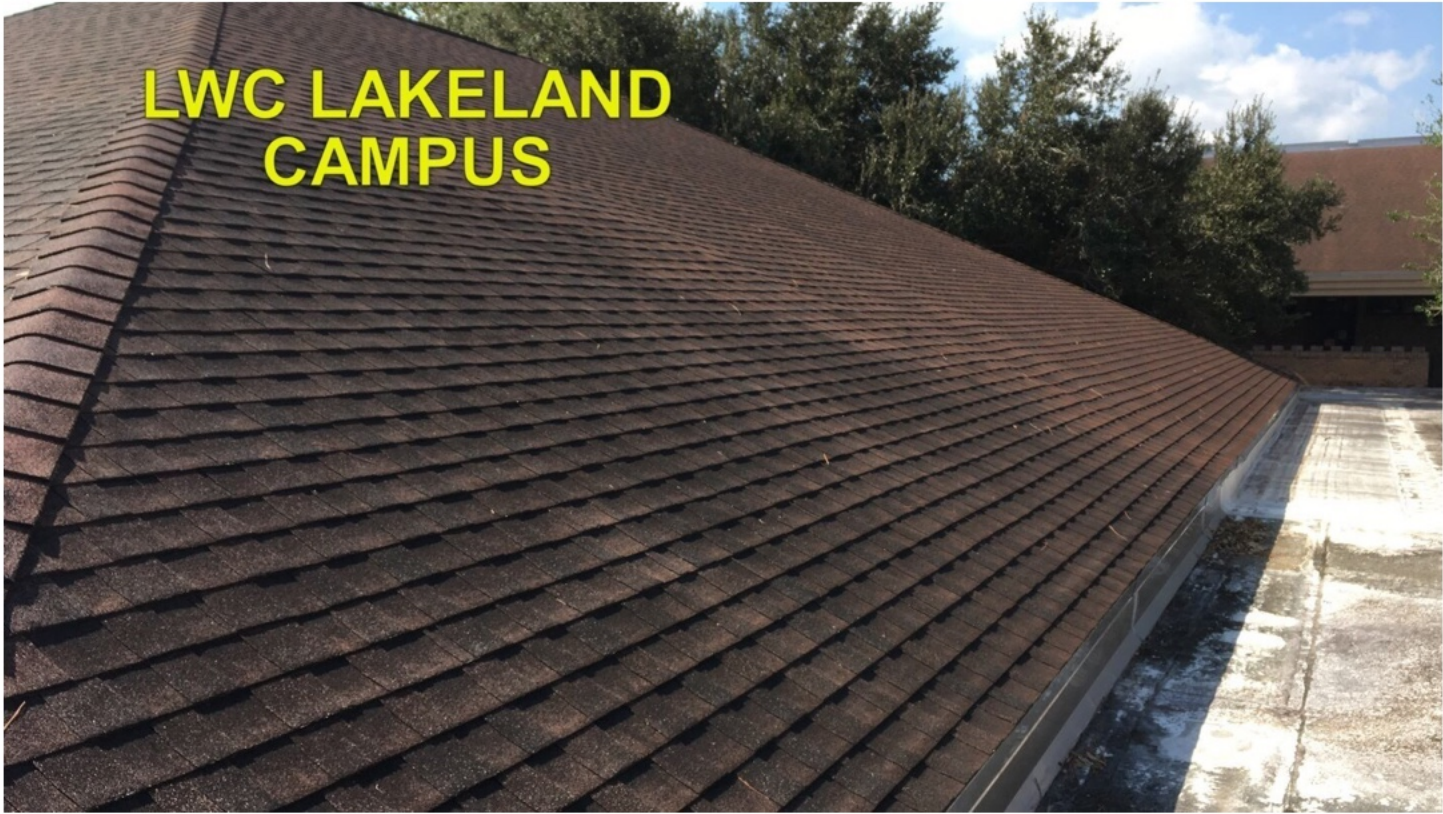
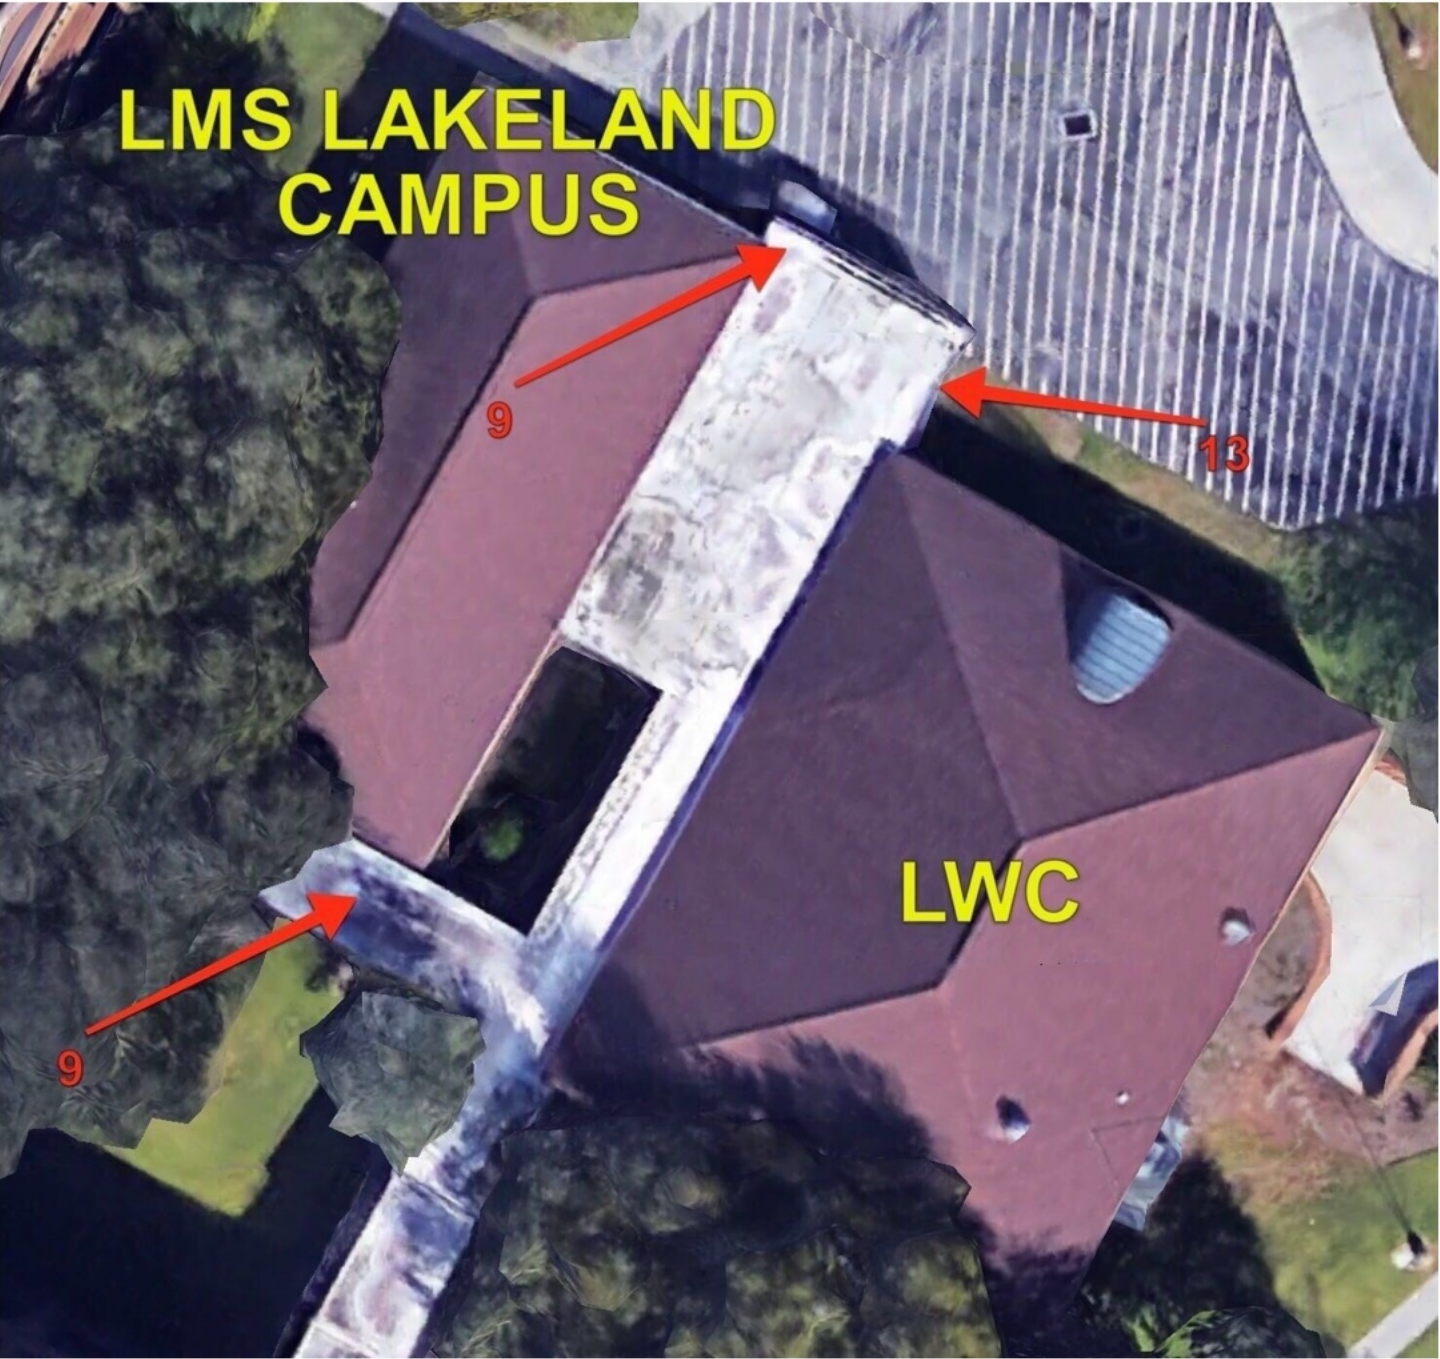
Item # 13- Displaced or damaged metal flashings.

Note: Item # 13 is also recorded in the LMS Building report as it is located between the two buildings.

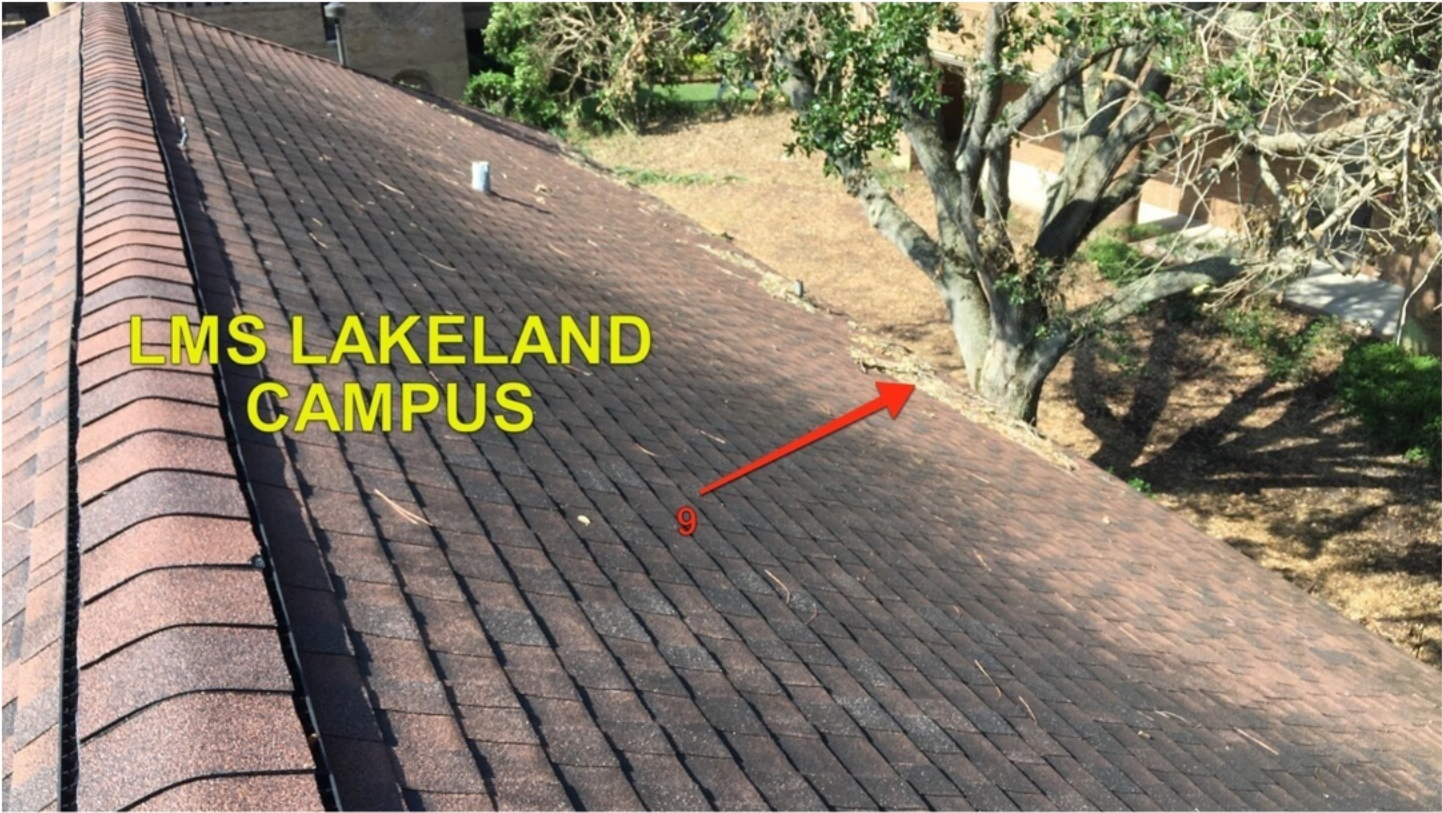
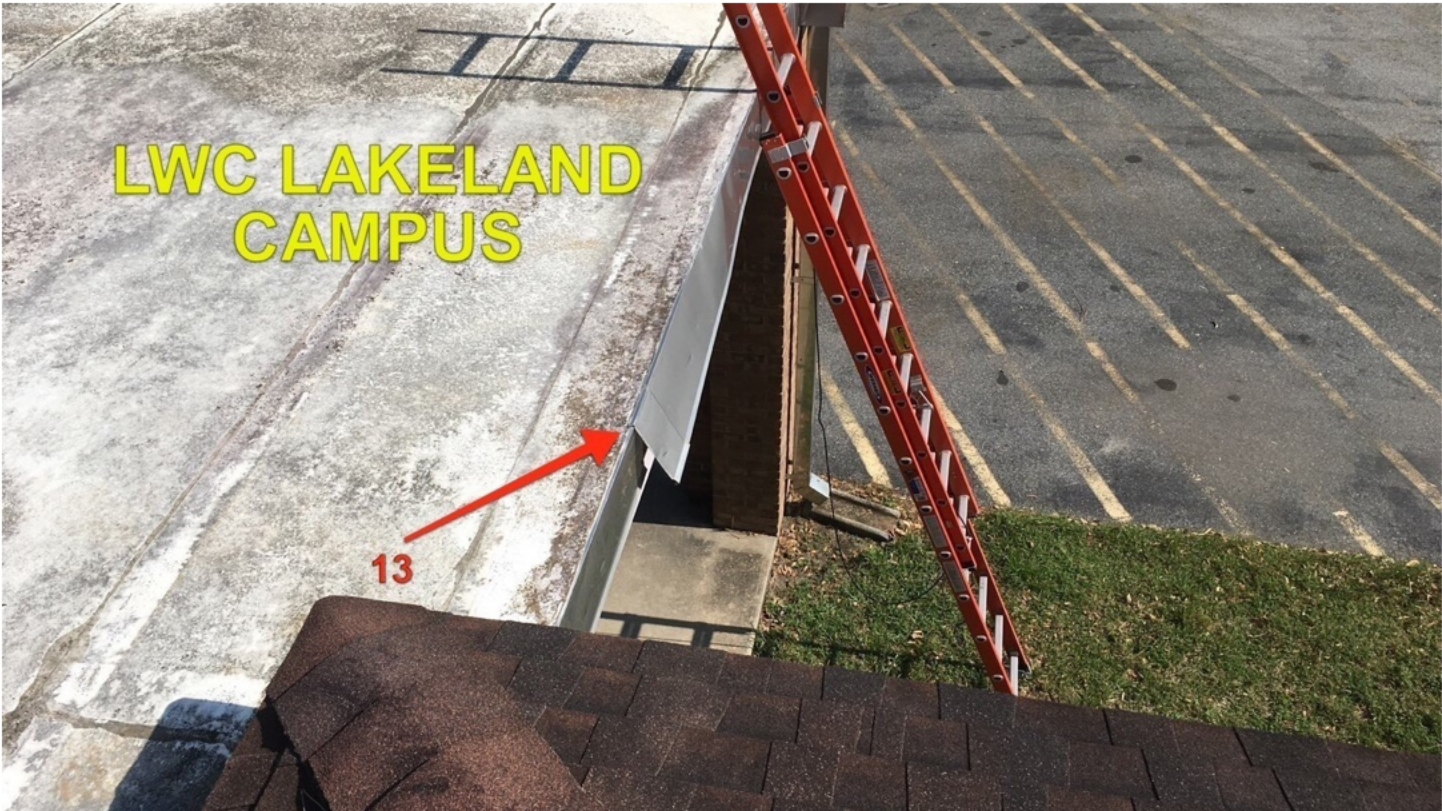
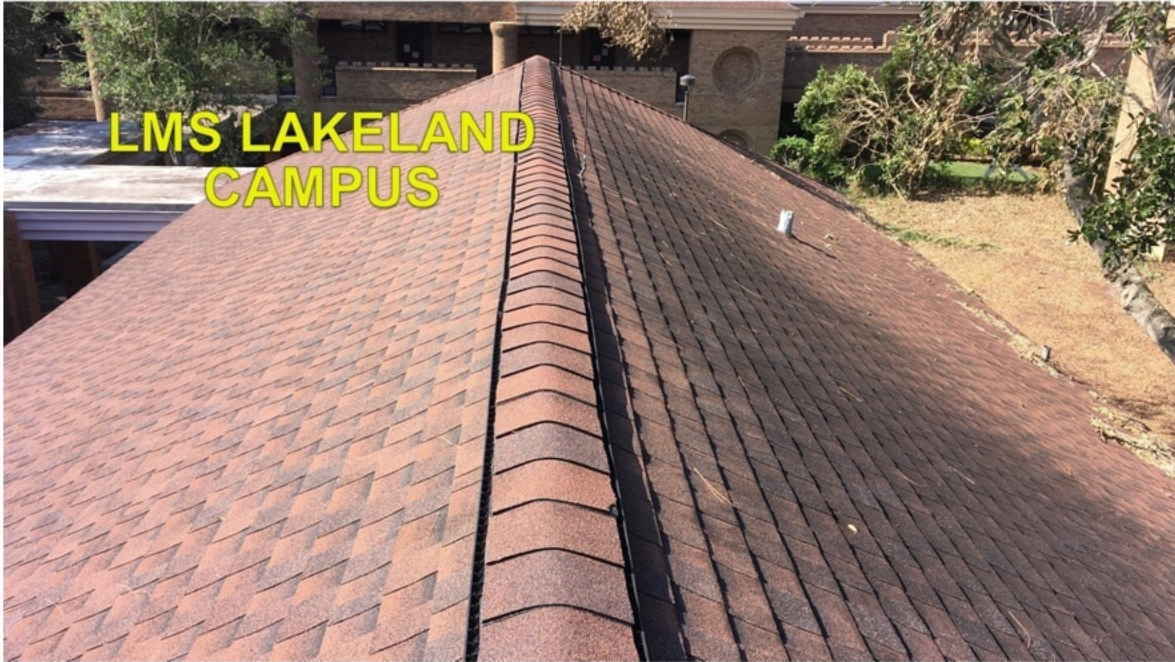
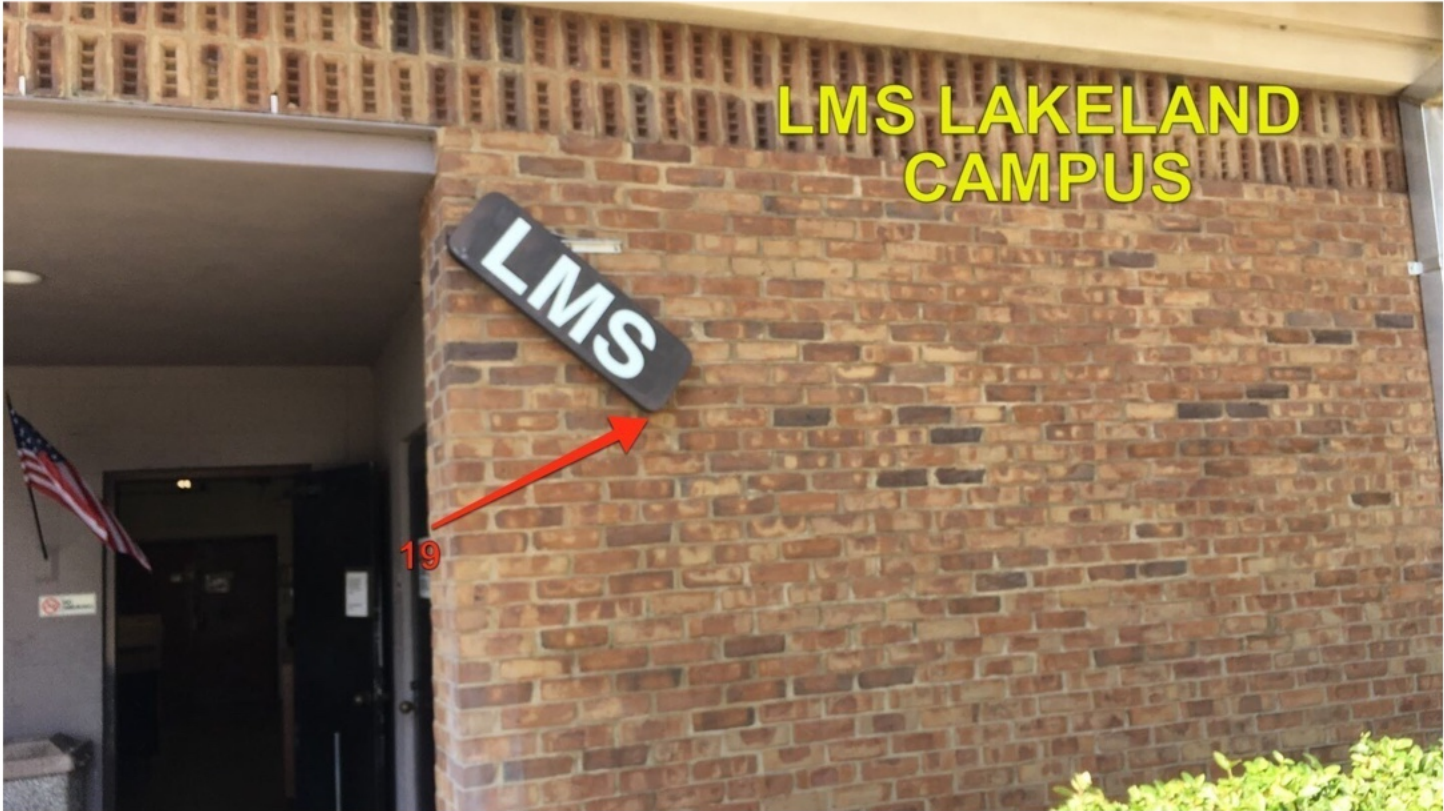
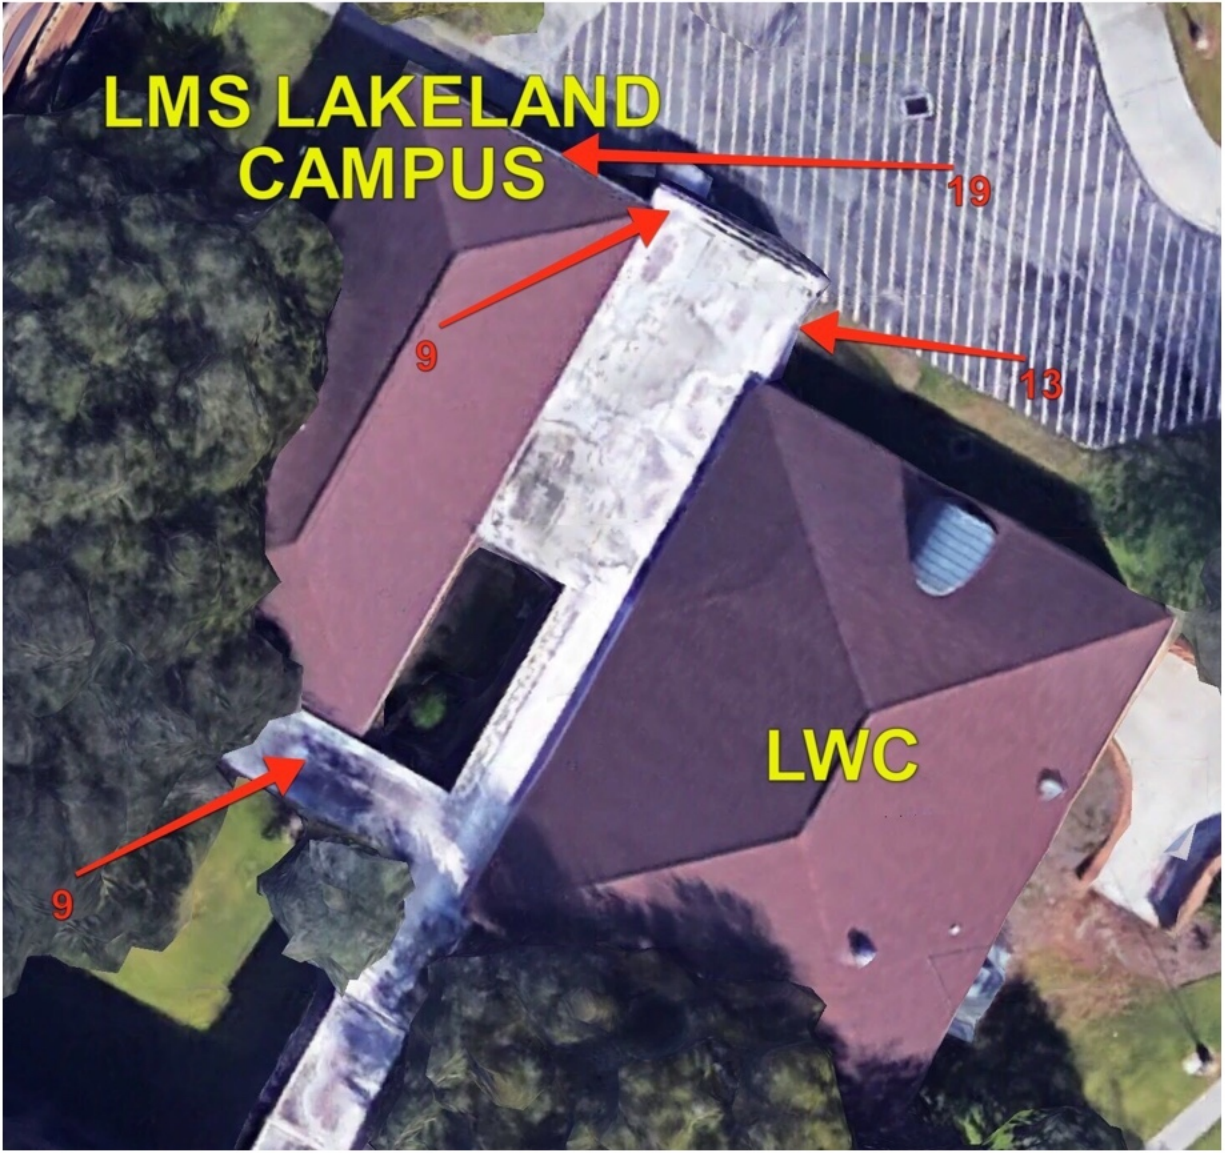
Item # 13- Damaged or displaced metal flashings.

Item # 19- Missing signage.
