RFP #18-02 for College-Wide Roof Repairs

**Damage Report**

DEFECT/DAMAGE LIST HURRICANE IRMA

### ROOF SURVEY DAMAGE REPORT- HURRICANE IRMA

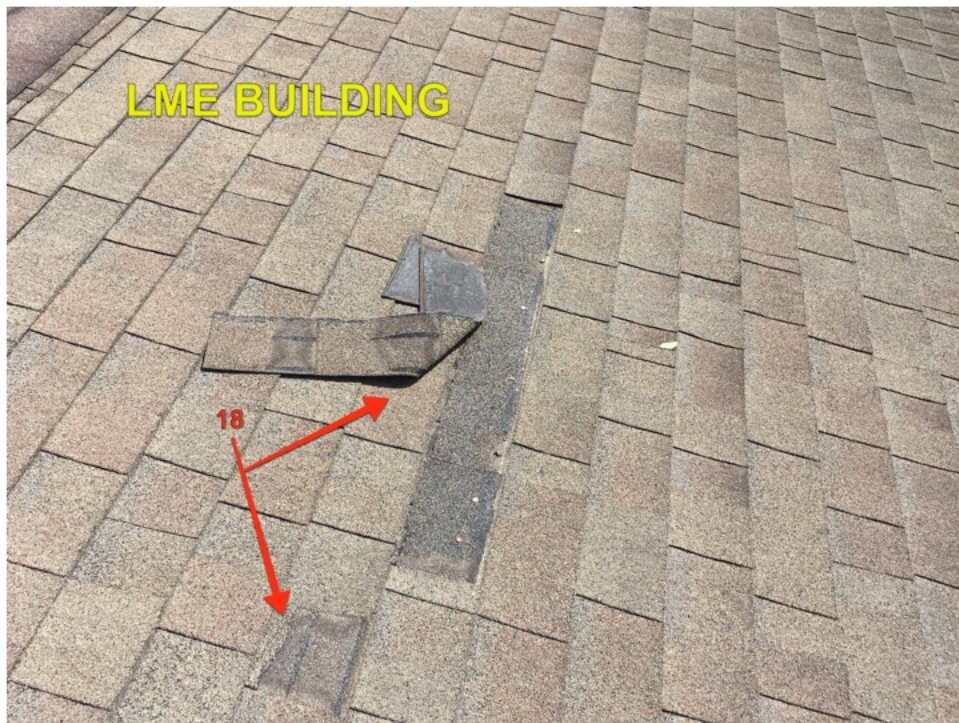
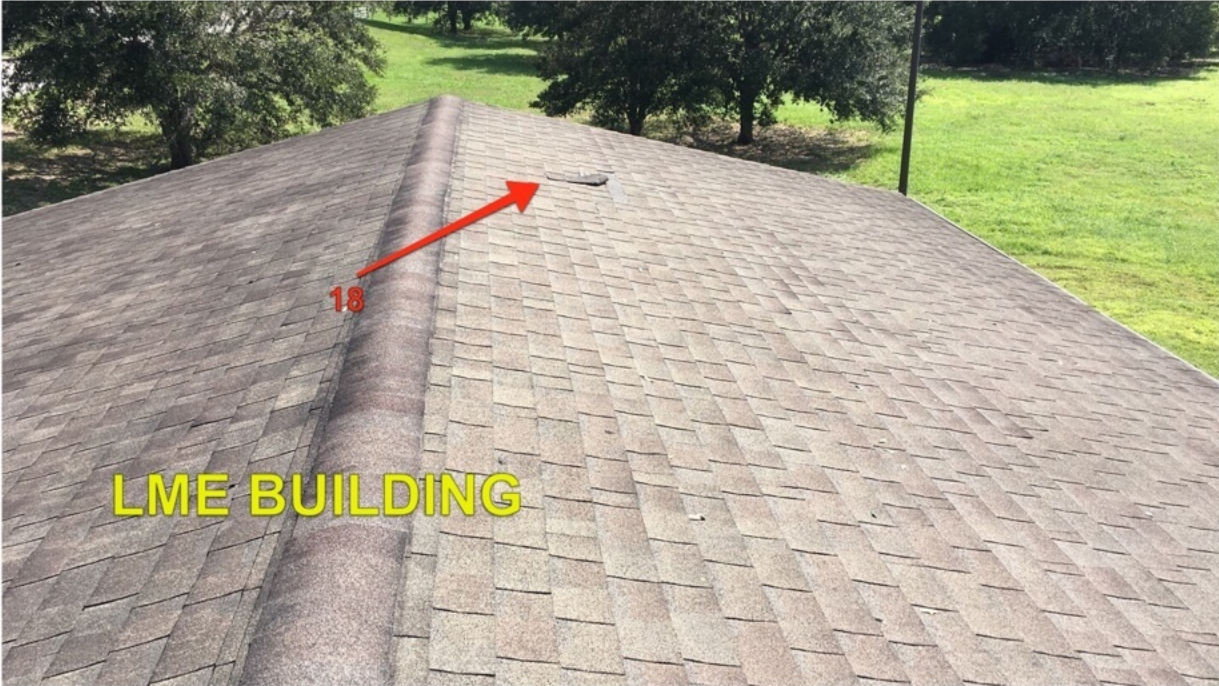
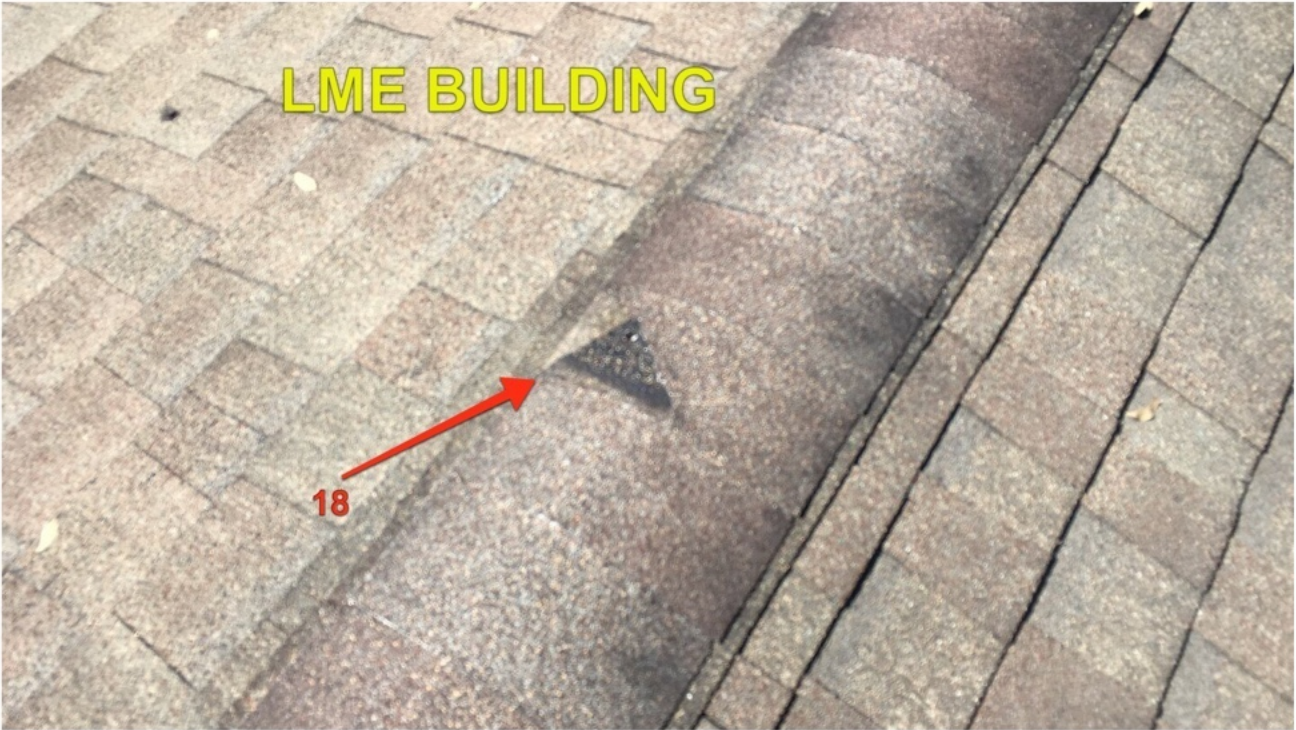
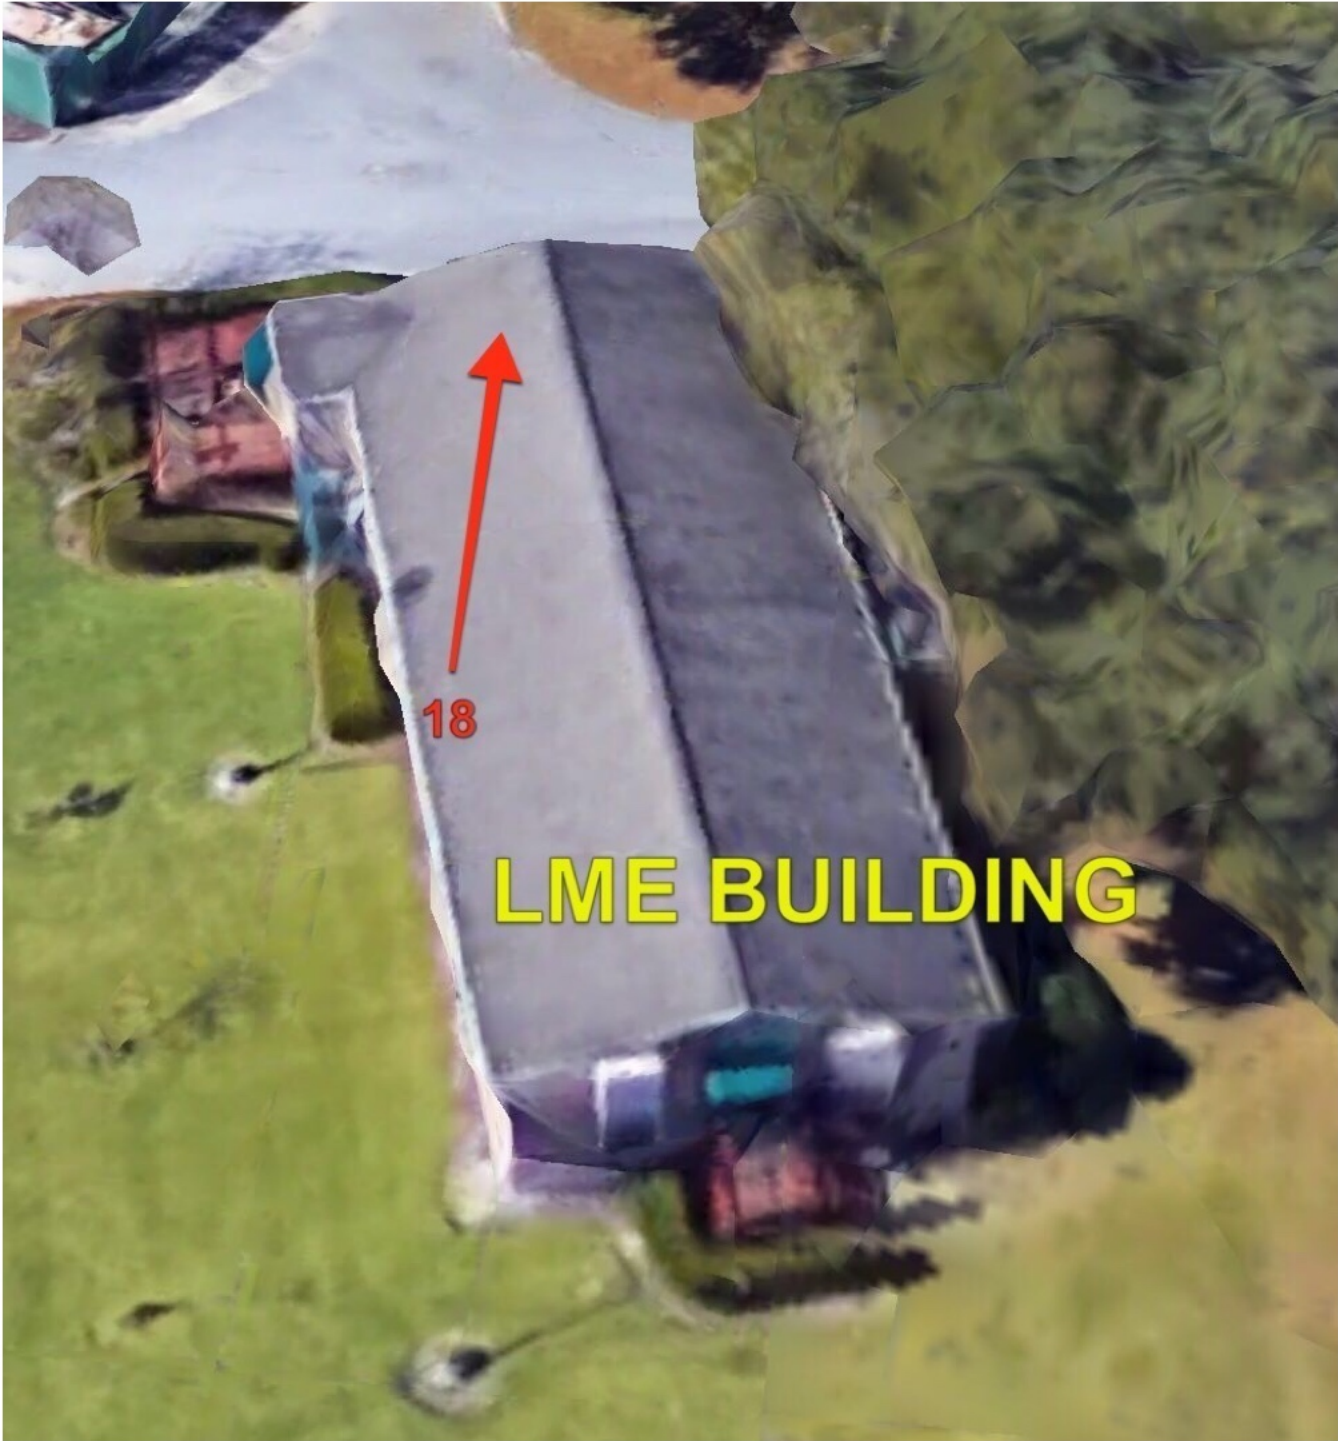
Item # 18- Damage to shingle system, broken shingles, missing flashings

Note: Minor shingle damage was noted.

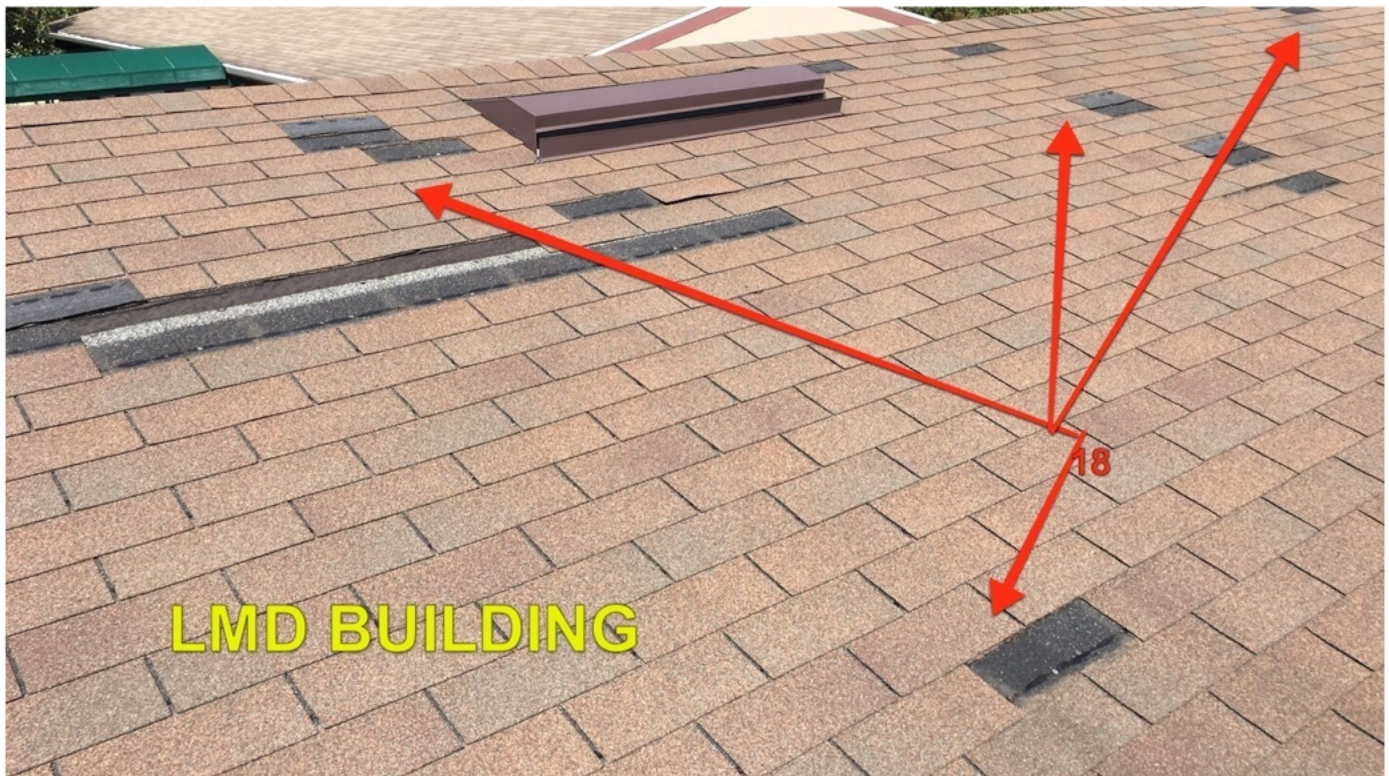
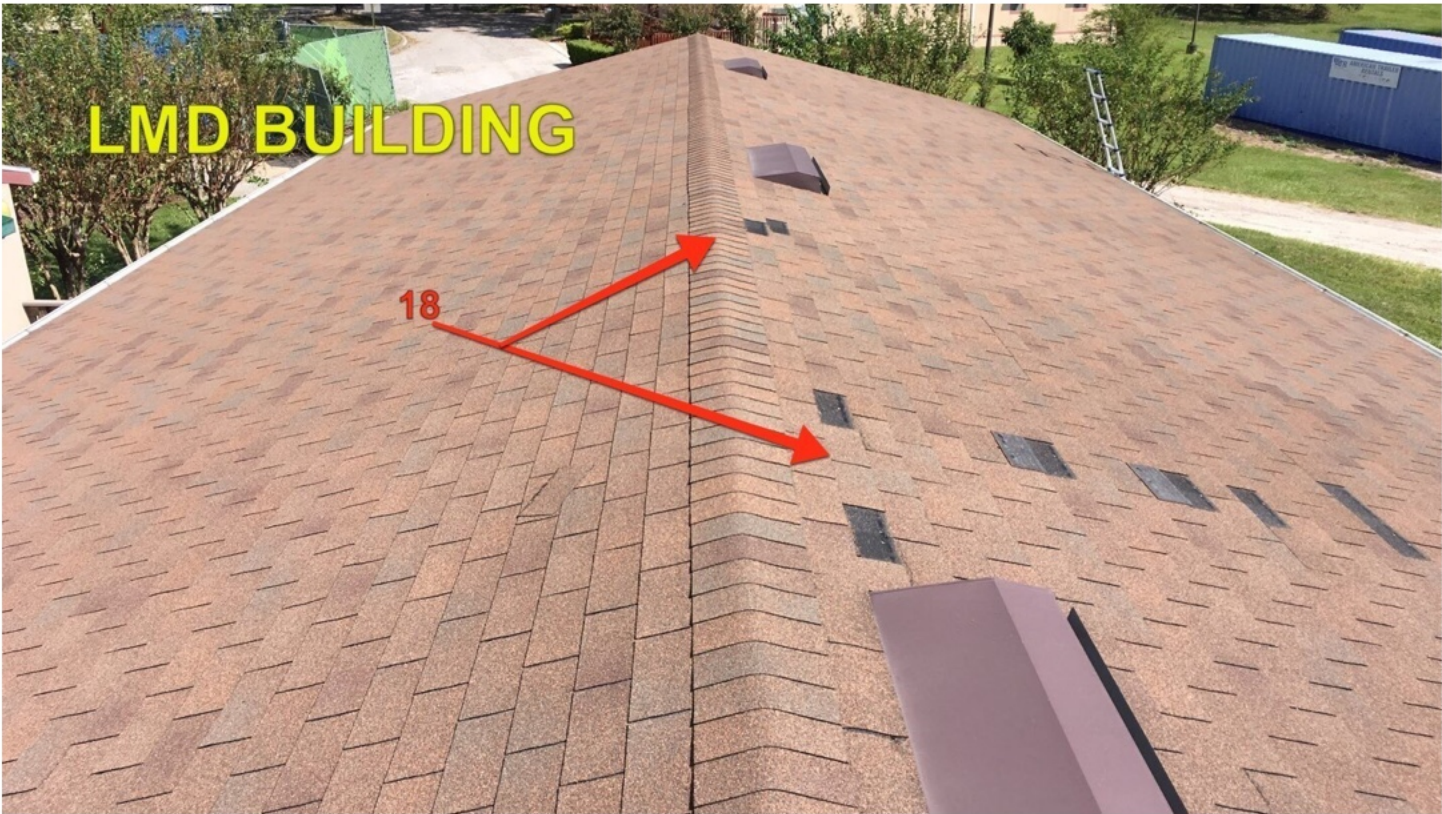
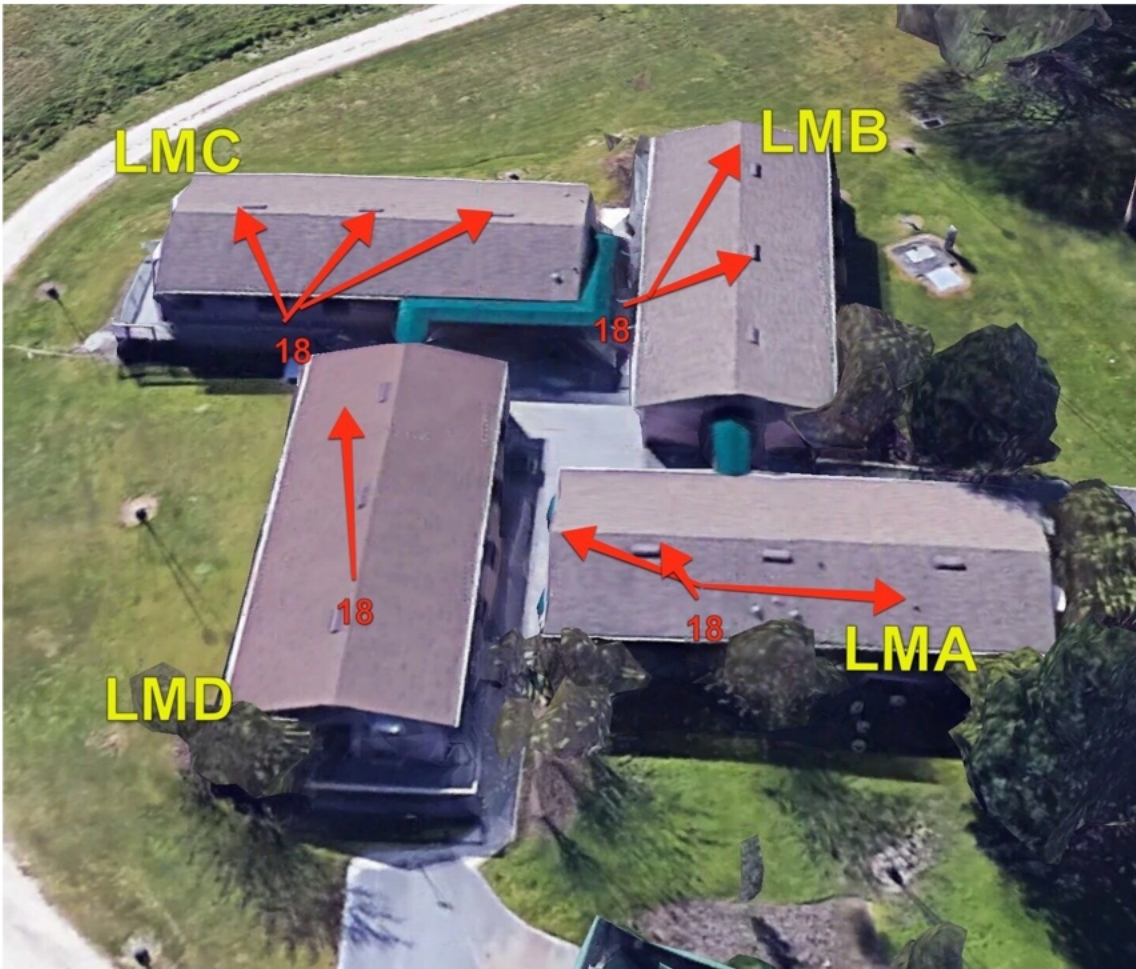
Item # 18- Damage to shingle system, broken shingles, missing flashings

Note: Minor shingle damage was noted.

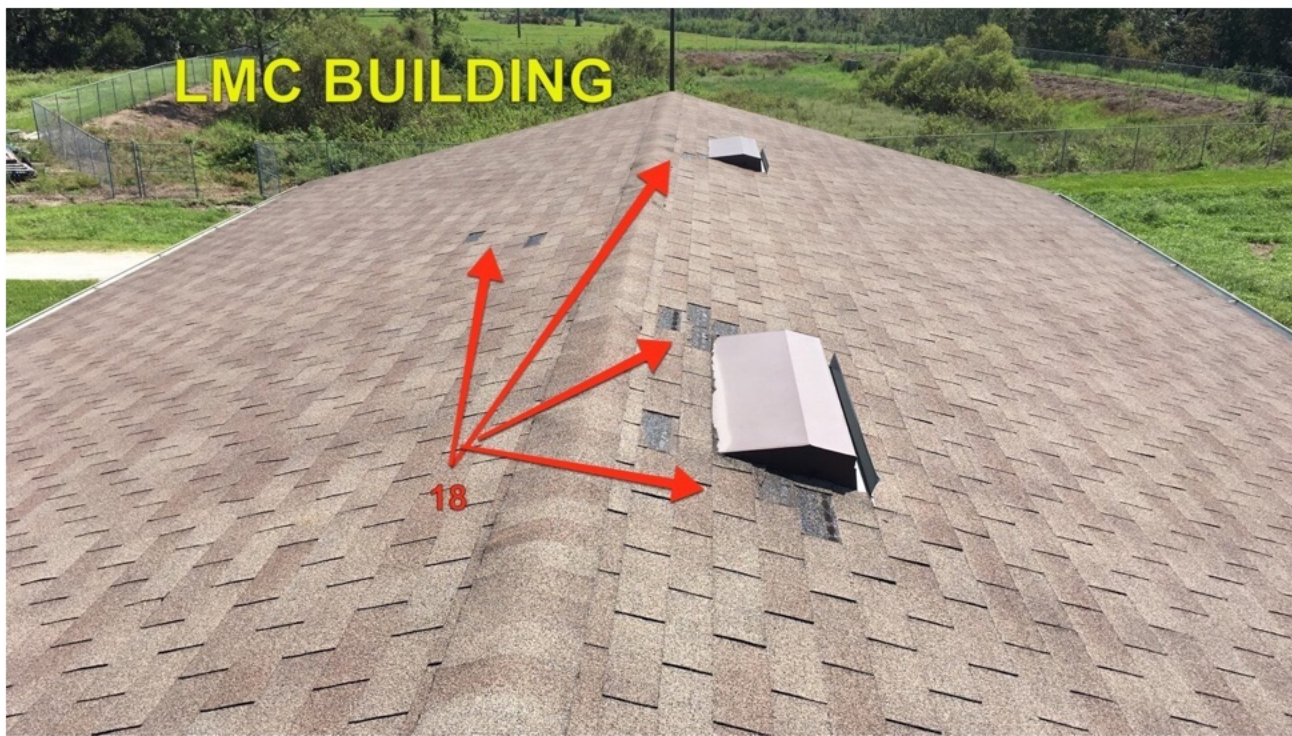
Item # 18- Damage to shingle system, broken shingles, missing flashings

Note: Minor shingle damage was noted.

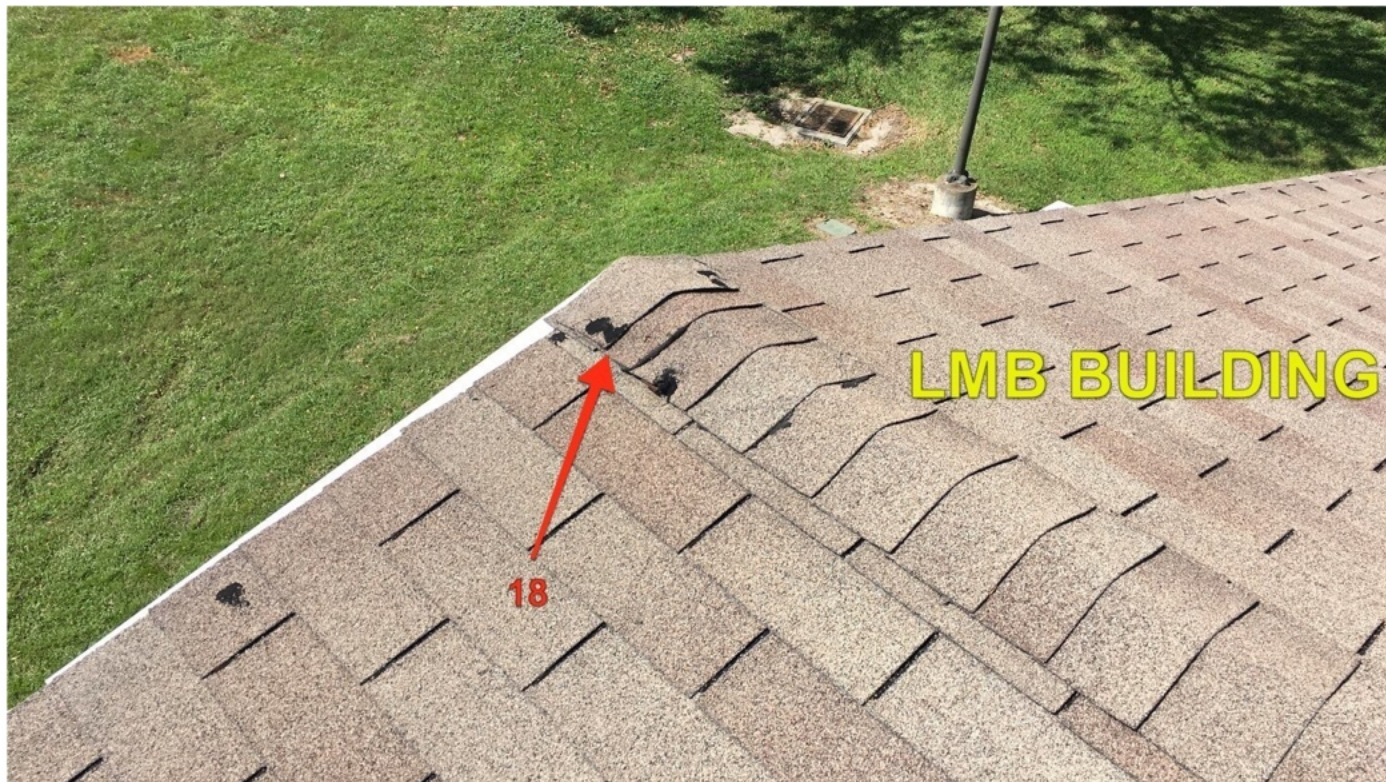
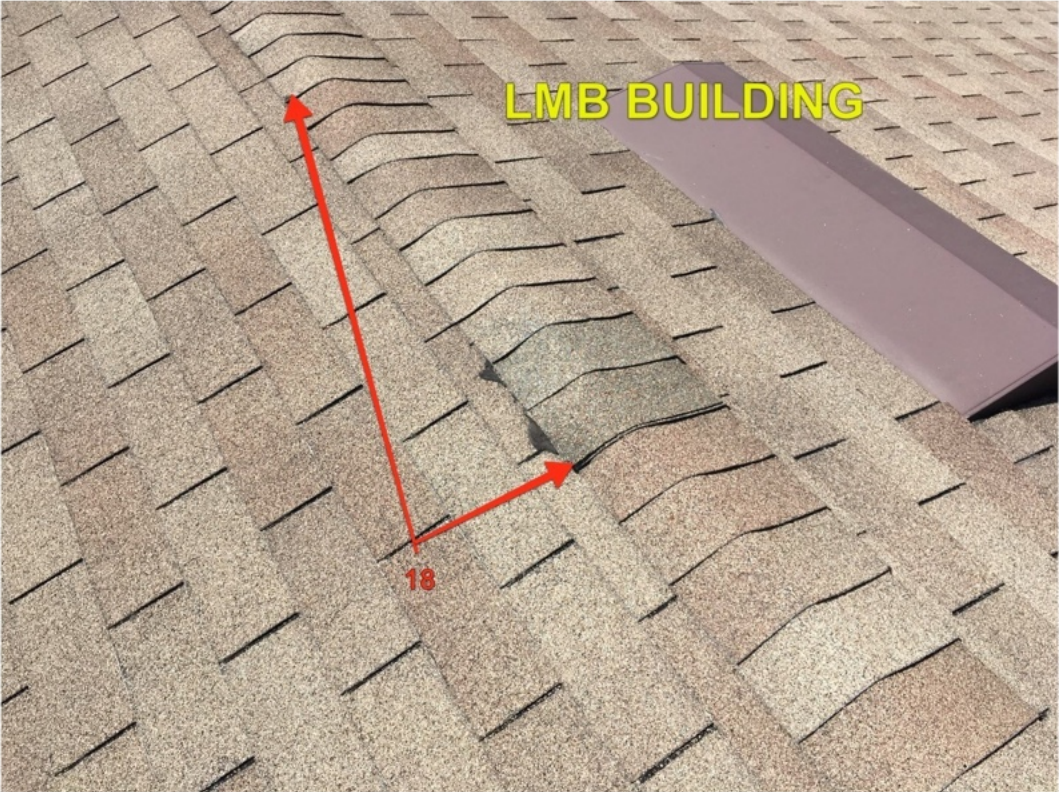
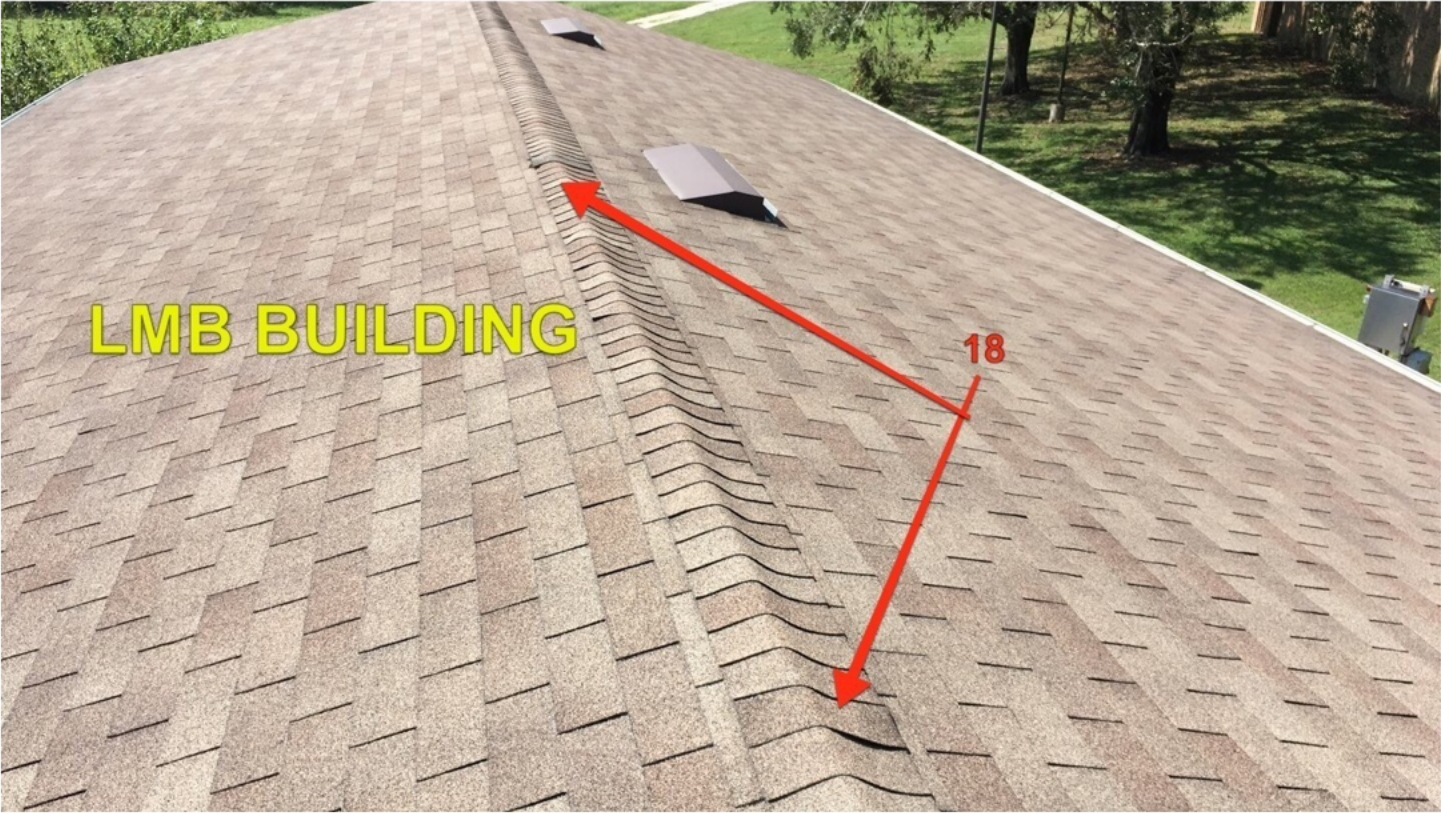
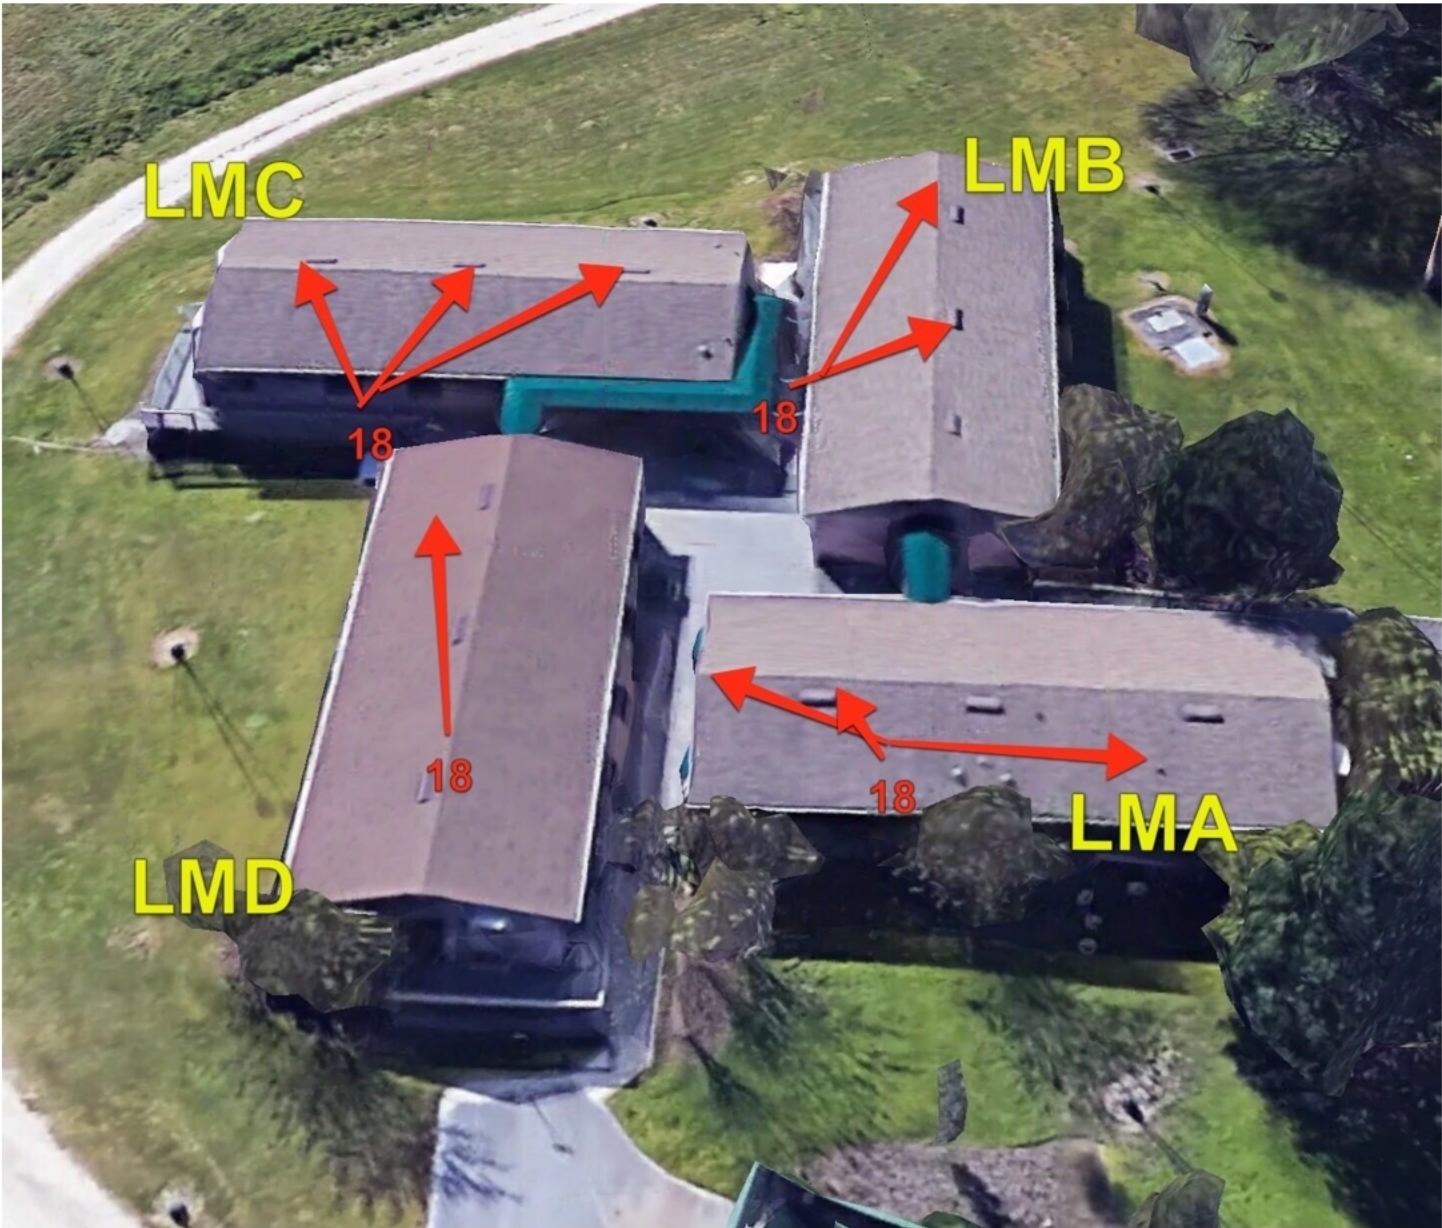
Item # 18- Damage to shingle system, broken shingles, missing flashings

Note: Minor shingle damage was noted.

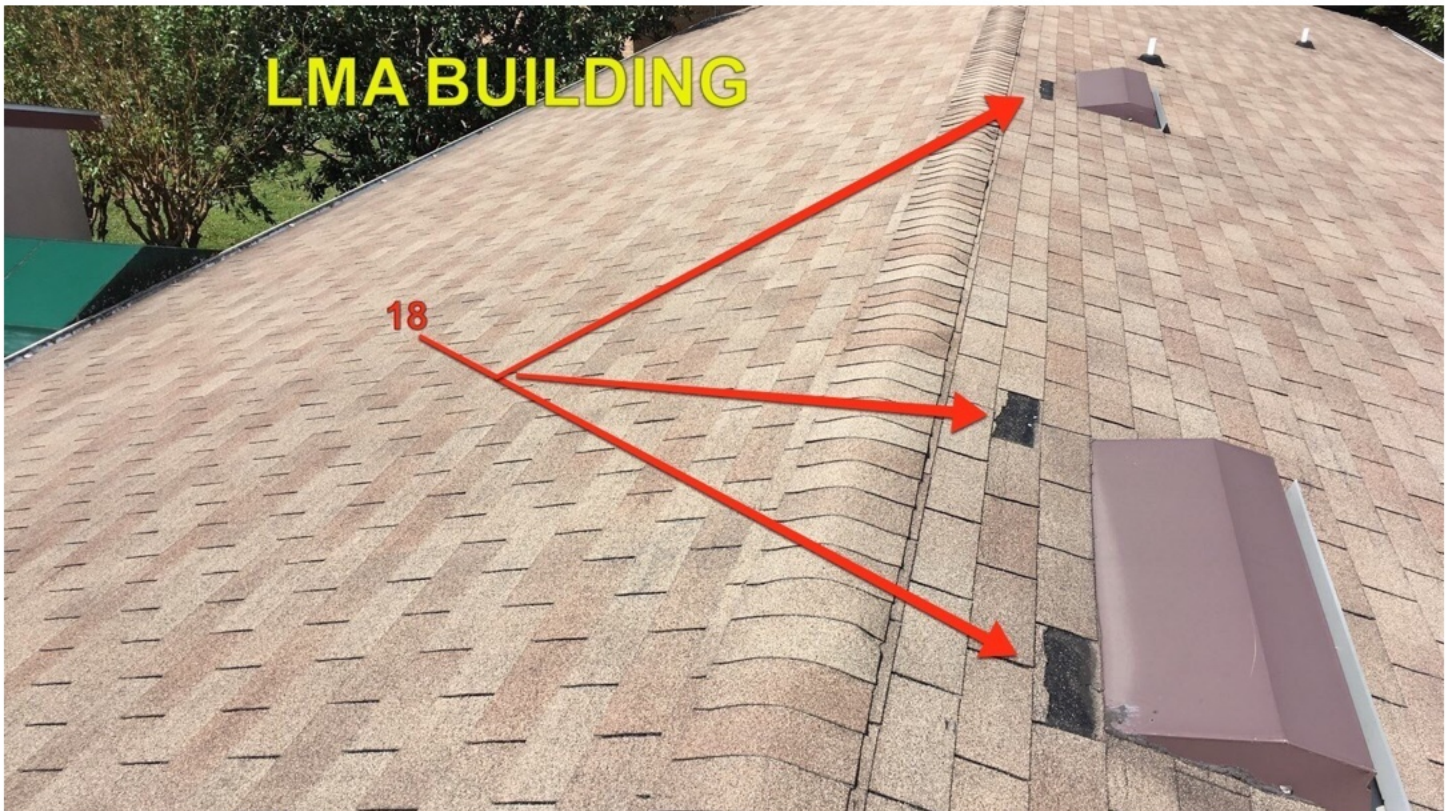
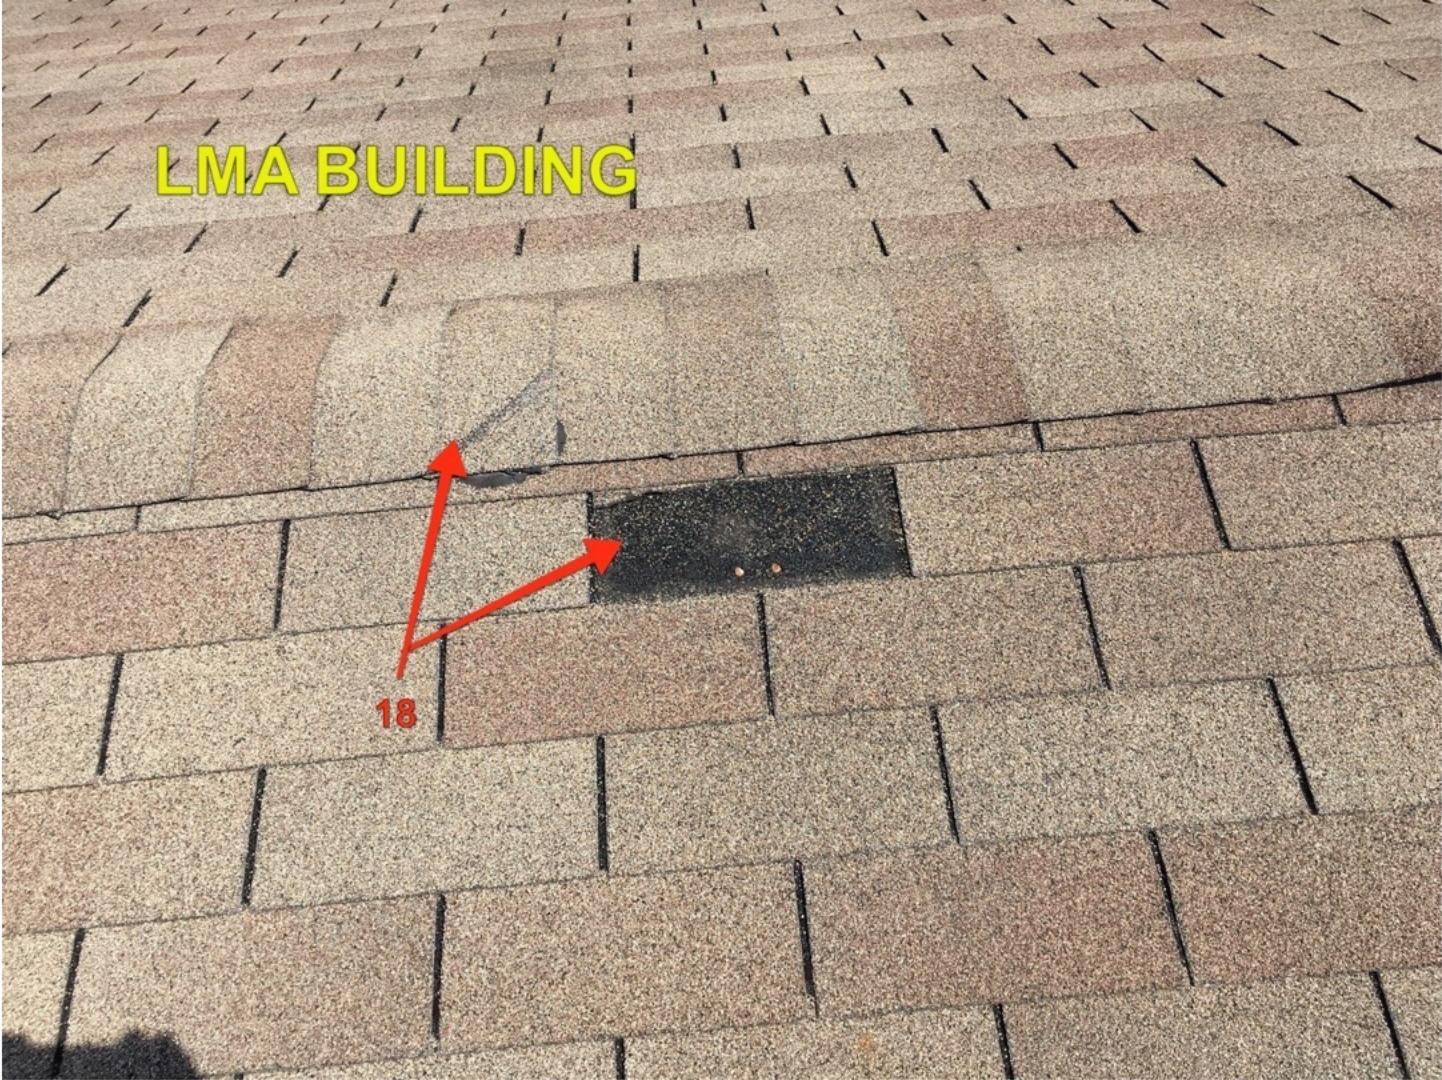
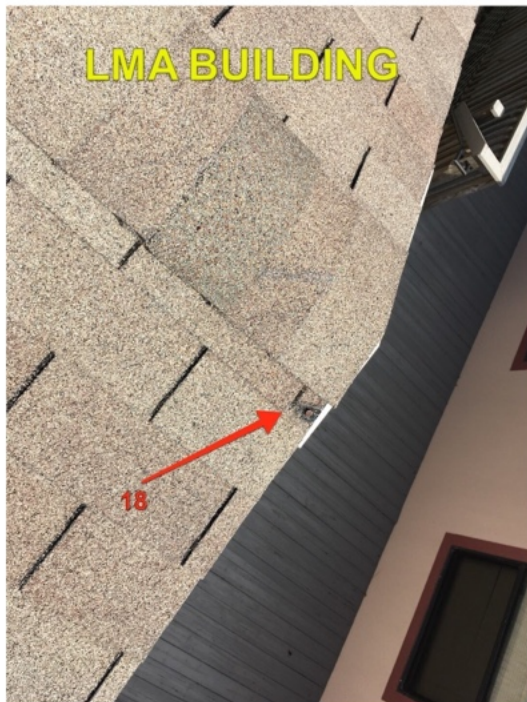
Item # 18- Damage to shingle system, broken shingles, missing flashings

Note: Minor shingle damage was noted.

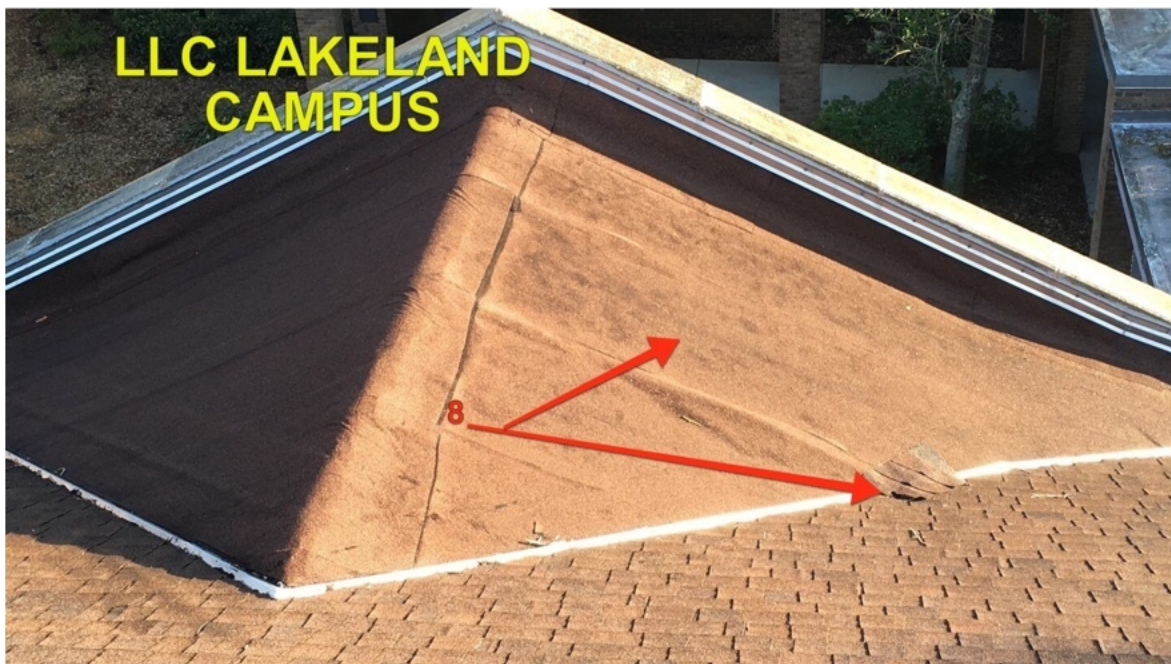
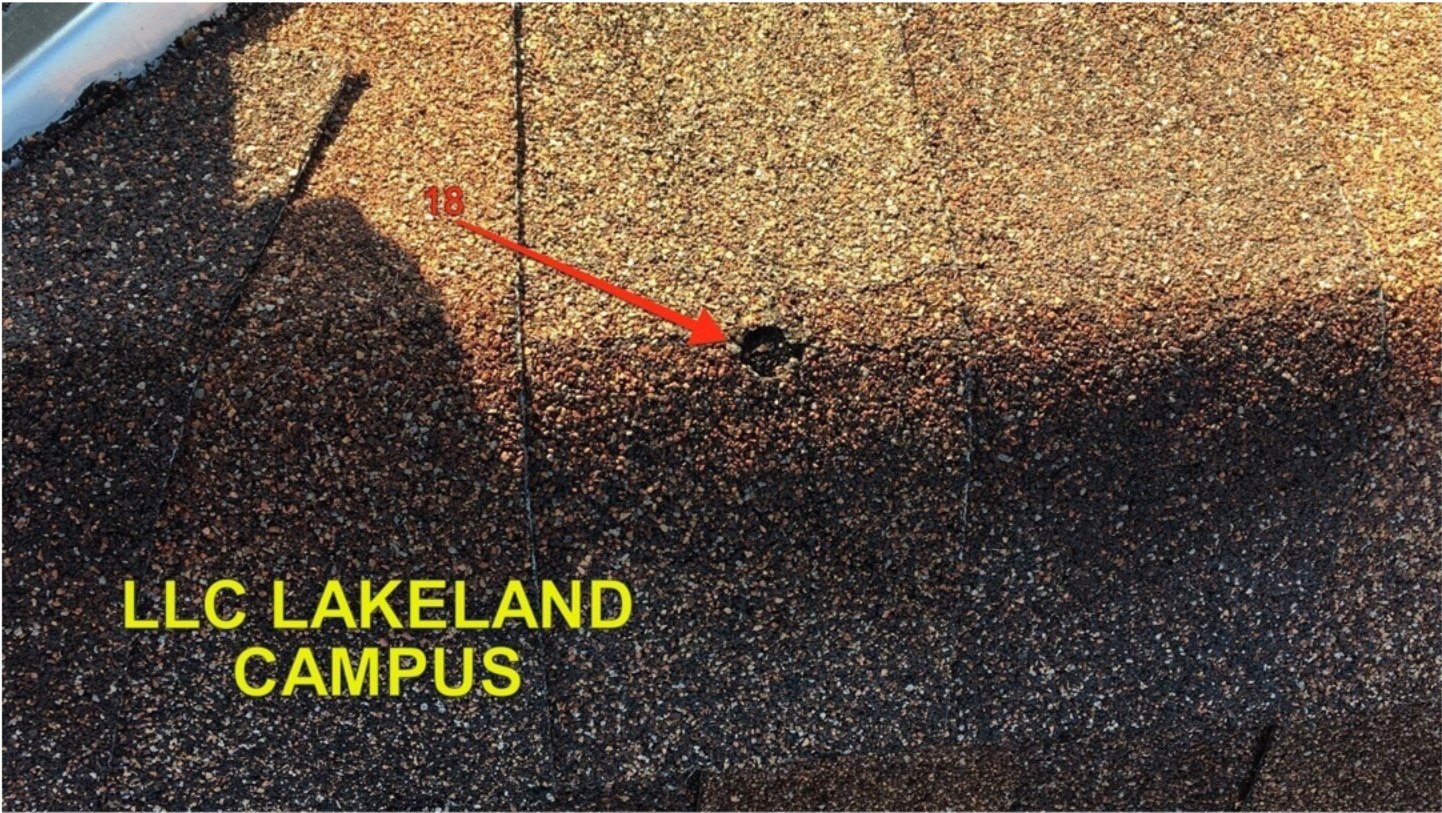
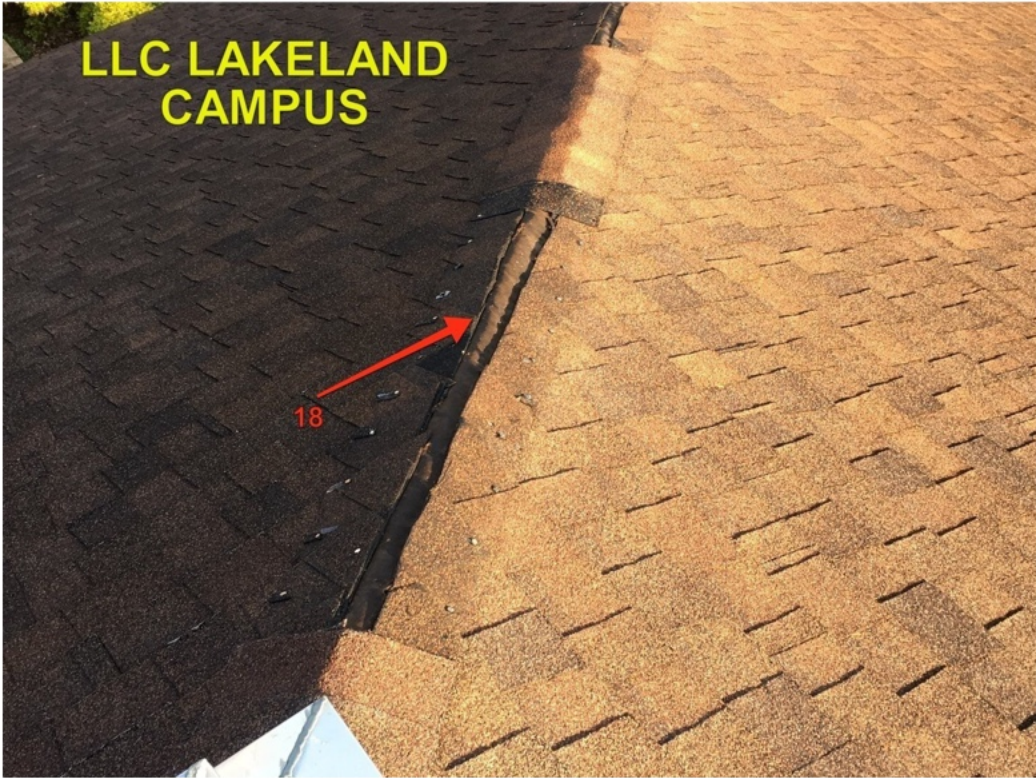
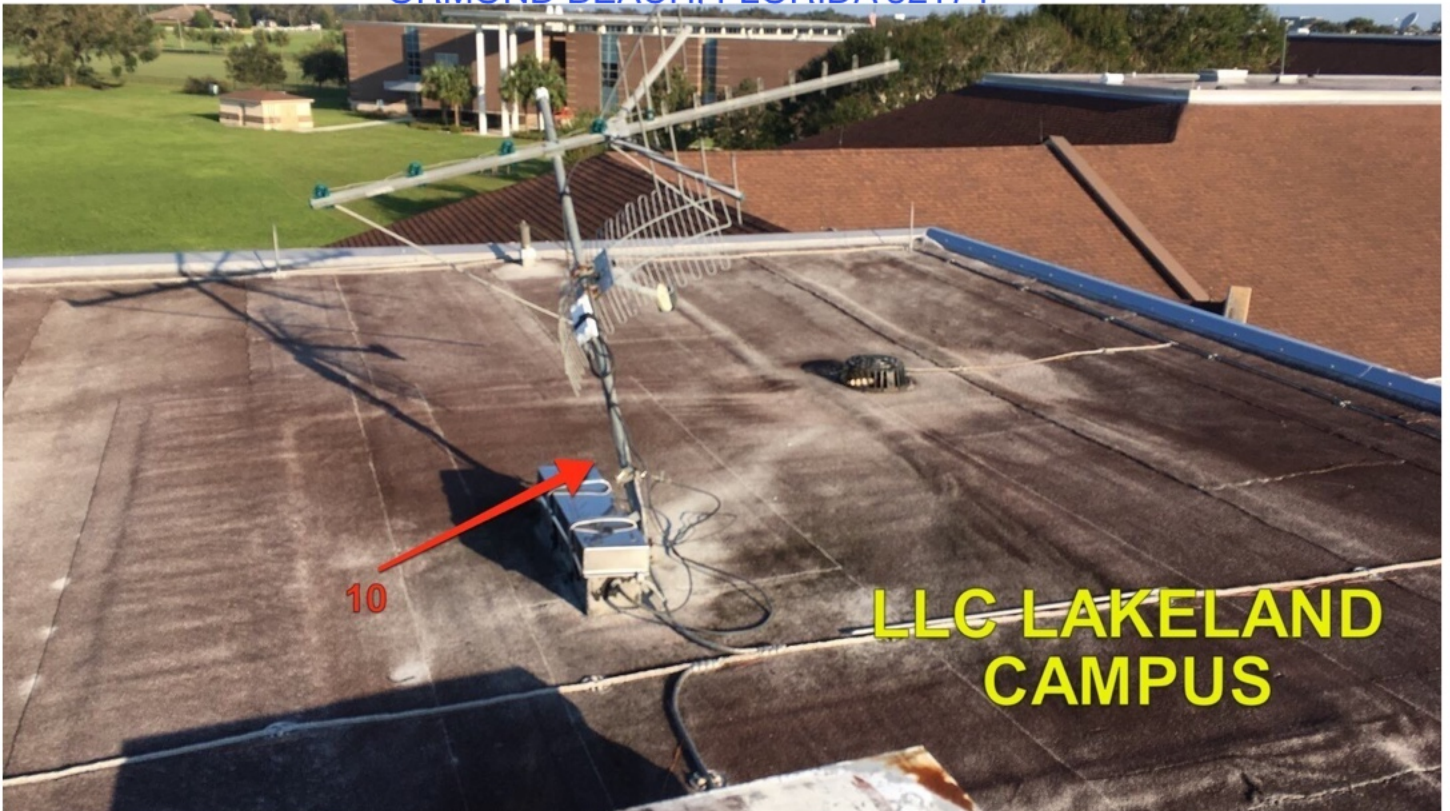
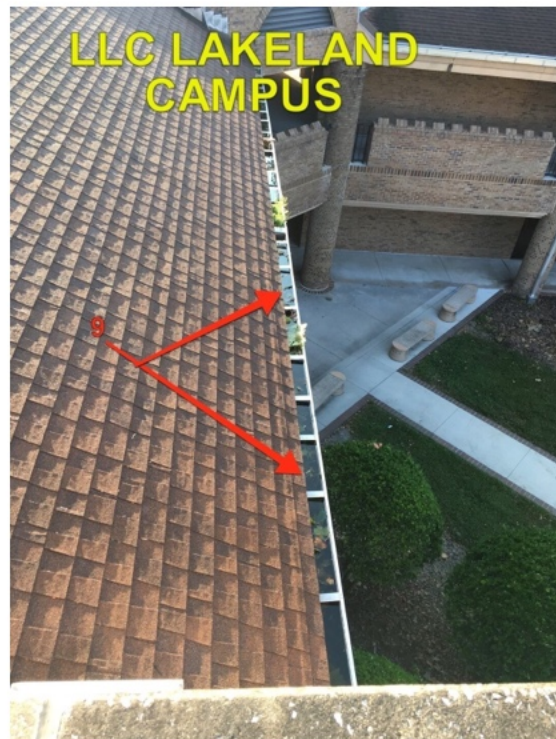
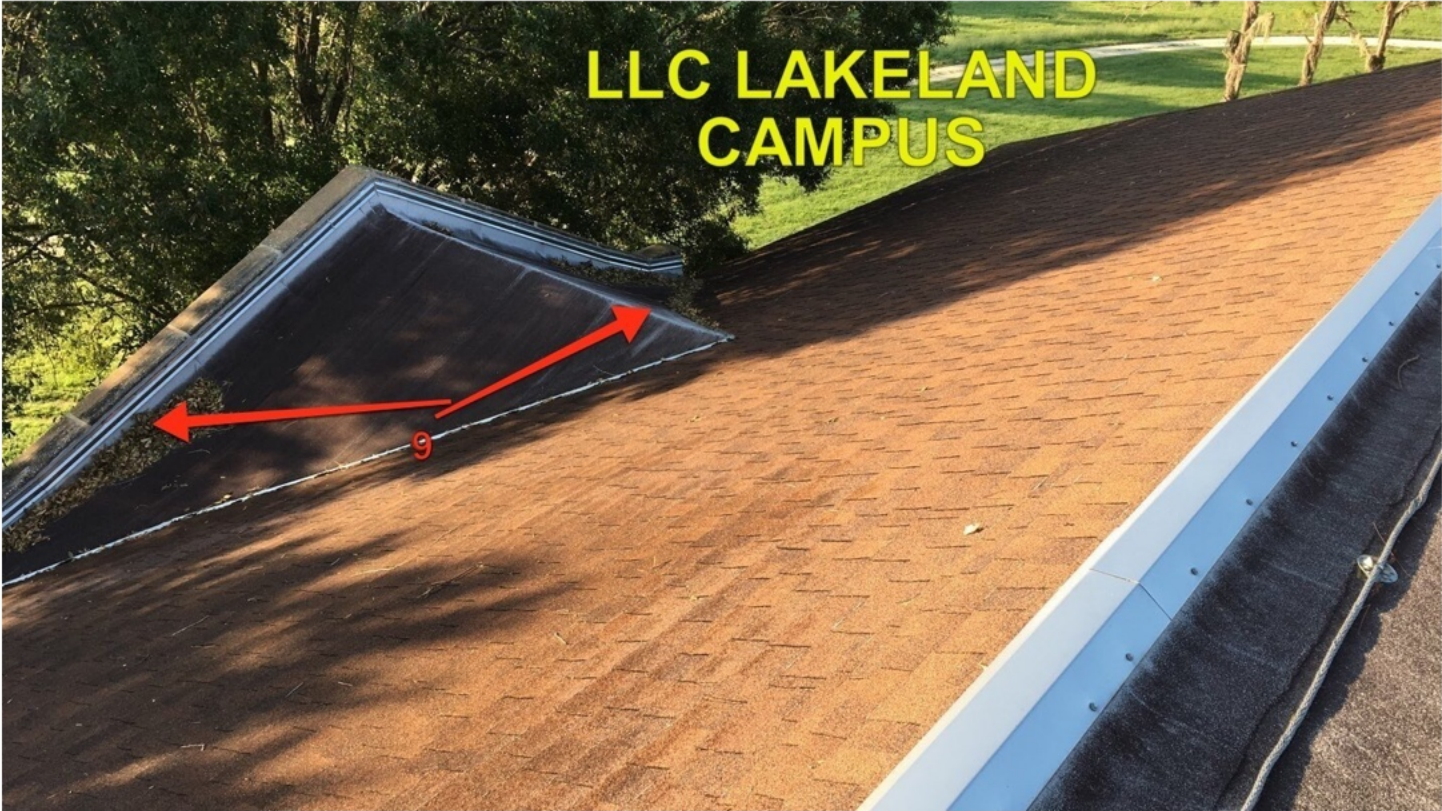
Item # 10- Damage to equipment, vents, power ventilators hoods

Item # 18- Damage to shingle roof system, broken shingles, missing flashings

Note: This appears the most damaged of buildings on the Lakeland Campus.
