RFP #18-02 for College-Wide Roof Repairs

**Damage Report**

DEFECT/DAMAGE LIST HURRICANE IRMA

### ROOF SURVEY DAMAGE REPORT- HURRICANE IRMA

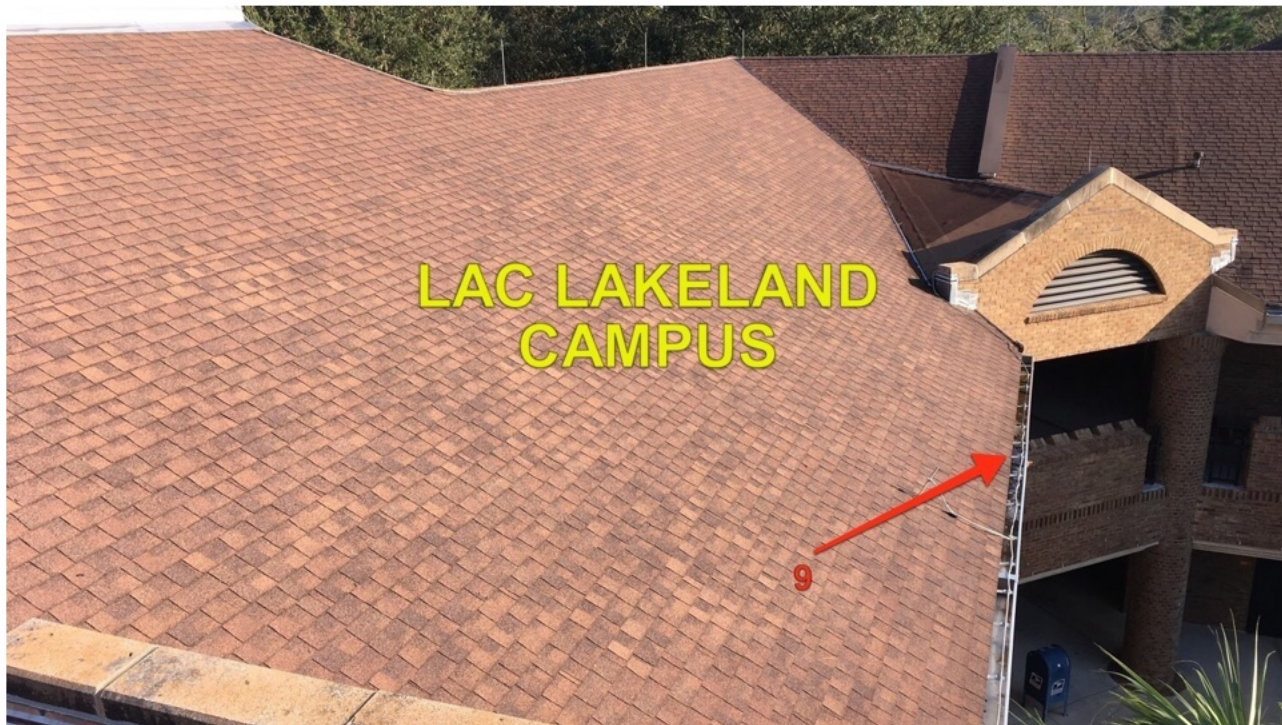
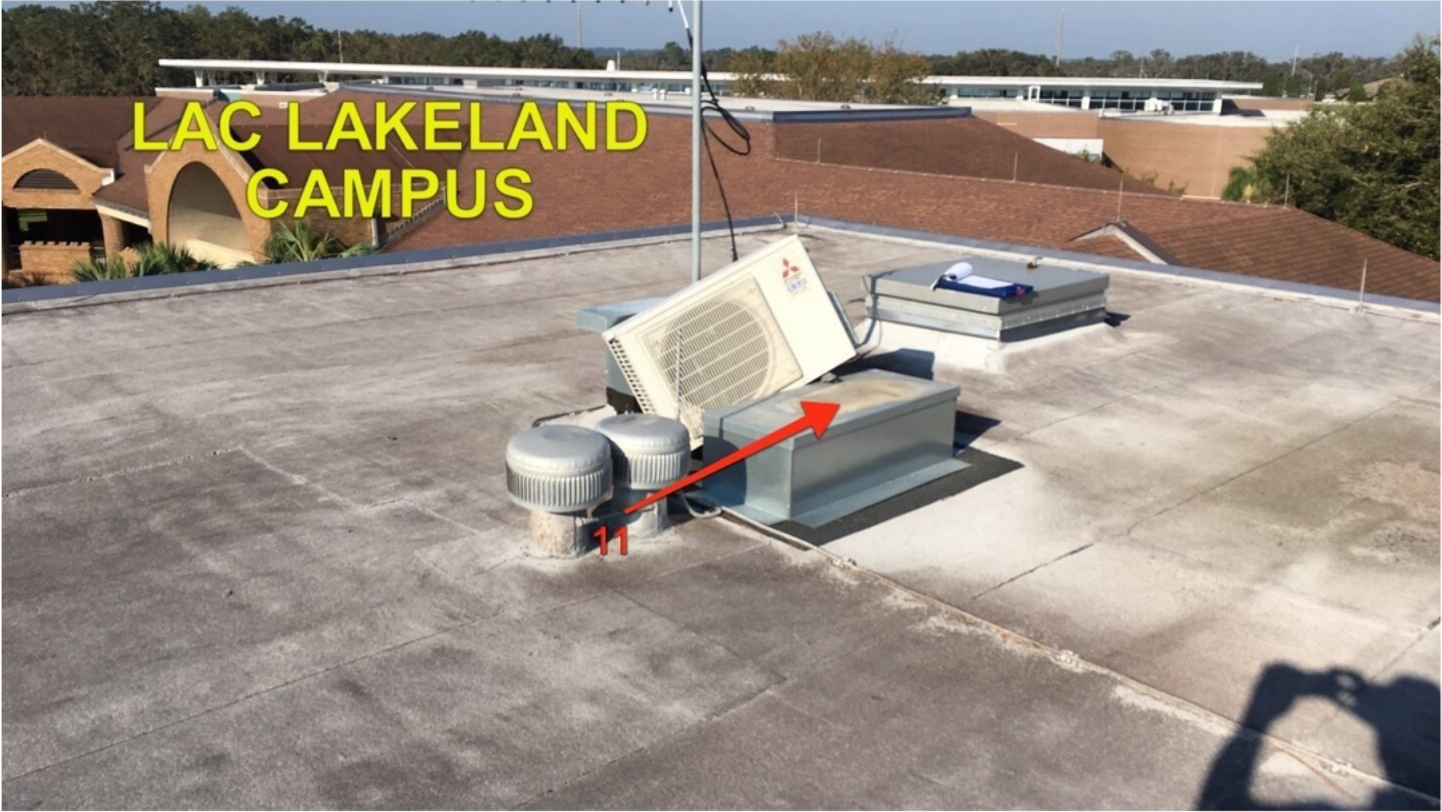
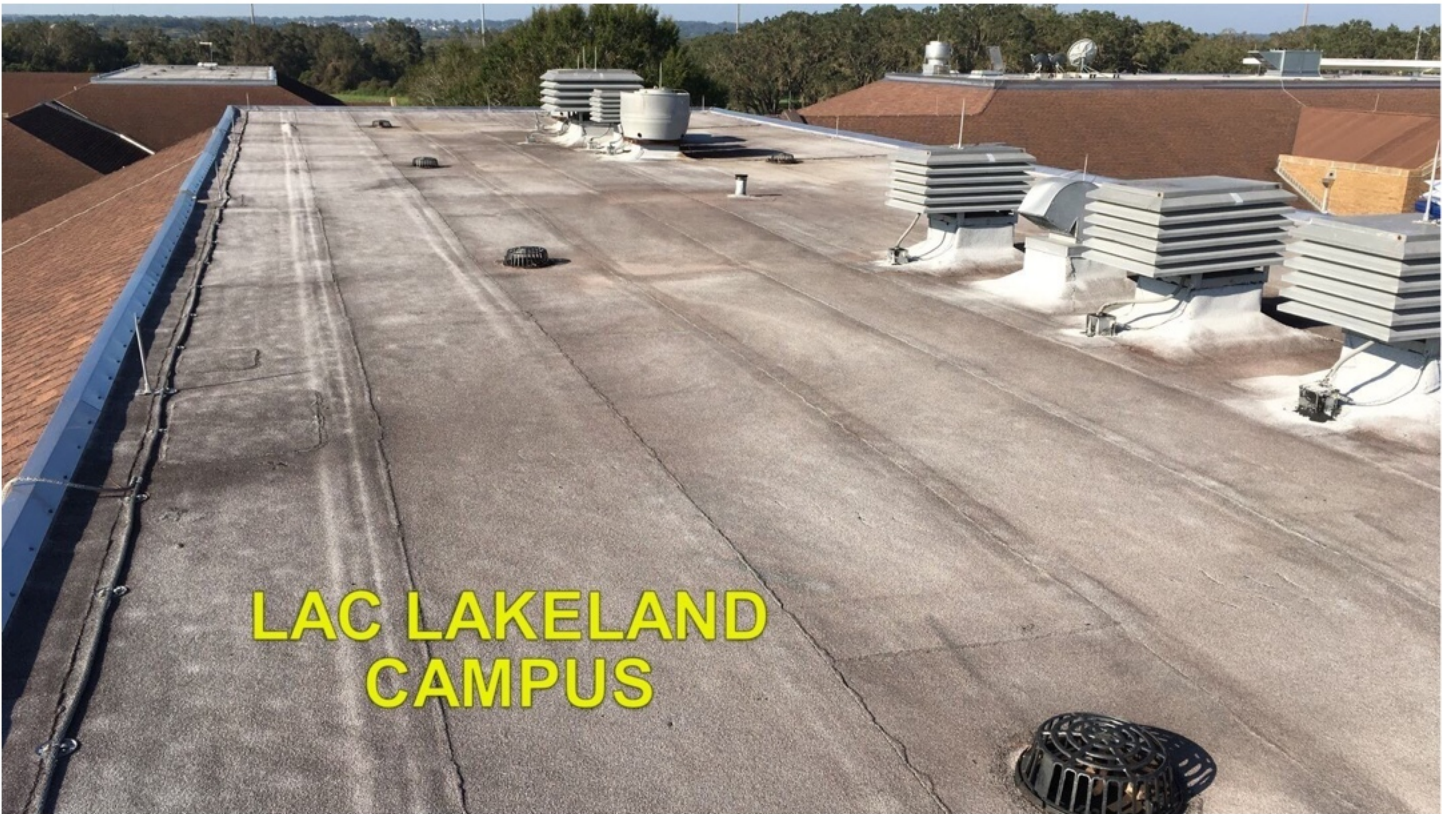
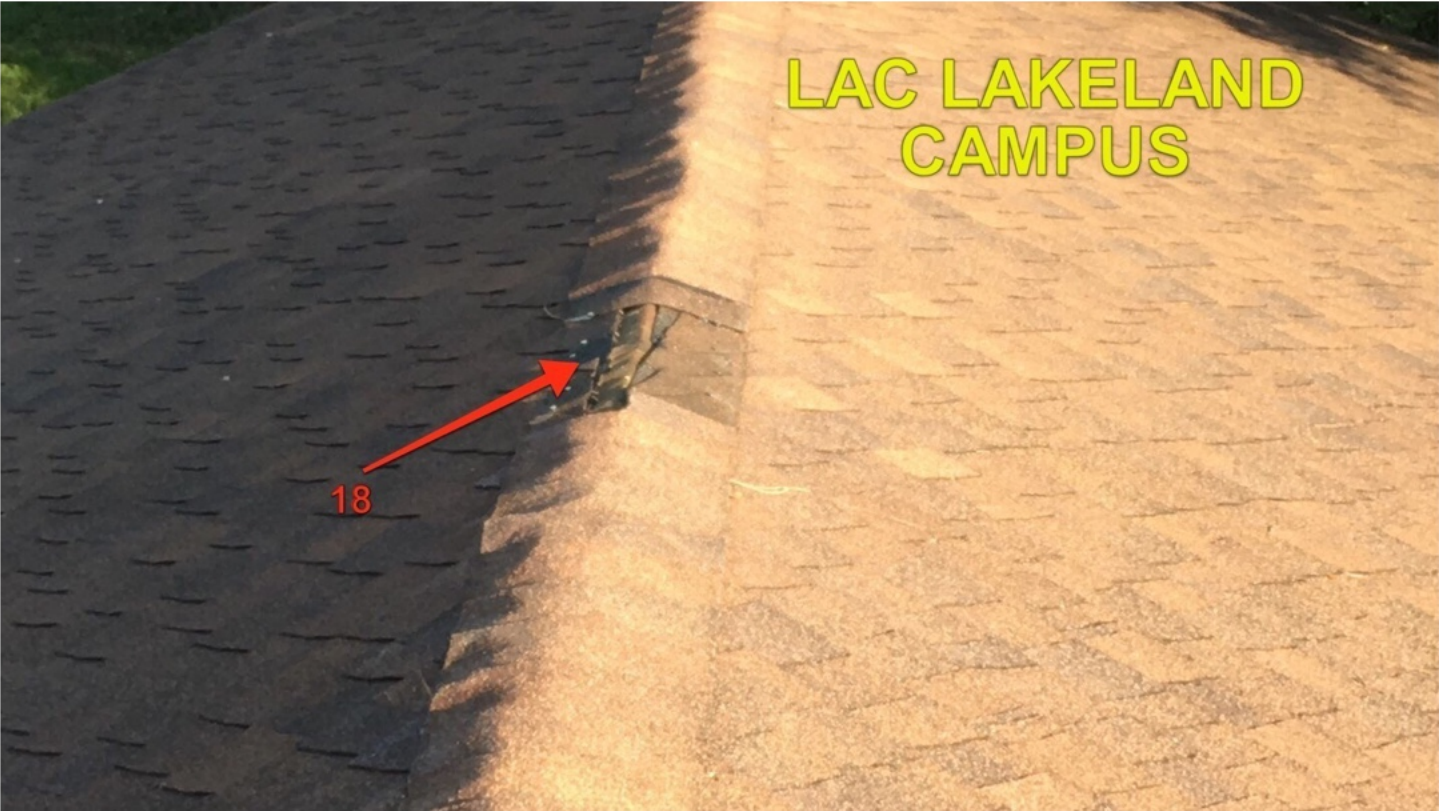
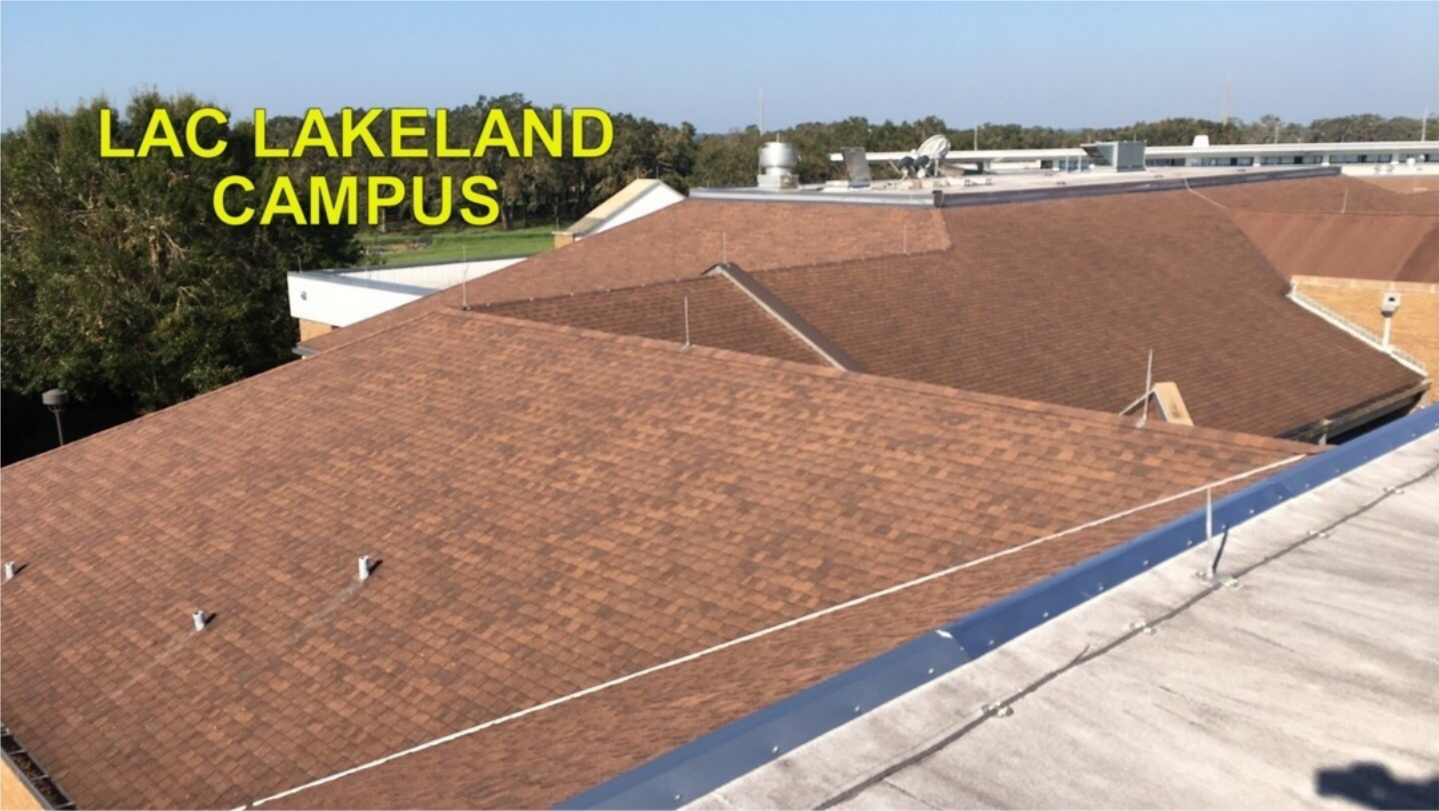
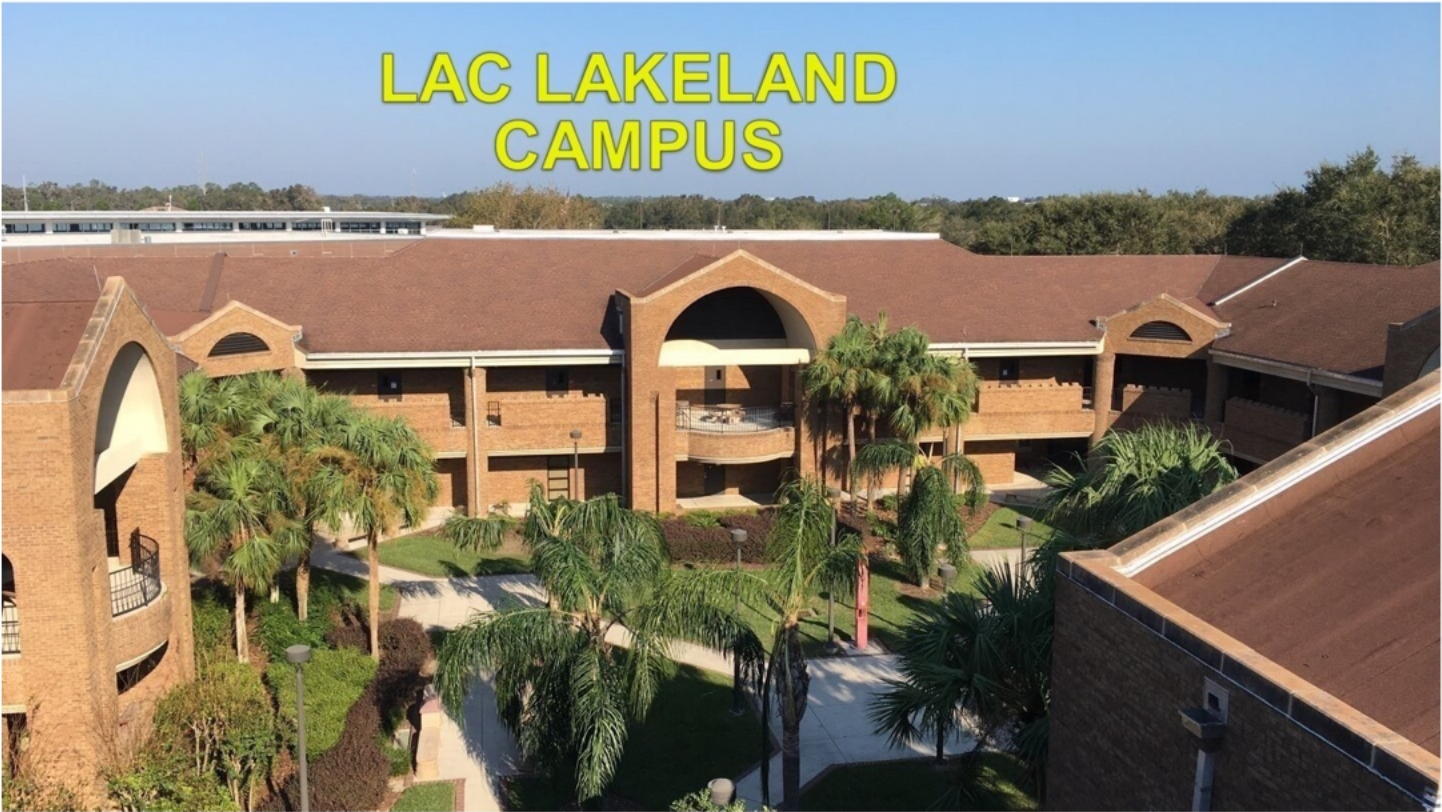
Item # 11- Damage to air conditioning units.

Item # 18- Damage to shingle roof system, broken or missing shingles, missing flashings

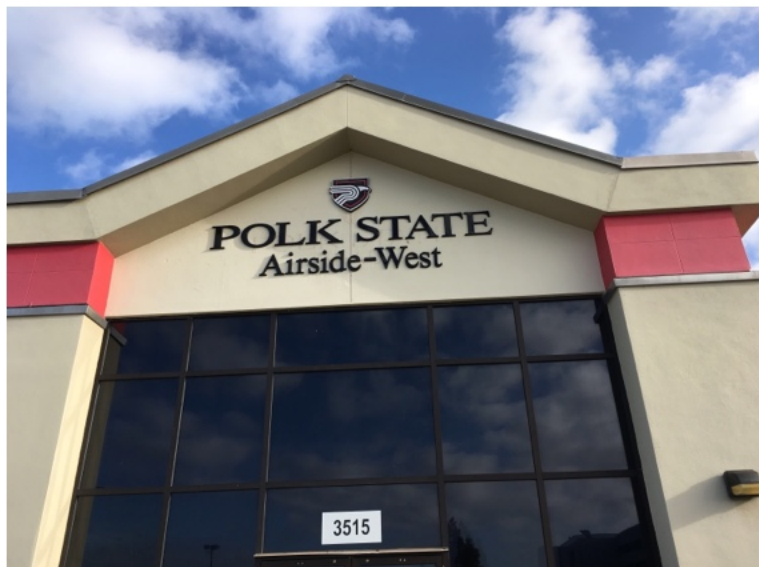
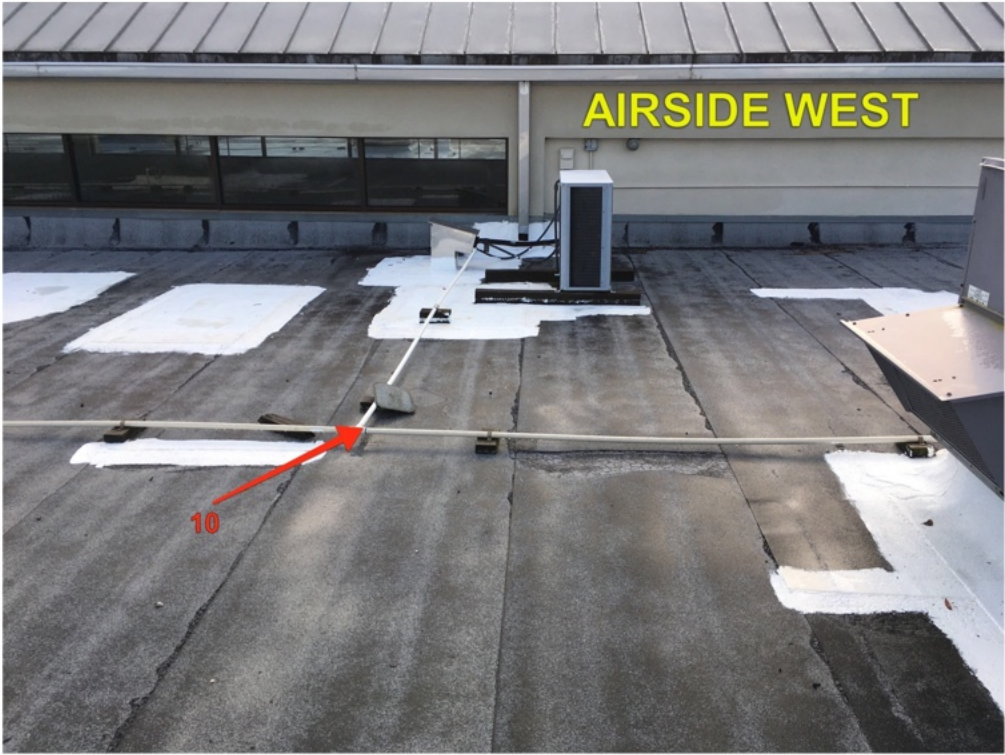
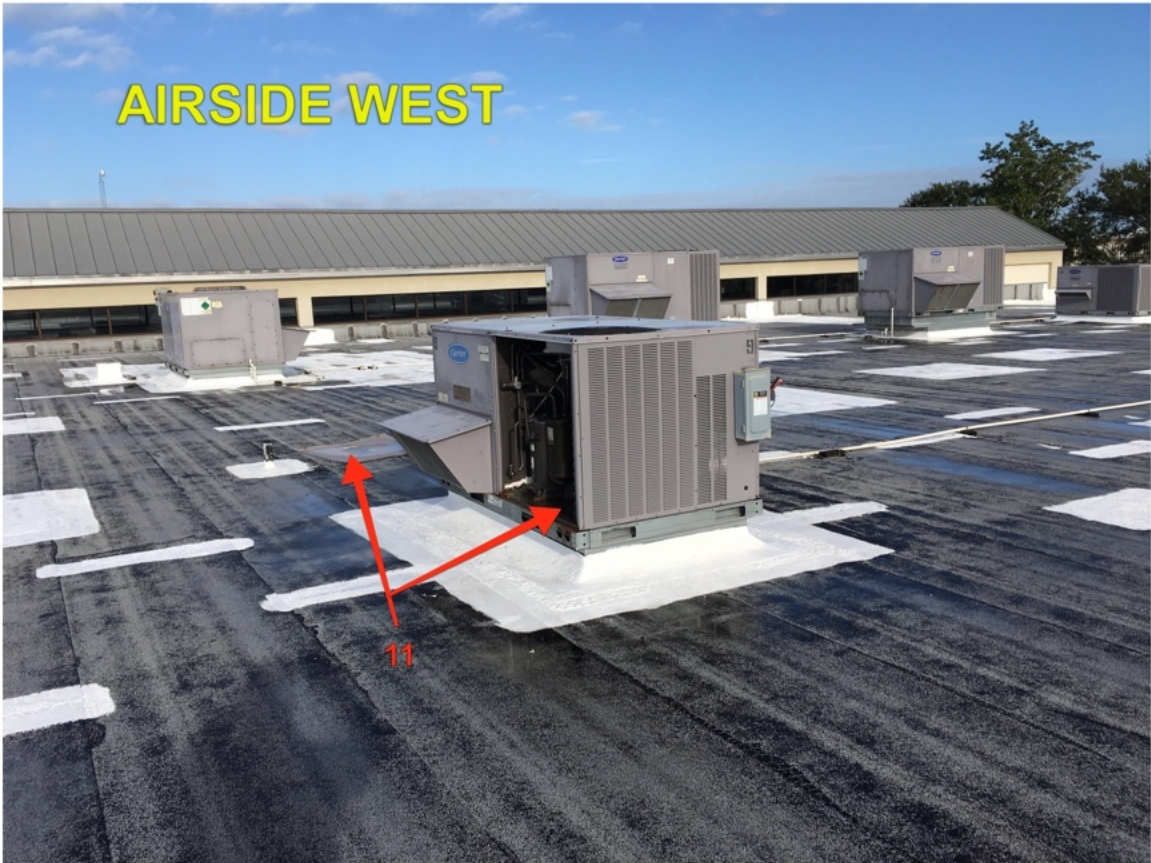
Item # 10- Damage to equipment, power ventilators, vents, hoods.

Item # 11- Damage to Air Condition Units.

Item # 13- Displaced or damaged metal flashings.

Item # 21- Possible impact damage to stucco finish.

Note: It appears that HVAC units may have suffered some damage from parts blown off during storm. Additionally impact from parts may have cracked stucco finish at East side of high roof of building. The metal flashing is missing and damaged at the low metal roof at the rear of the building.

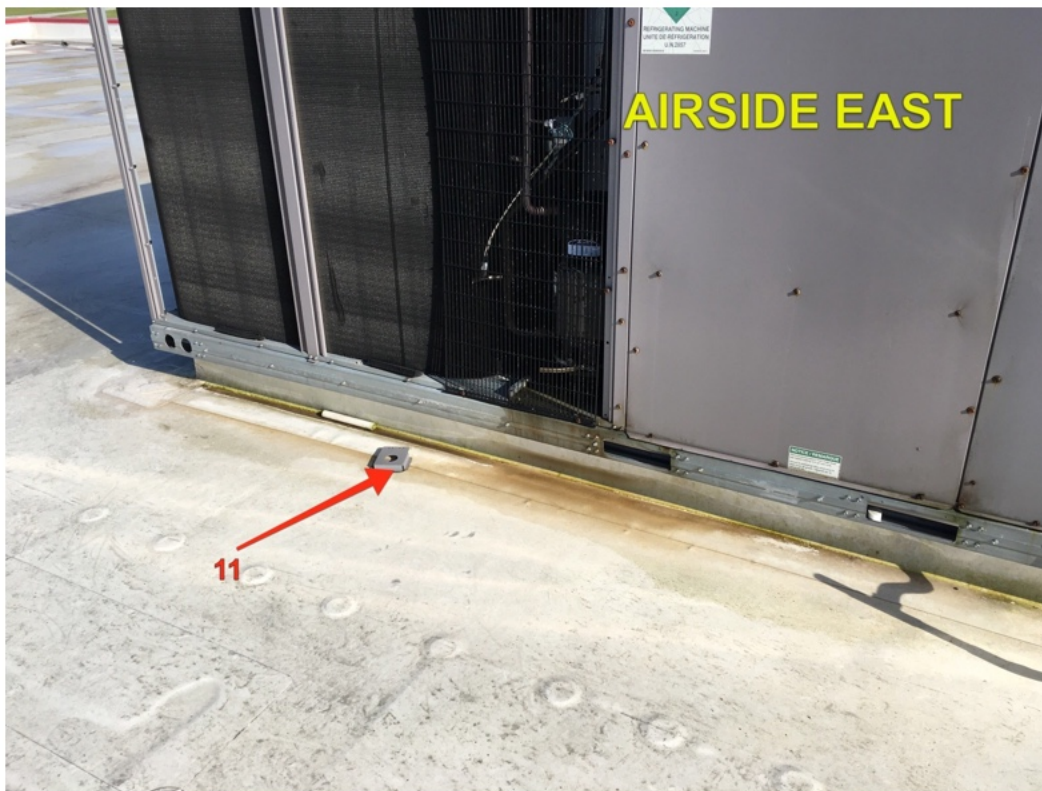
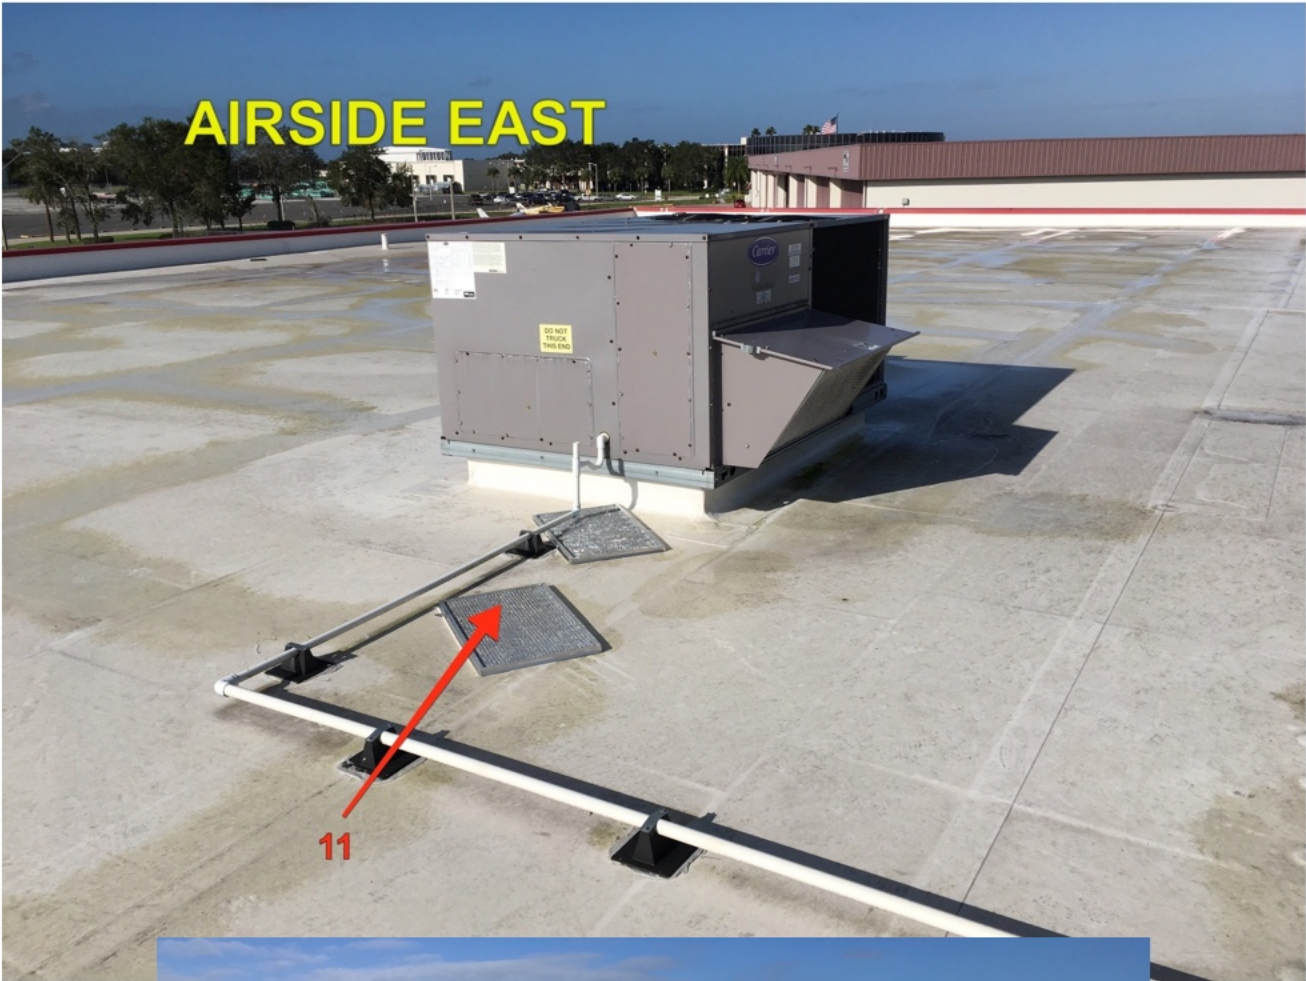
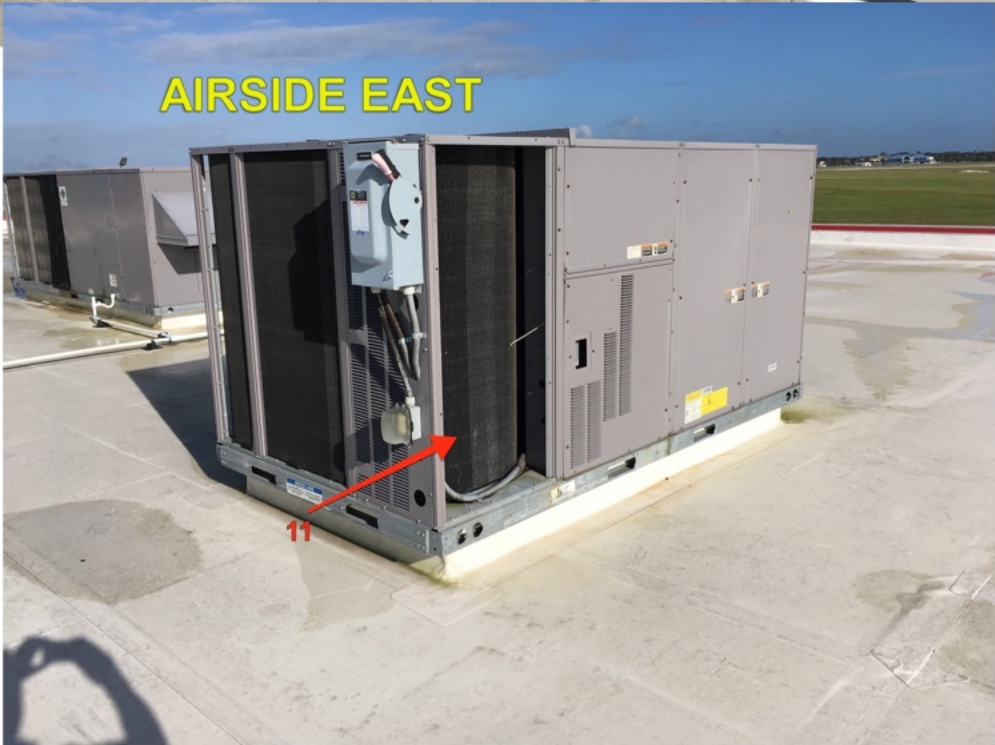
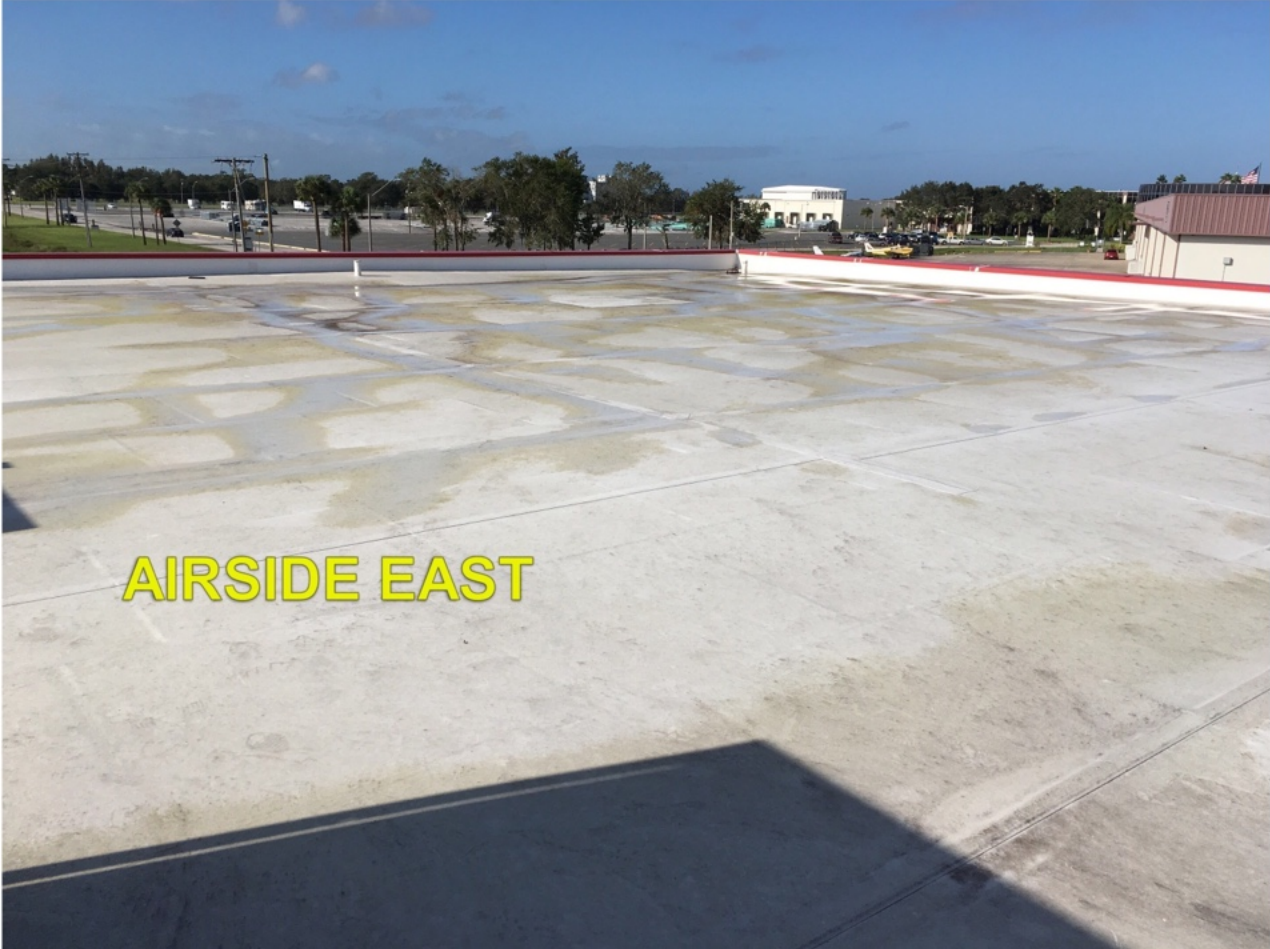
Items # 11- Damage to air conditioning units.

Note: It appears wind damage has blown some covers and components of the HVAC units loose.
